Japanese Tea Garden Master Plan

Japanese Tea Garden
Master Plan
San Antonio, Texas

June 2007

SWA Group
Project Landscape Architect
Houston, Texas

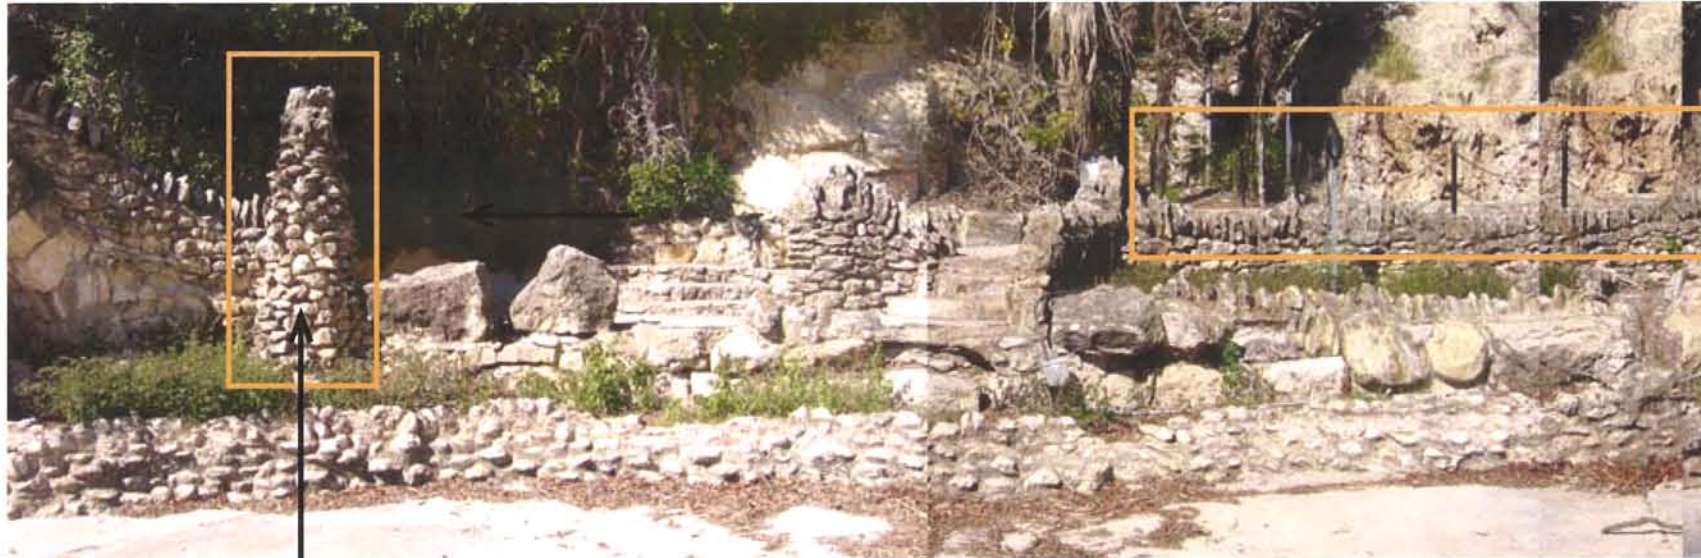
21

HISTORIC PYLON IN GOOD CONDITION

21. The pond wall in this portion has been compromised by overgrown and invasive cane. The cane should be removed. The pond wall is cracked, deteriorating, or even missing in much of the portion. The area is also impacted by rock slides from above, which is especially dangerous because there is a pedestrian path through this area. There is also a non-historic railing. Historically, this was a lower pathway that allowed visitors to view the ponds at water level. This is an important user experience and should be restored. The ponds should be reconstructed so the railing is not a necessary safety precaution.

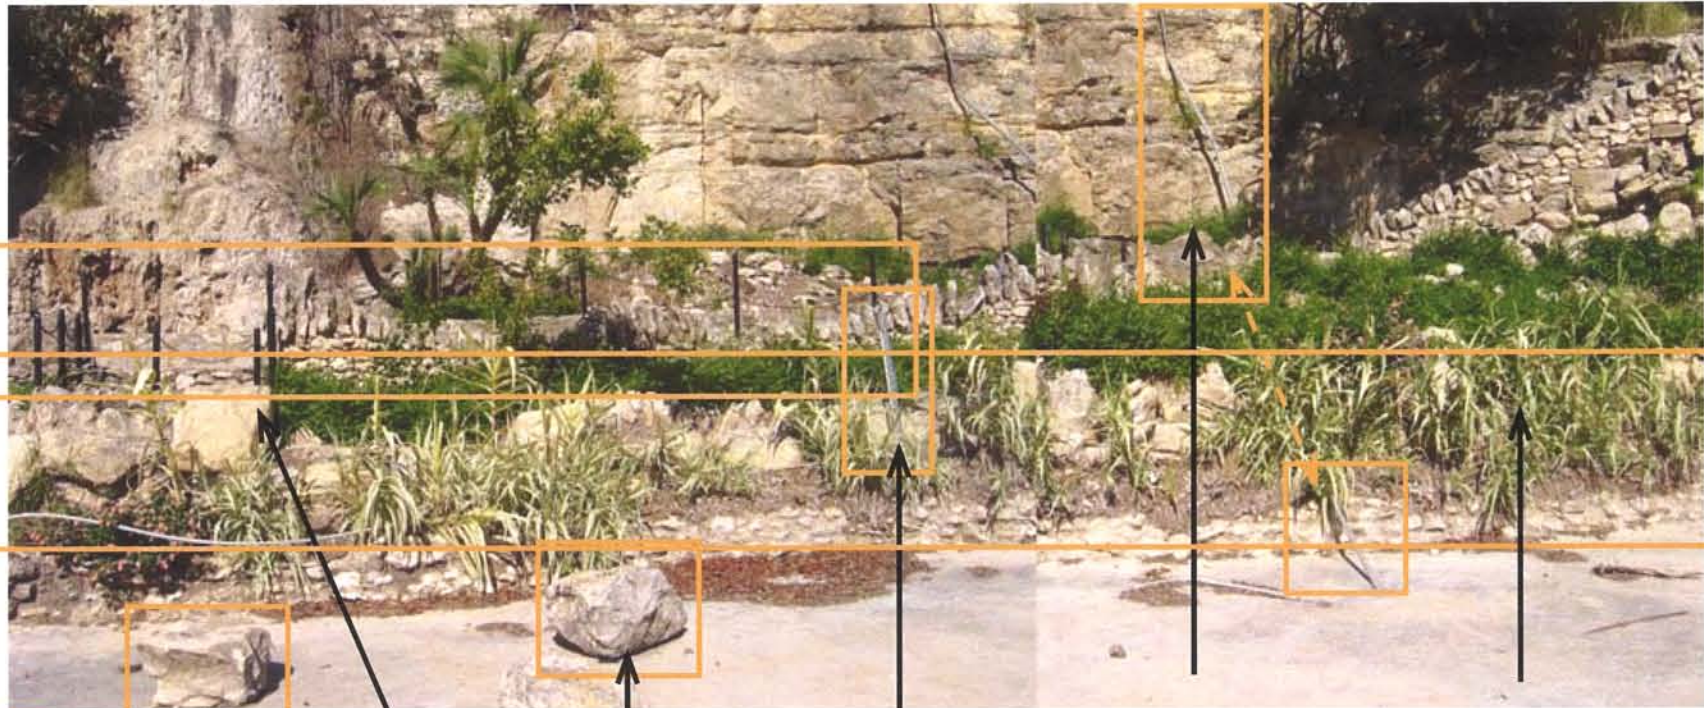
23
 FALLEN ROCK
 REMOVE NON-HISTORIC RAIL
 FALLEN ROCK
 REMOVE LIGHT POST.
 REMOVE METAL CONDUIT.
 WALL CRACKED AND DETERIORATING OR NOT EXISTING IN THIS AREA. INVASIVE AND OVERGROWN CANE TO BE REMOVED

23. The pond wall in this portion has been compromised by overgrown and invasive cane. The cane should be removed. The pond wall is cracked, deteriorating, or even missing in much of this portion. The area is also impacted by rock slides from above. Measures should be taken to prevent future rock slides. Securing Alpine Drive from above will be a great step towards this measure (see safety and security analysis).

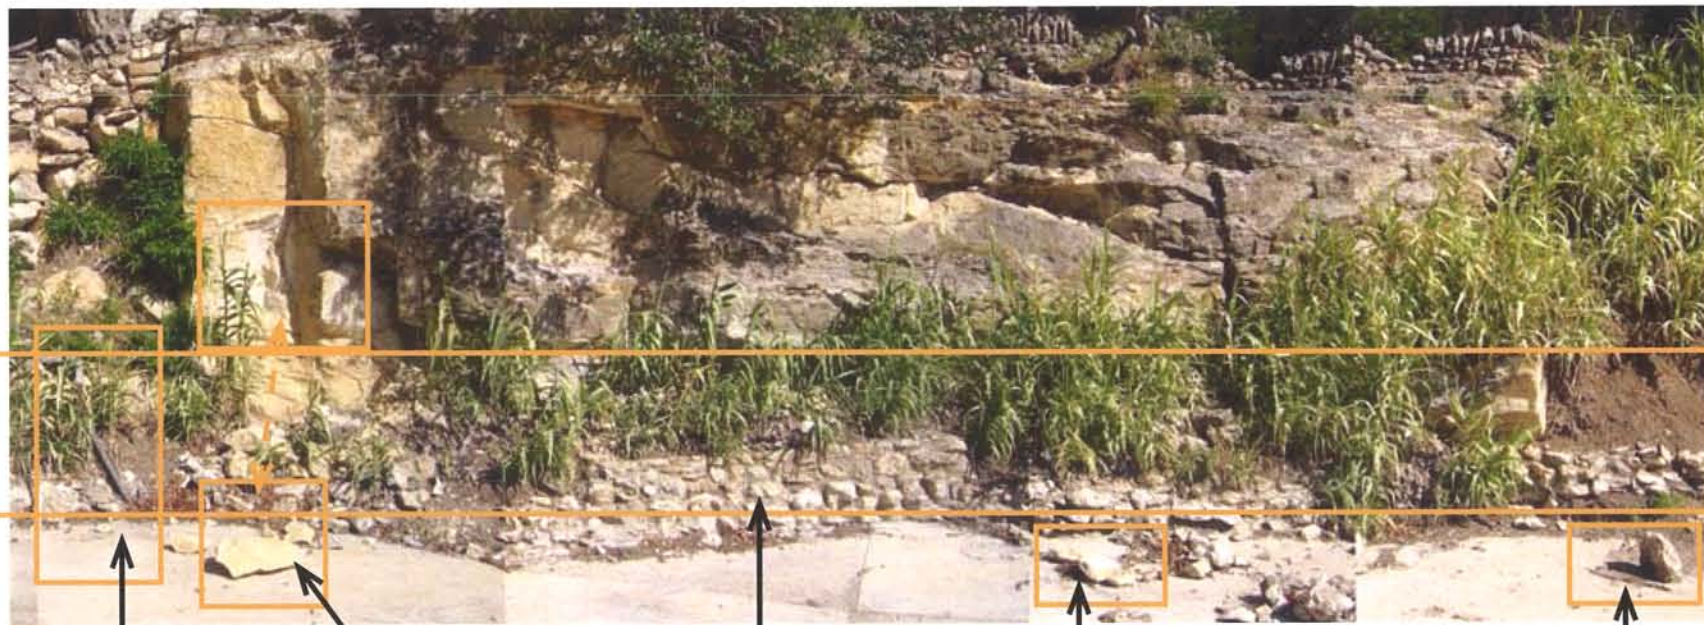
24. The pond wall in this portion has been compromised by overgrown and invasive cane. The pond wall is cracked, deteriorating, or even missing in much of this portion. The area is also impacted by rock slides from above. Measures should be taken to prevent future rock slides. Securing Alpine Drive from above will be a great step towards this measure (see safety and security analysis). The cane should be removed. Repair wall as necessary.

24
 REMOVE METAL CONDUIT/PIPE.
 LIMESTONE WALL SPLITTING AND FALLING INTO POND.
 WALL CRACKED AND DETERIORATING OR NOT EXISTING IN THIS AREA. INVASIVE AND OVERGROWN CANE TO BE REMOVED.
 LIMESTONE WALL SPLITTING AND FALLING INTO POND.
 LIMESTONE WALL SPLITTING AND FALLING INTO POND.

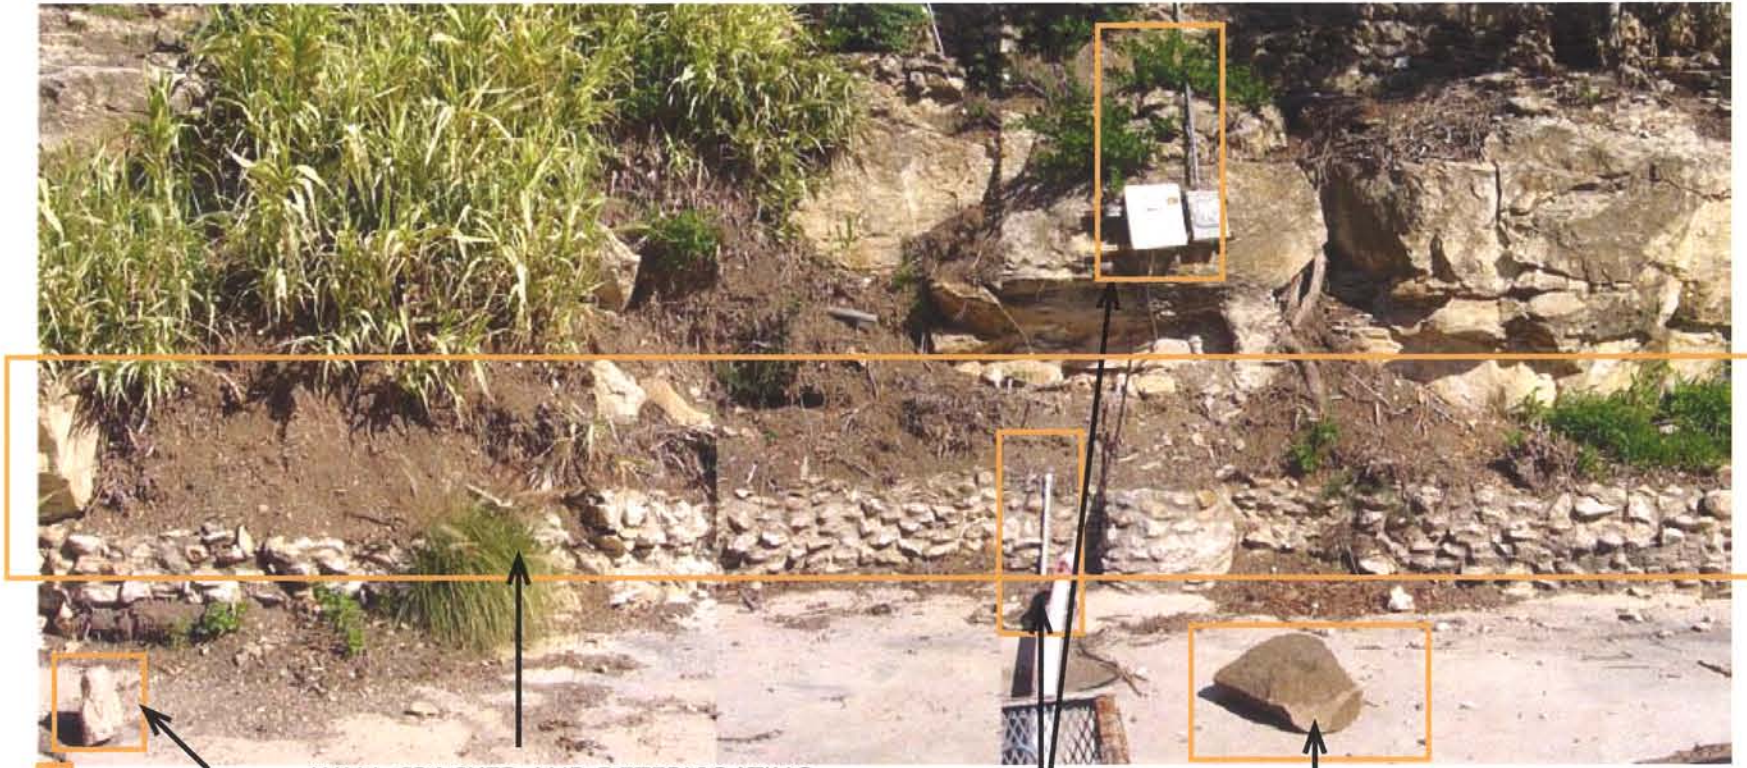
25 **FALLEN ROCK** WALL CRACKED AND DETERIORATING OR NOT EXISTING IN THIS AREA. INVASIVE AND OVERGROWN CANE TO BE REMOVED.

REMOVE METAL CONDUIT, PIPE + ELECTRICAL PANEL.

25. The pond wall in this portion has been compromised by overgrown and invasive cane. Remove cane. The pond wall is cracked, deteriorating, or even missing in much of this portion. The area is also impacted by rock slides from above. Measures should be taken to prevent future rock slides. Securing Alpine Drive from above will be a great step towards this measure (see safety and security analysis). All exposed piping, conduit and electrical panels should be hidden with either planting or placed in a non-conspicuous location. All unused piping should be removed.

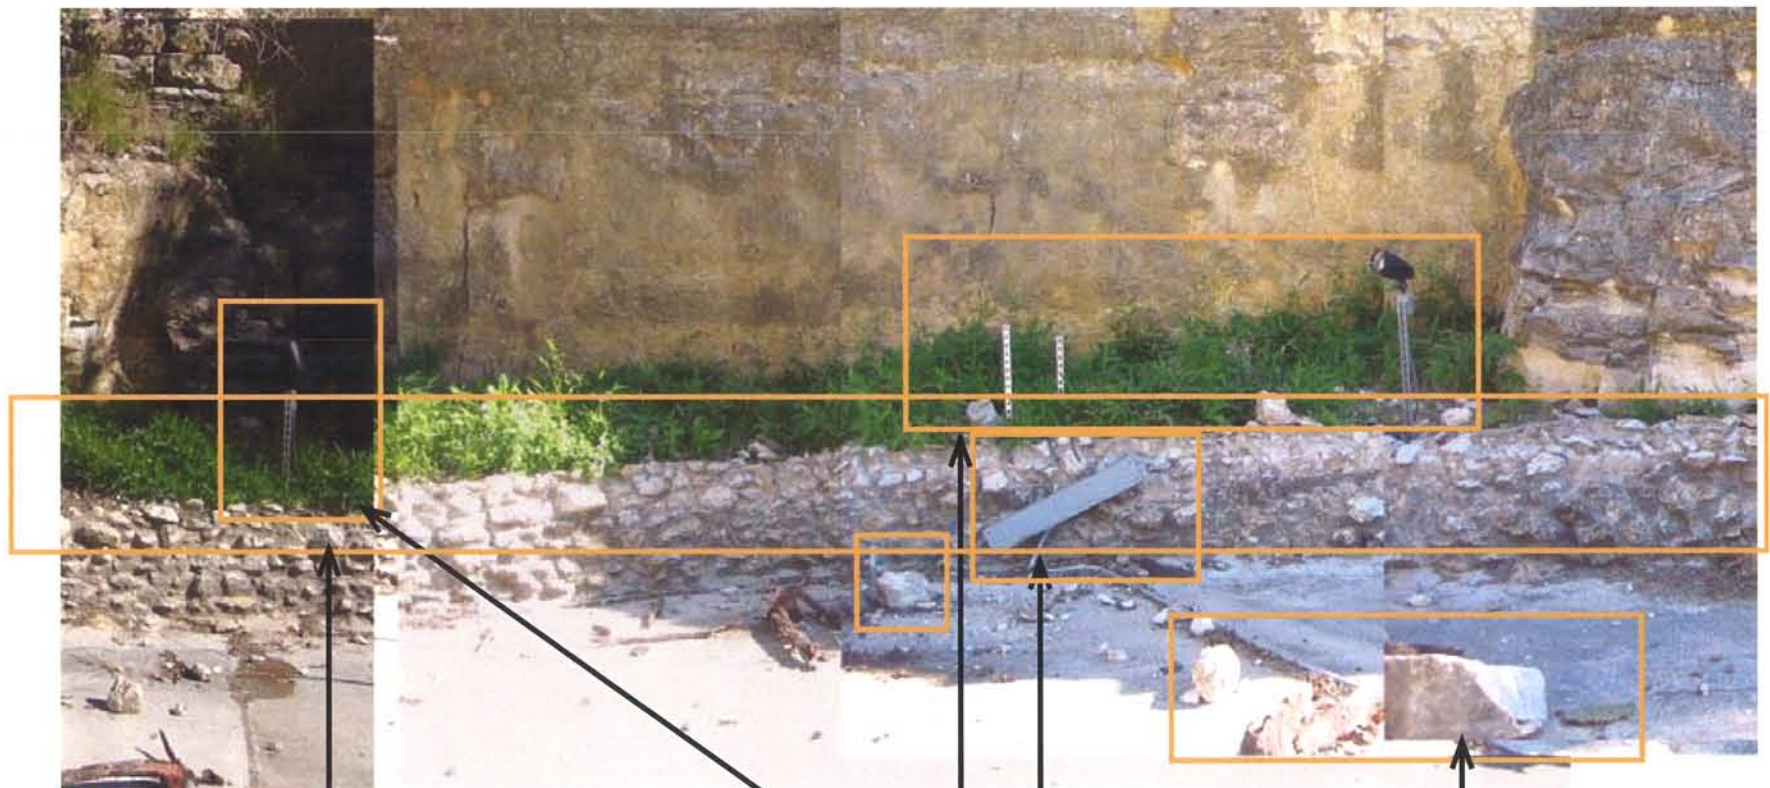
26. The stone cap is missing in much of this portion. Repair wall as necessary. The area is also impacted by rock slides from above. Securing Alpine Drive from above will be a great step towards this measure (see safety and security analysis). All lights and posts should be removed. See lighting analysis for recommendations. All exposed piping, conduit and electrical panels should be hidden with either planting or placed in a non-conspicuous location. All unused piping should be removed.

26 **STONE CAP MISSING IN THIS AREA.**

REMOVE METAL POSTS AND LIGHTS. SEE LIGHTING ANALYSIS FOR RECOMMENDATIONS.

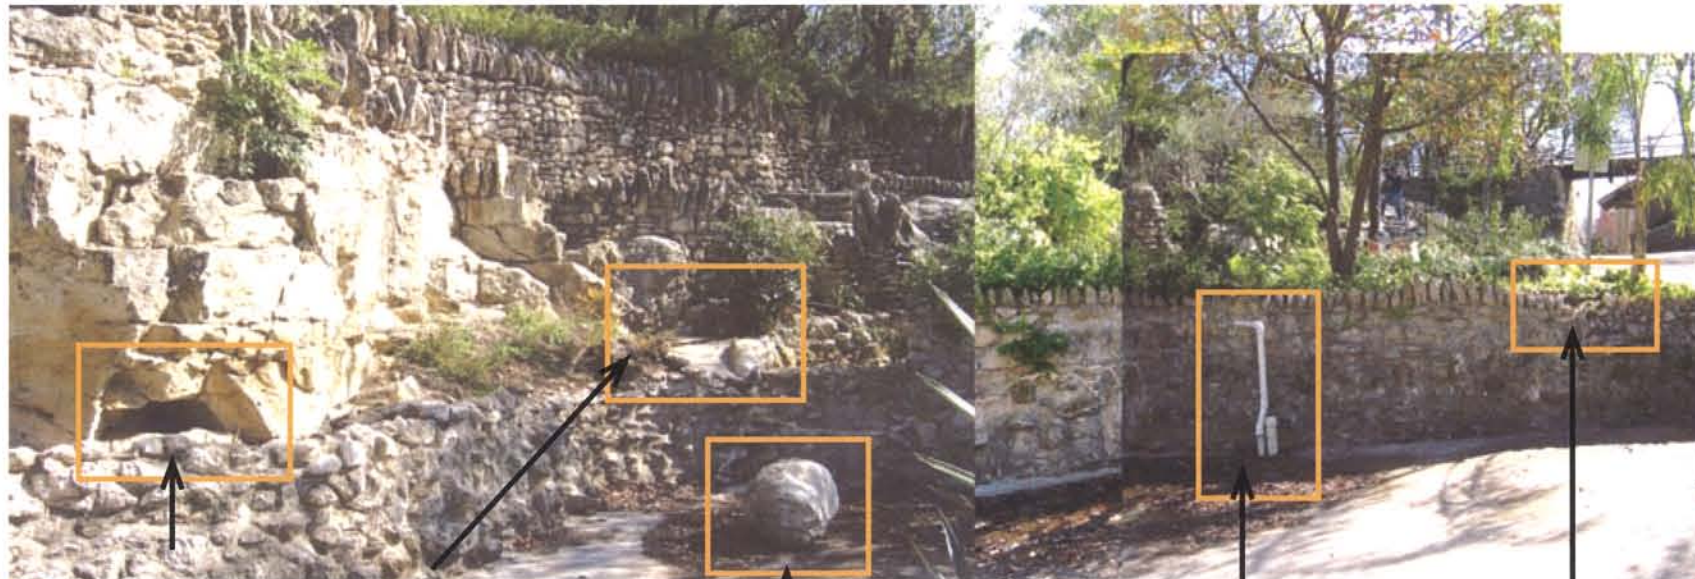
30 HOLE IN LIMESTONE WALL. SPILLWAY PRESENTS SAFETY HAZARD TO PEDESTRIANS. FALLEN ROCK. REMOVE PIPING. STONE CAP MISSING

30. Generally, this portion of the wall is in good condition. There is one small section where the stone cap is missing and should be replaced. Fallen rock is coming from the pathways above. All rock should be secured. Also, the addition of perimeter security fencing will prevent trespassers from pushing rock down to the lower portions of the core garden (see safety and security analysis).

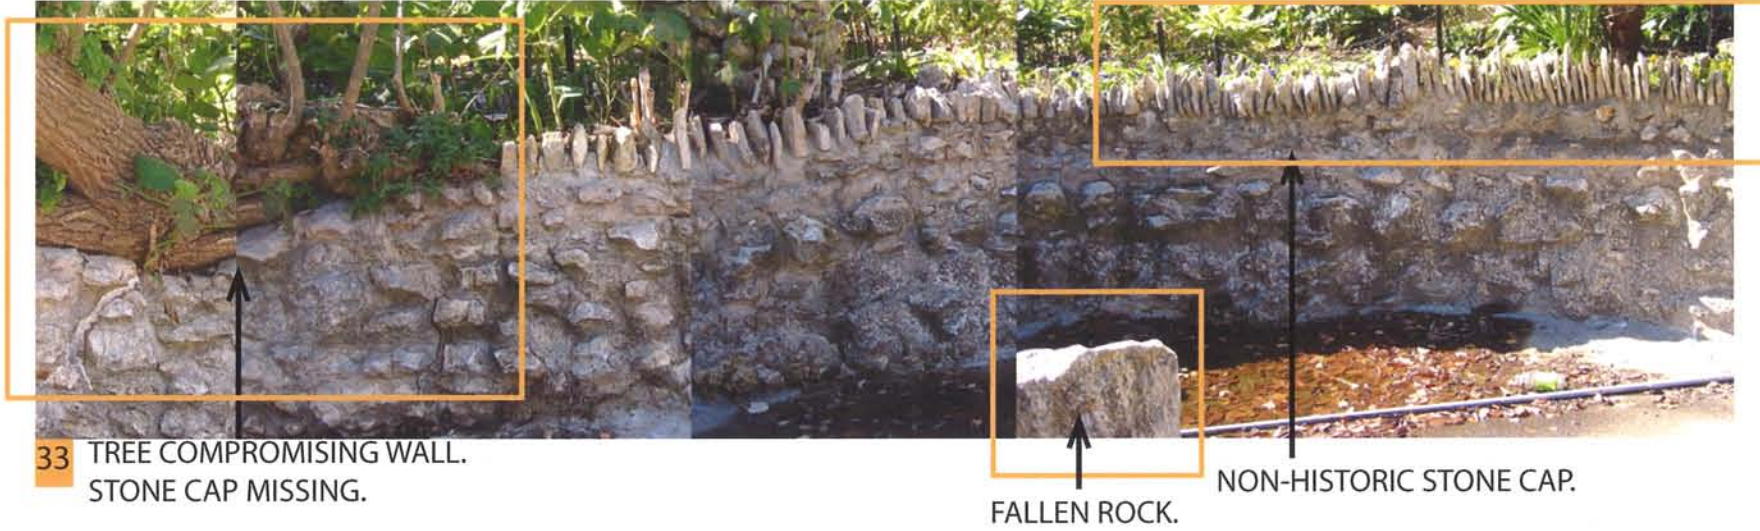
33 TREE COMPROMISING WALL.
STONE CAP MISSING.

FALLEN ROCK.

NON-HISTORIC STONE CAP.

The wall is cracked and deteriorating. The fallen rock is likely from the other side of the pond, as there are no pathways or walls directly above the enter island. A portion of the stone cap looks like it as been replaced. Smaller stone was used and was placed in a very upright position. All future stone cap restoration should try to match the historic cap as much as possible.

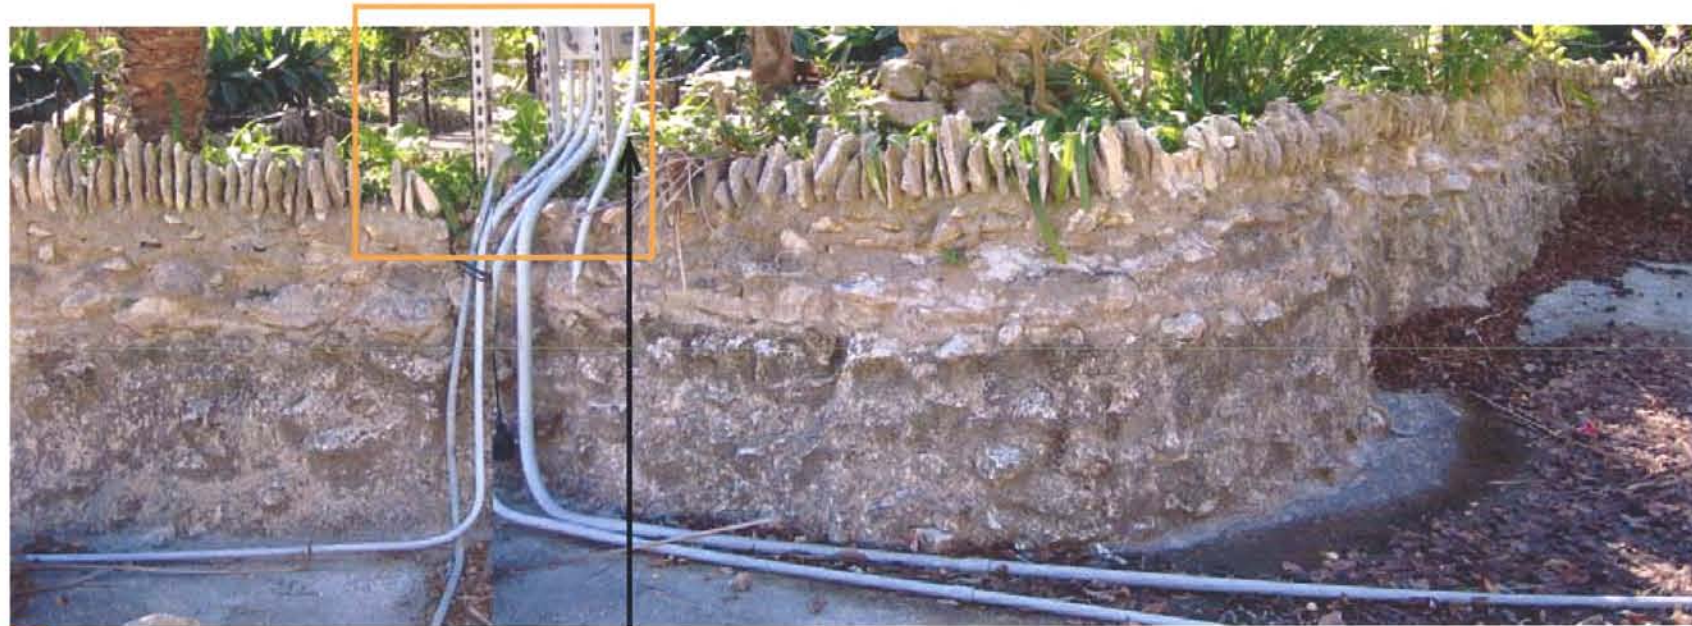
34 CAP MISSING BECAUSE OF EXTENSIVE PIPING IN AREA. REMOVE/PROTECT METAL CONDUIT/PIPE. HIDE WITH PROPOSED PLANTING. PAINT CONDUIT BLACK TO BLEND WITH LINER.

- 34. A portion of the stone cap is missing because of existing piping and conduit. All piping should be removed or replaced with systems that are inconspicuous and do not take away from the natural setting. Replace stone cap.

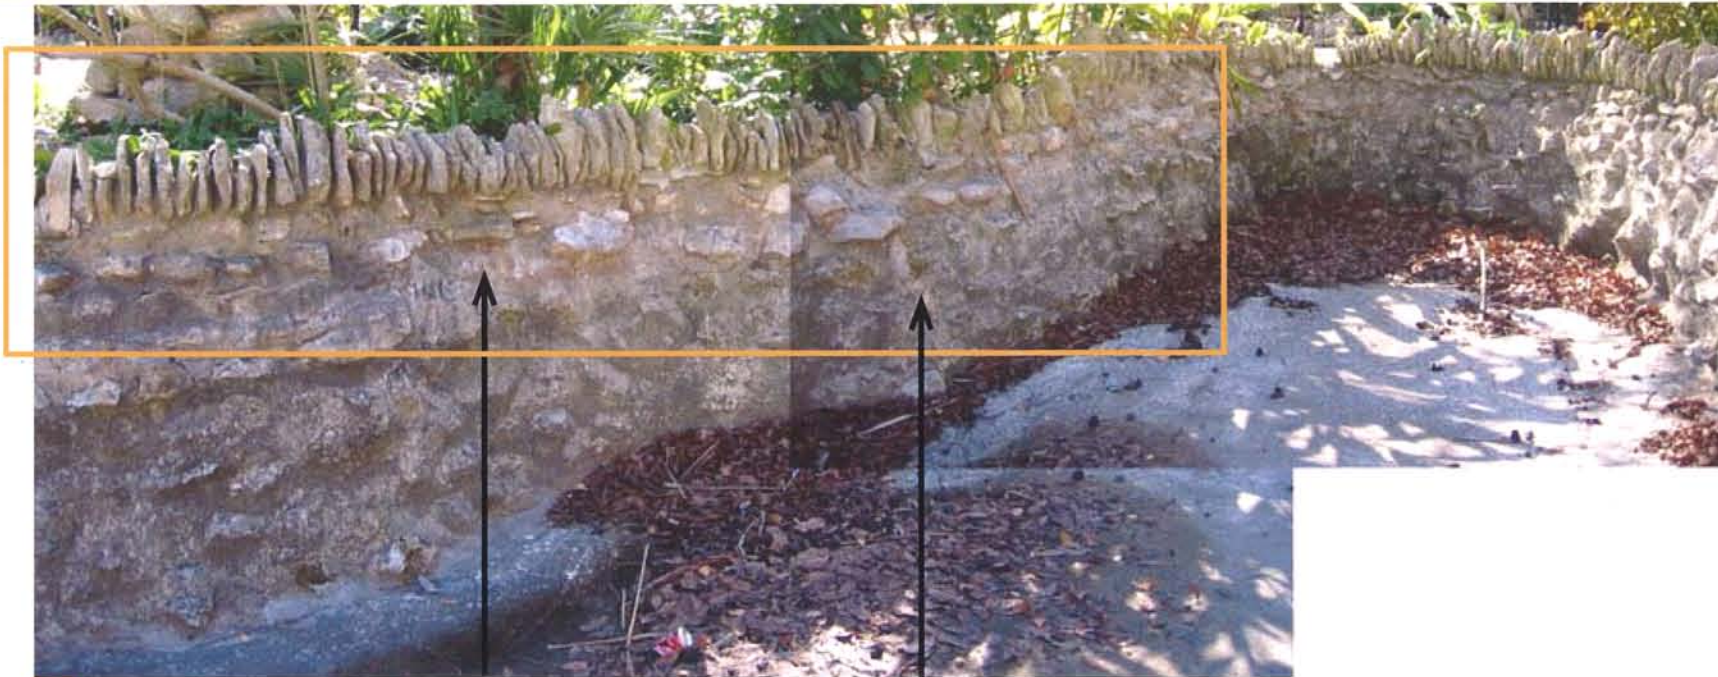
35 TOP TWO FEET OF WALL CRACKING AND DETERIORATING. EVIDENCE OF PREVIOUS REPAIRS.

PRIOR CRACK REPAIRED. MORTAR DOES NOT MATCH THE WALL AND IS EVIDENT.

- 35. The top 1'-1/2" - 2' of the wall have received repairs in the past. There are still several cracks and, therefore, it might be necessary to repair the stone cap in this area. There is also a large crack that appears to have been fixed with white mortar or a material that stands out from the limestone walls. Repair wall as necessary.

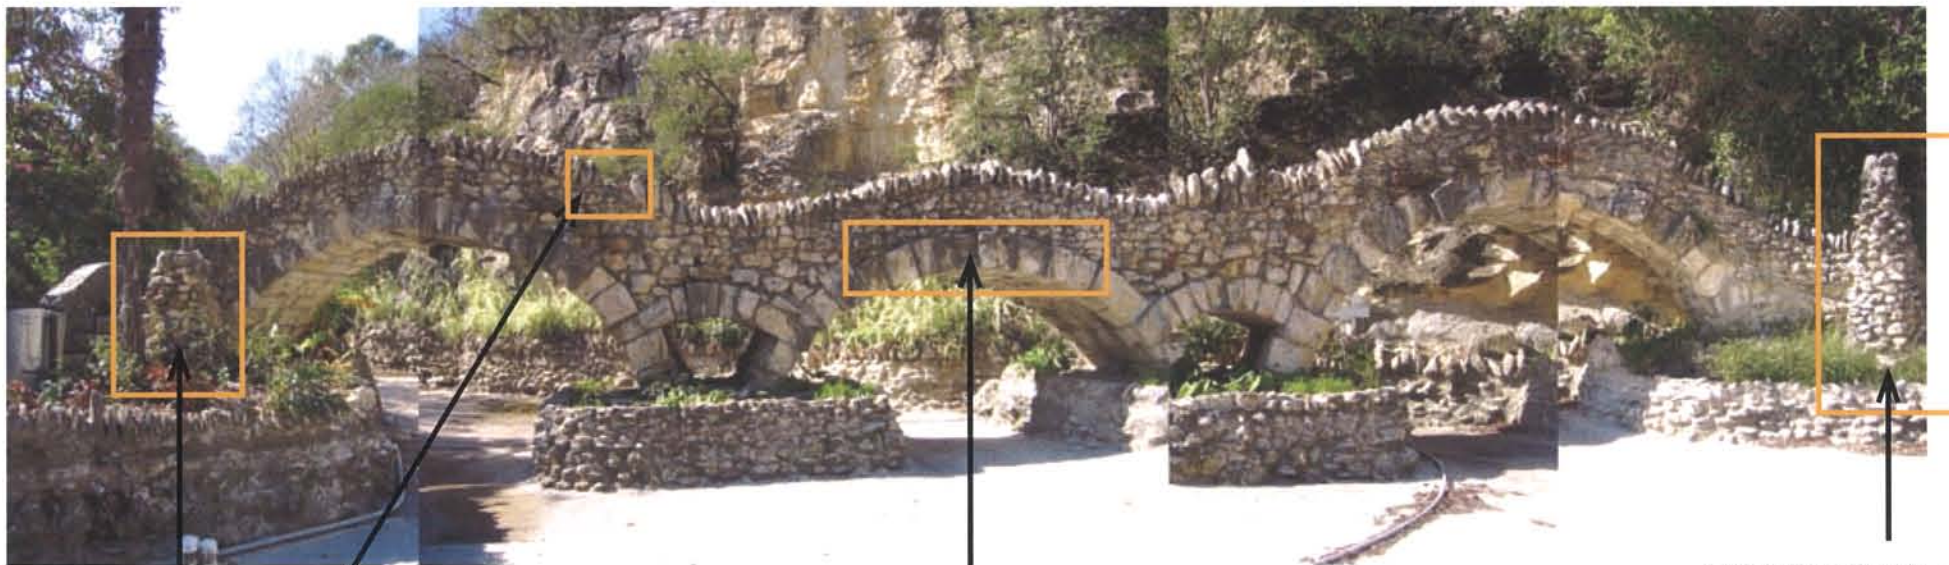
87

HISTORIC PYLON STONE CAP MISSING

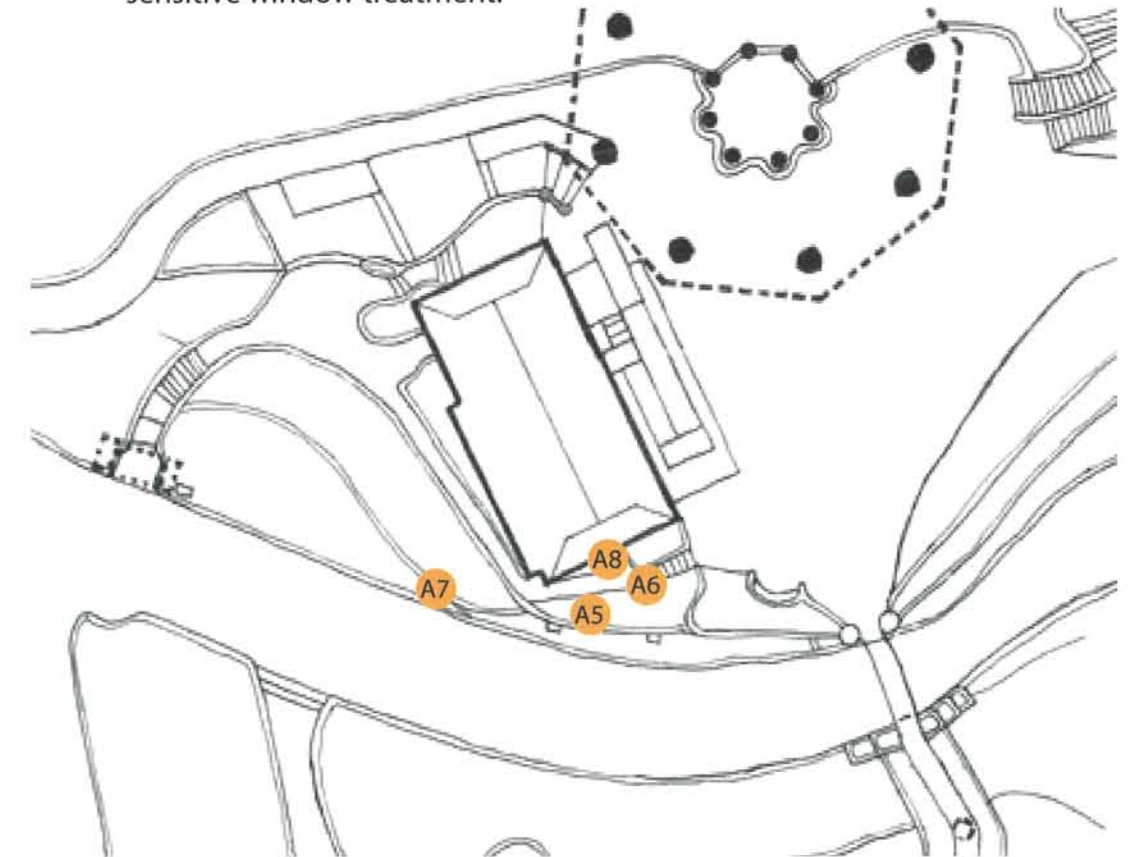
1. Railing at Southern walkway is in disrepair, presents unsafe condition. Replace railing or restrict public access to the area.
2. Exposed cleanout at rear door, walkway
3. Hose bibs/plumbing have damaged retaining walls. Repair landscape walls as necessary for stabilization and screen hose bibs.
4. Exposed wood at stucco sill; remove exposed wood at all locations and replace with stone cap or other period sensitive treatment.
5. CMU infill vents; remove (typical at all locations) and replace with period sensitive window treatment.
6. Stone infill below CMU vents, typ. Remove and replace with period sensitive window treatment.

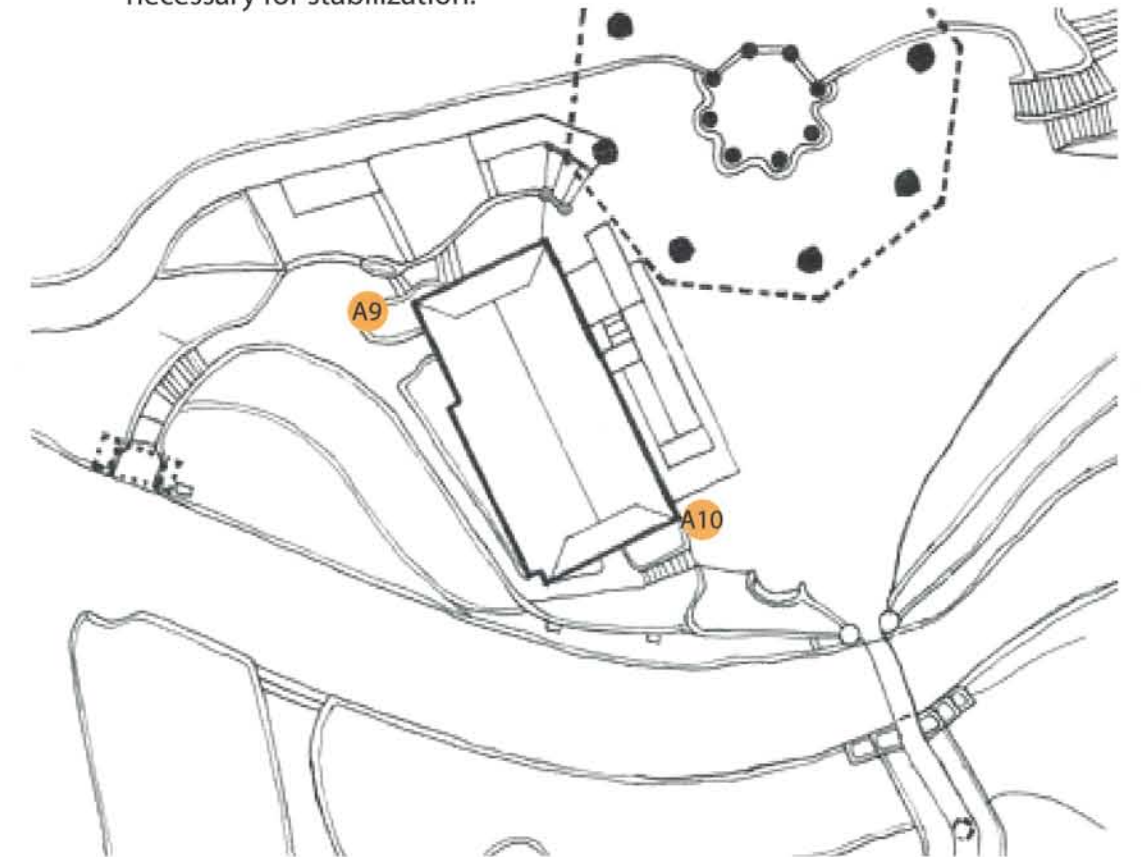
1. New (synthetic) thatched roof
2. Kitchen exhaust fans; remove or screen as appropriate for future use.
3. Roof structure and decking repaired/repainted
4. Unsympathetic lighting, typ. Replace all fixtures with period appropriate placement and selections.
5. Continuous 1/4" crack from infill wall to grade. Repoint mortar as necessary for stabilization.

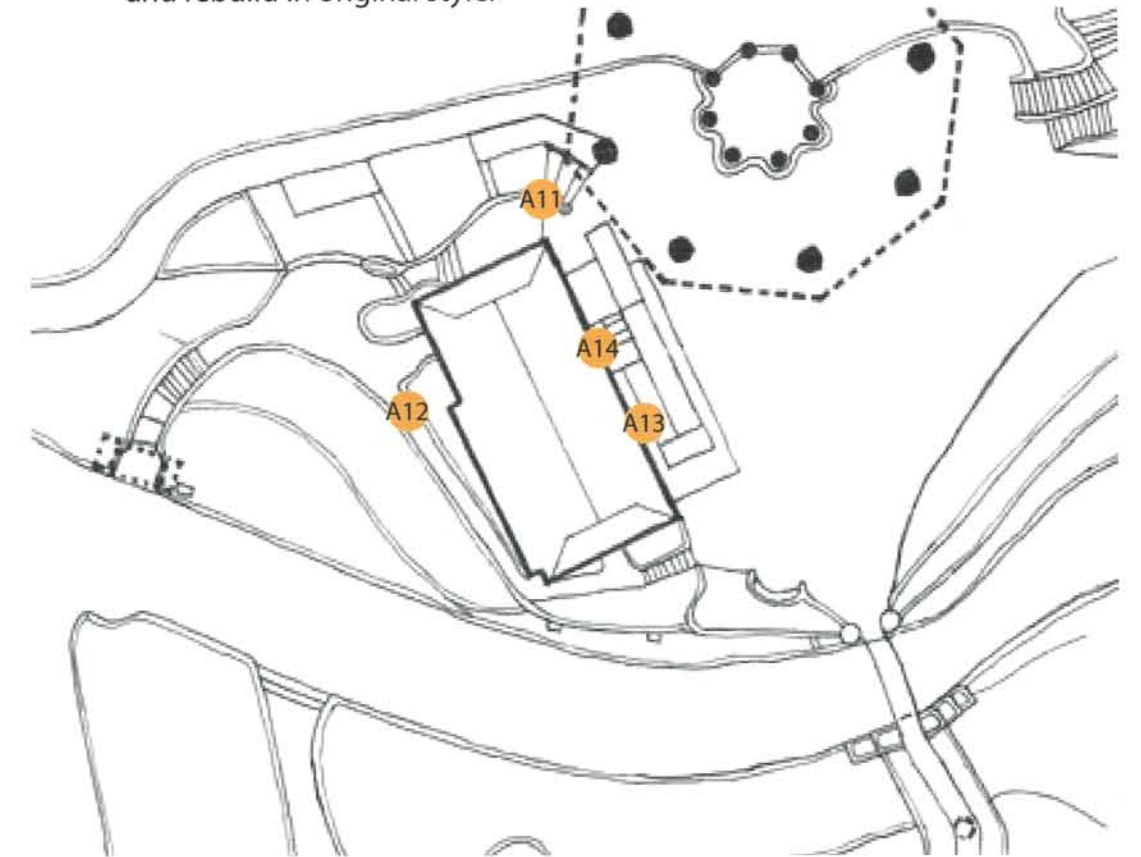
1. Stucco infill at windows; remove and replace with period sensitive window treatment.
2. Stone masonry repair area
3. Continuous vertical crack; repoint mortar as necessary.
4. Continuous horizontal crack at 2nd floor line; 3" gap at steps; assess for structural stability and repair as necessary.
5. CMU infill, typ. Remove and replace with period sensitive window treatment.
6. Security screens at windows, & transoms unsympathetic, typ. Remove and replace with period sensitive window treatment.
7. Doors and screens unsympathetic, typ. Remove and replace.
8. Stone infill does not match style of original masonry. Remove unsympathetic stone and rebuild in original style.
9. Top of stone wall deteriorated along eave line. Remove unsympathetic stone and rebuild in original style.
10. Unsympathetic stone infill below window; Remove unsympathetic stone and rebuild in original style.

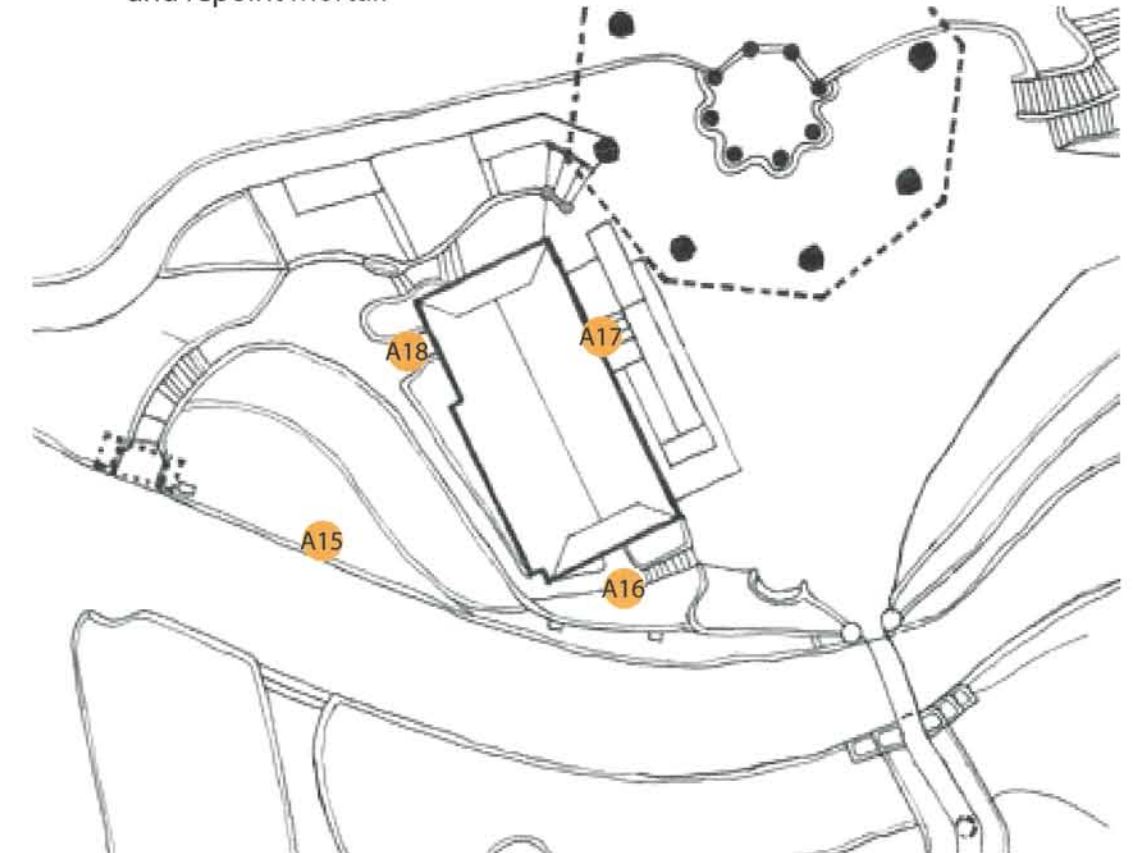
1. Stucco panel infill at screen porch and window locations; remove and replace with period sensitive window treatment.
2. Remove, relocate, or screen exposed HVAC equipment.
3. Relocate overhead telephone lines (to underground.)
4. Stone masonry in disrepair; repair/repoint as necessary, typ. Exposed wood several locations, typ.
5. Wood door deteriorated, screen door missing. Remove and replace with period door.
6. Restroom HVAC equipment; relocate or screen as necessary.
7. Mortar cracked at screen door frames, typ. repoint mortar as necessary for stabilization.
8. Water damage, vertical crack at low stone masonry wall. Clean stone wall and repoint mortar.

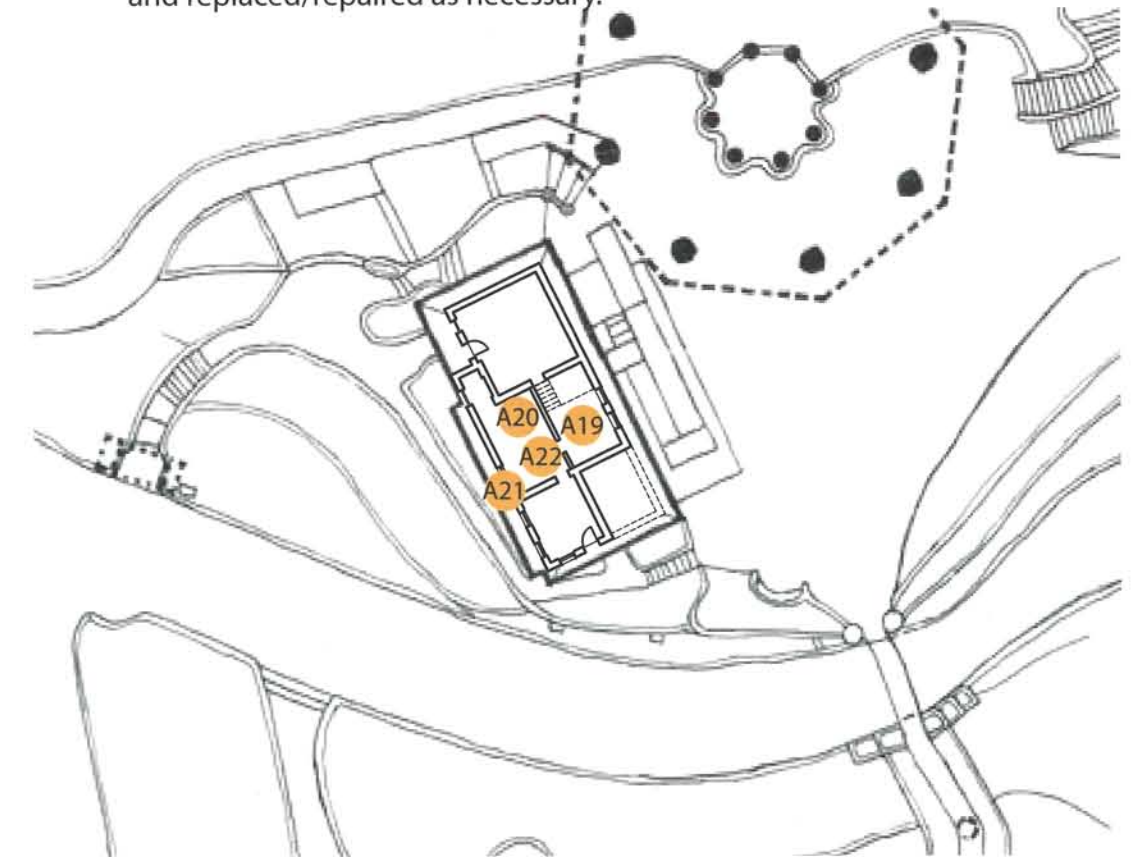
1. High-low ceiling condition at grade transition above (stairs from upper level are visible.)
2. New steel shoring supporting 2nd floor, typ. (Installed during restroom renovation; supported on concrete floor with wood blocking.) Future use to determine more appropriate structural reinforcement
3. Major water damage to 2nd floor structure throughout; remove and replace damaged structure
4. Window infill panels do not appear to be damproofed/waterproofed; remove infill and replace with period sensitive treatment
5. Concrete floor uneven and not level; appears to be infill without water barrier (sweating.) Relevel/rebuild floor as appropriate for future use
6. Exposed piping in poor condition, typ; clearance under pipes less than 7'-0" clear in some areas. Piping needs to be determined for future use and replaced/repared as necessary.

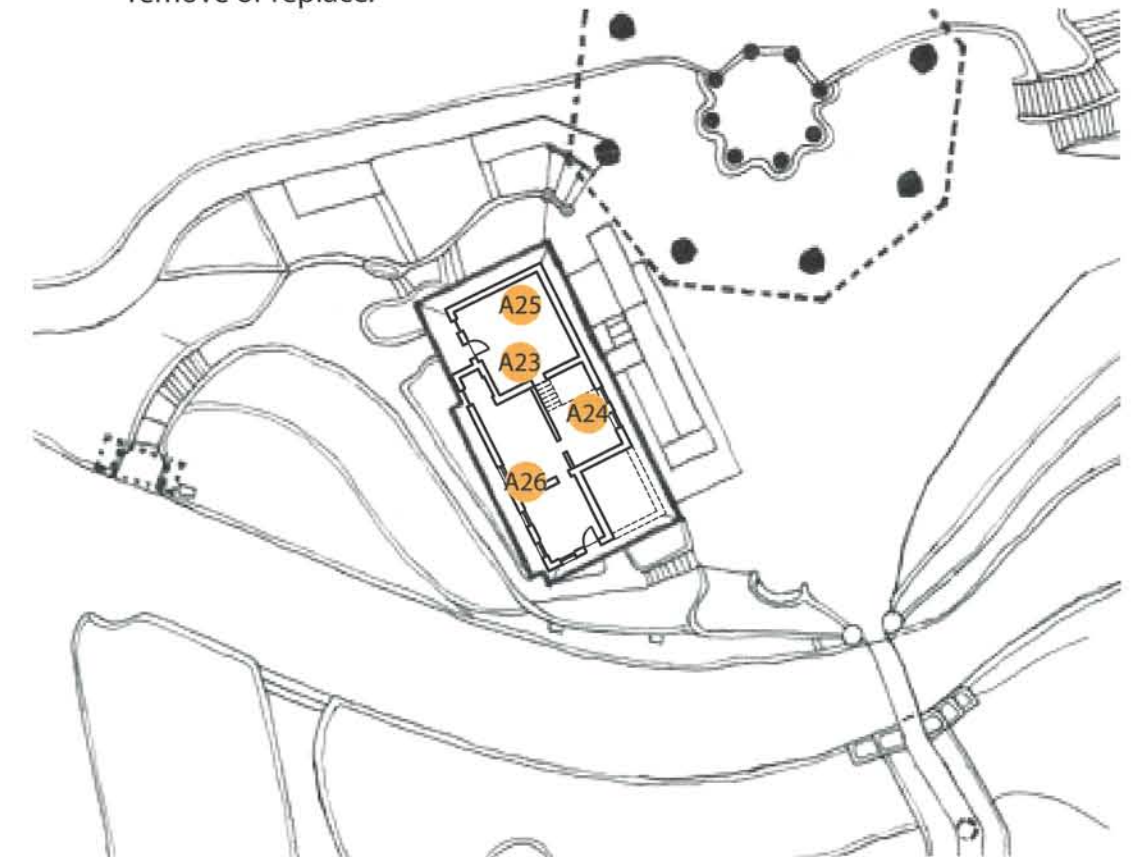
1. Wood batten walls deteriorated due to water damage. Future use of this level to determine level of preservation or non-historical repair (typ.)
2. Plaster walls are cracked, deteriorated, typ. Mold and water stains are present; does not appear to be waterproofed. Repair plaster, rebuild walls with adequate moisture barrier.
3. All electrical devices are exposed; some appear abandoned. Determine functional electrical service and remove nonfunctional equipment.
4. Mold/ mildew growth present at multiple locations; clean and remove mold and repair/rebuild walls as necessary.
5. Piping penetrations damaging walls. Determine needs for piping and remove or replace.

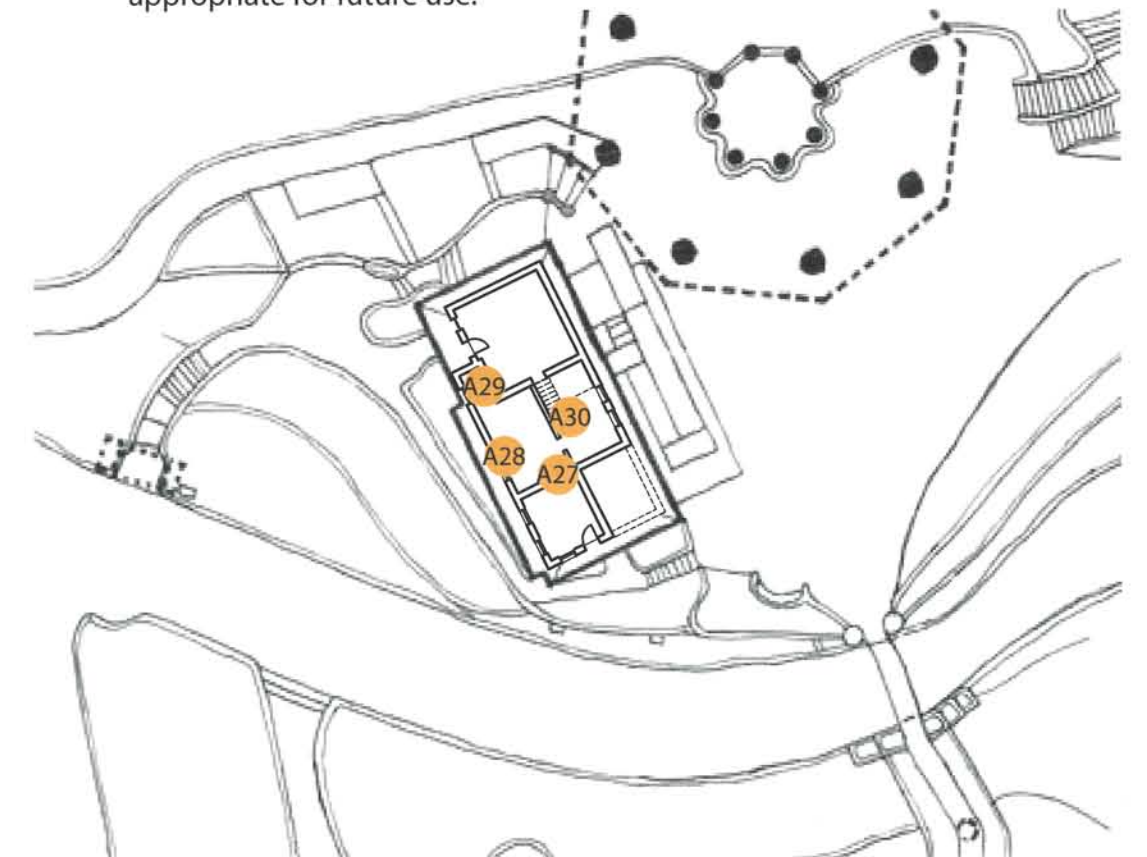
1. Door frames are deteriorated, wood rotted, typ. Remove and replace with period door.
2. Infill at window locations, typ; do not appear to be damproofed/ waterproofed; remove and replace with period sensitive window treatment.
3. New patch work at West exterior wall; future use to determine level of interior wall restoration necessary.
4. Water damage at floor, typ; floor uneven. Relevel/rebuild floor as appropriate for future use.

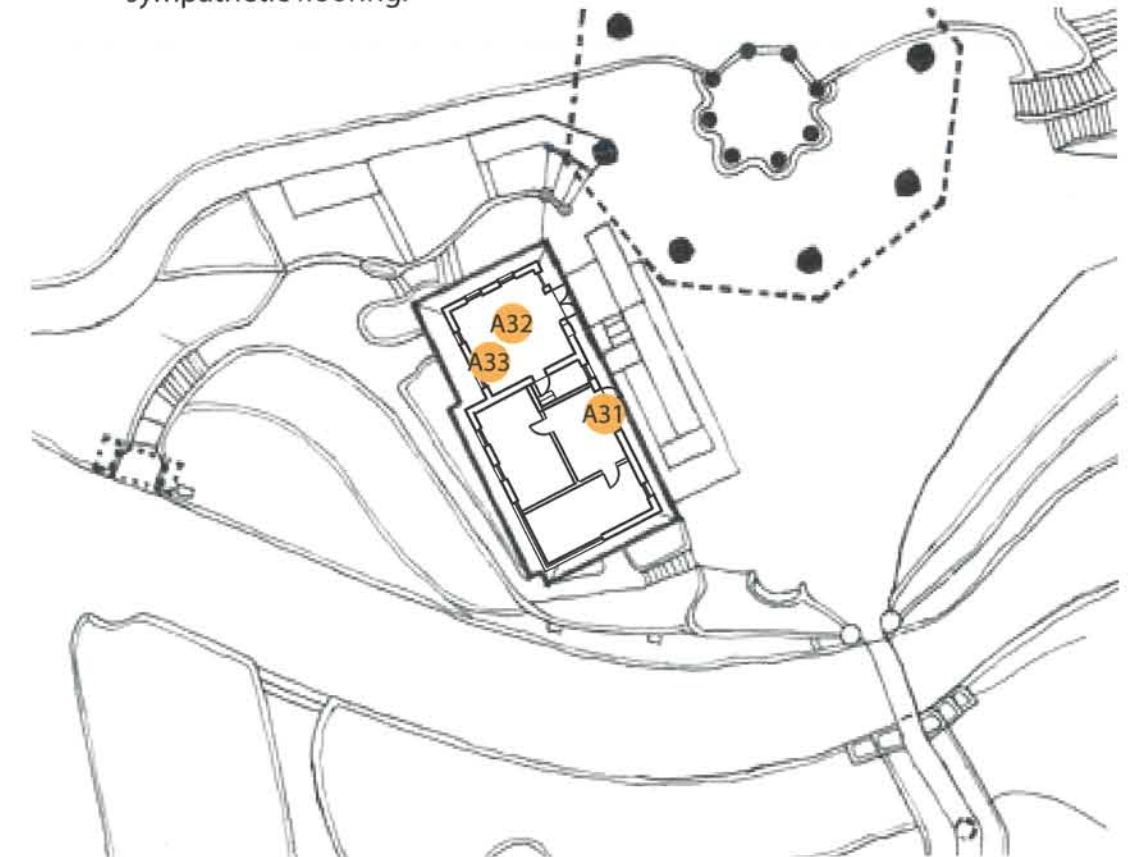
1. Current restroom renovations prohibit preservation of structure to original house plan. Future use will determine needs of this area.
2. Water damage evident at concession stand ceiling, typ. Remove and replace ceiling deck; further damage assesment will be necessary.
3. Light fixtures require bulb guards; electrical work not installed to workman-like standard. Remove and replace with fixtures suited to future use.
4. Vine growth spread to interior, damaging walls. Remove source of vine growth and repair walls as necessary.
5. Plumbing and electrical services exposed; some appear abandoned. Unable to determine if functional; determine future needs and repair or replace as necessary.
6. Water damage at quarry tile floor. Remove and replace with sympathetic flooring.
