Japanese Tea Garden Master Plan

Japanese Tea Garden
Master Plan
San Antonio, Texas

June 2007

SWA Group
Project Landscape Architect
Houston, Texas

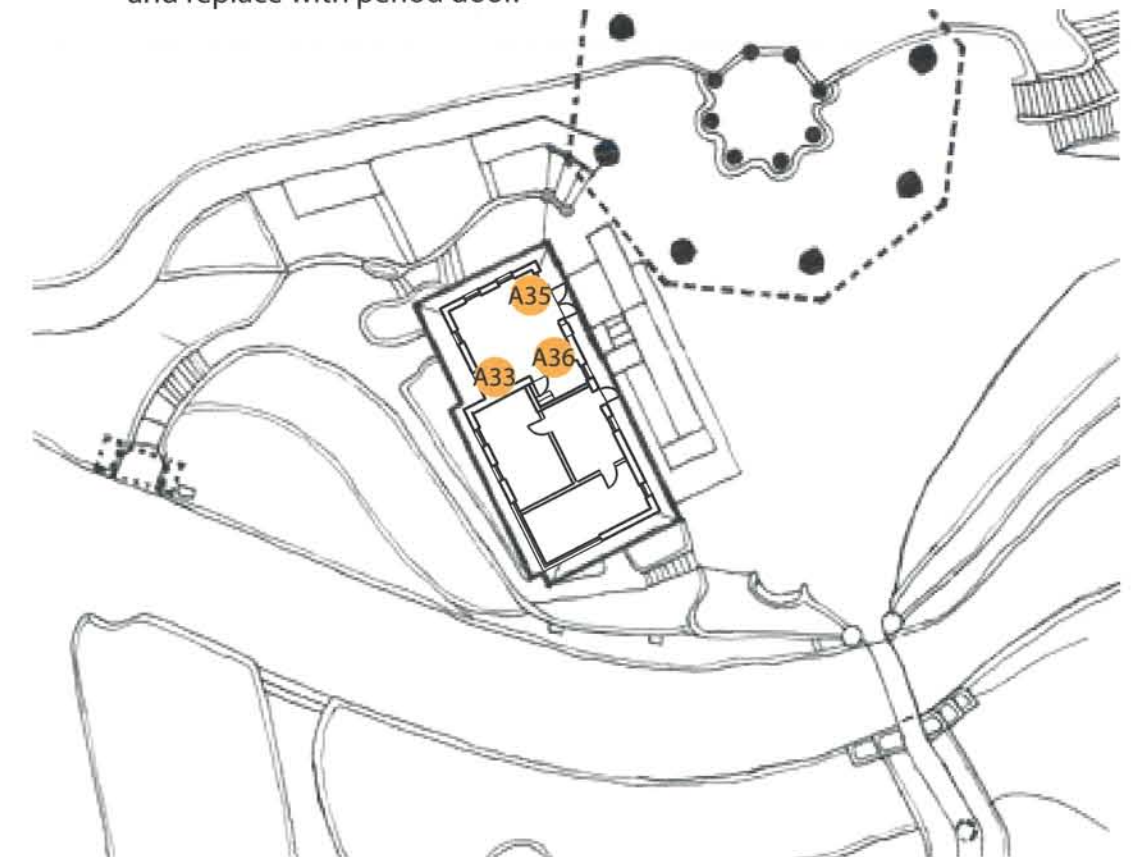
1. Exposed pipe, conduit at interior, typ; insulation in poor or nonexistent condition. Determine needs for future use and repair or replace as necessary.
2. Vine growth on walls; remove source of vine growth and repair walls as necessary.
3. Miscellaneous abandoned kitchen equipment; remove
4. Concession stand in disrepair. Determine needs for future use; remove and discard materials and clean area.
5. Exposed electrical & HVAC lines appear to be disconnected; HVAC condensing unit located on West side of building. Determine needs for future use and remove or replace equipment, conduit, etc.
6. Original walls are in need of repair and restoration.
7. Door does not appear to be original, although location likely is. Remove and replace with period door.

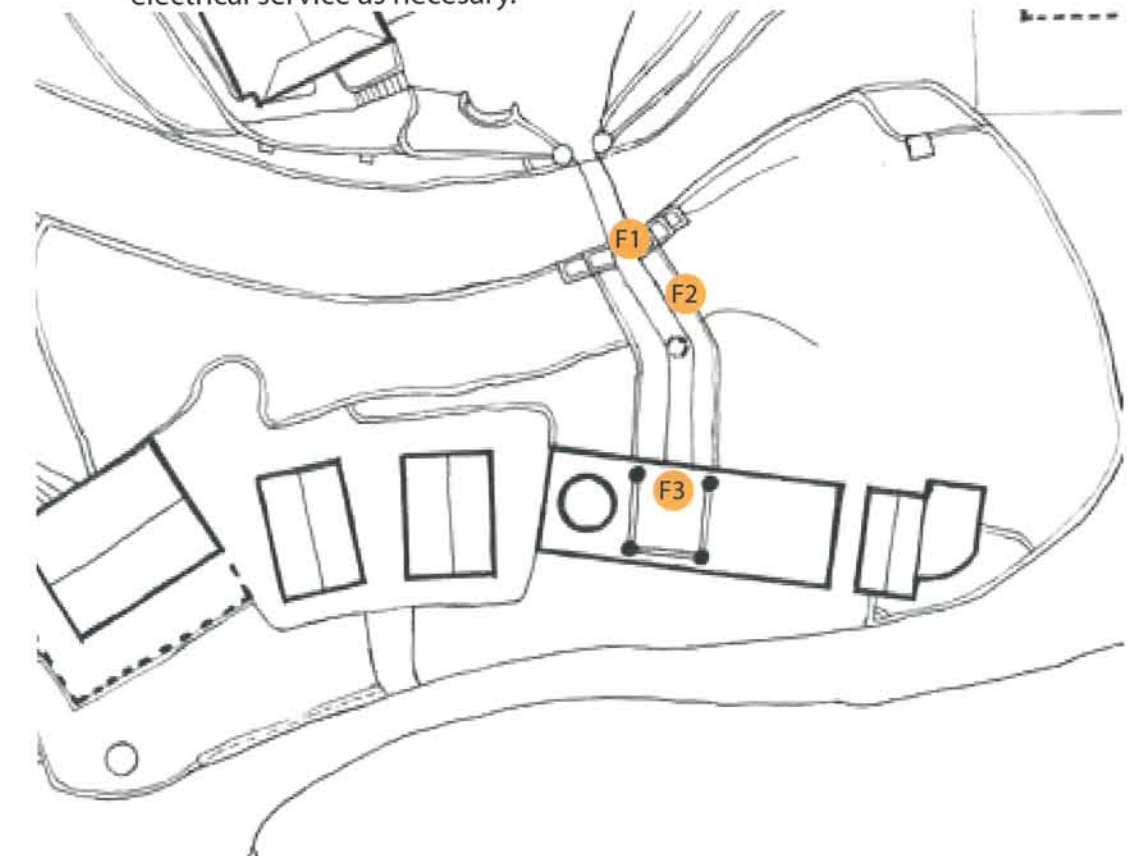
1. Wood bridge decking deteriorated; water damage apparant. Restore and repair as necessary to prevent further deterioration.
2. Hand rail deteriorated, nails exposed, guardrail not code compliant. Remove and install or repair period sensitive railing where needed.
3. Handrail bracing replaced with steel supports; remove and replace with period sensitive cedar post bracing as necessary.
4. Roof at overlook deteriorated, typ. Remove and replace with palapa-style roof.
5. Exposed wiring; remove all nonfunctional wiring and devices.
6. Unable to determine functionality of lighting; restore fixture and install electrical service as necessary.

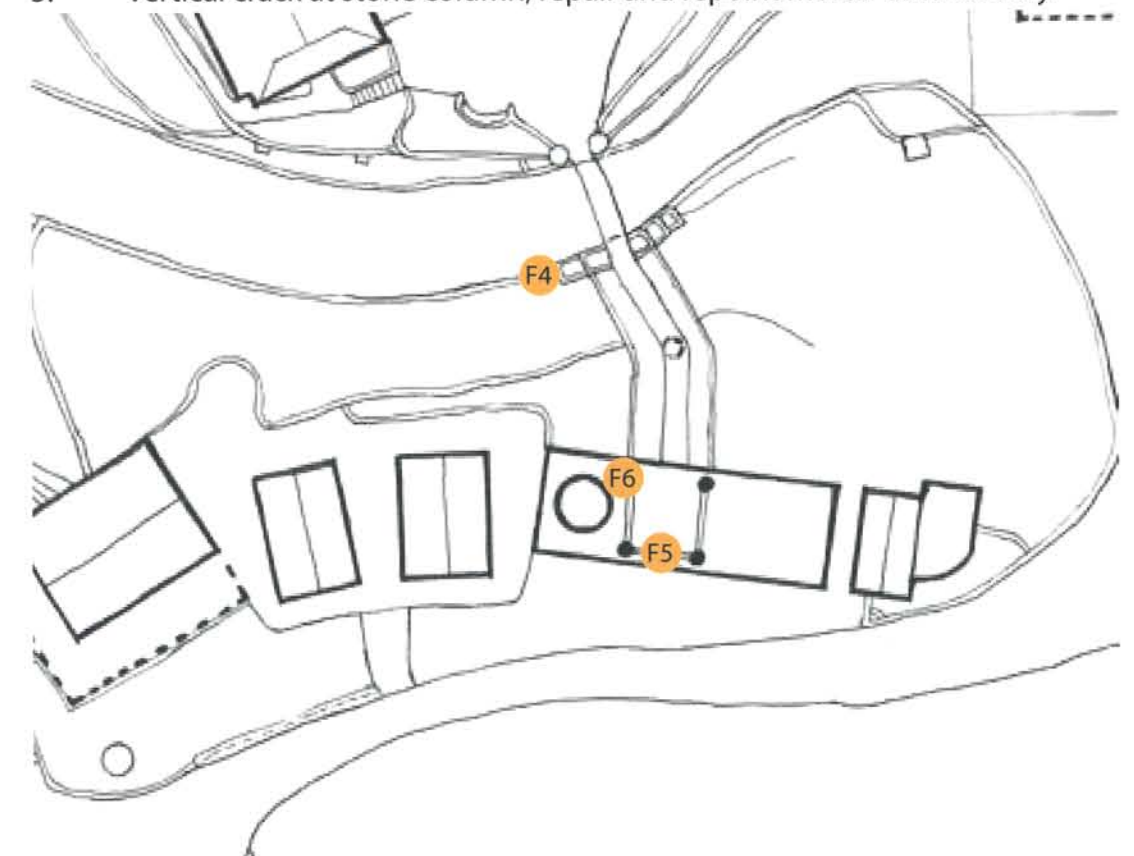
1. Thatched Palapa roof from pavillion no longer present
2. Insufficient guardrail at overlook, presents unsafe condition; determine need and install period sensitive railing where necessary.
3. Roof and structure deteriorated; remove and restore
4. Overgrowth of plants damaging stone masonry; remove source of growth and restore masonry where necessary.
5. Vertical crack at stone column; repair and repoint mortar as necessary.

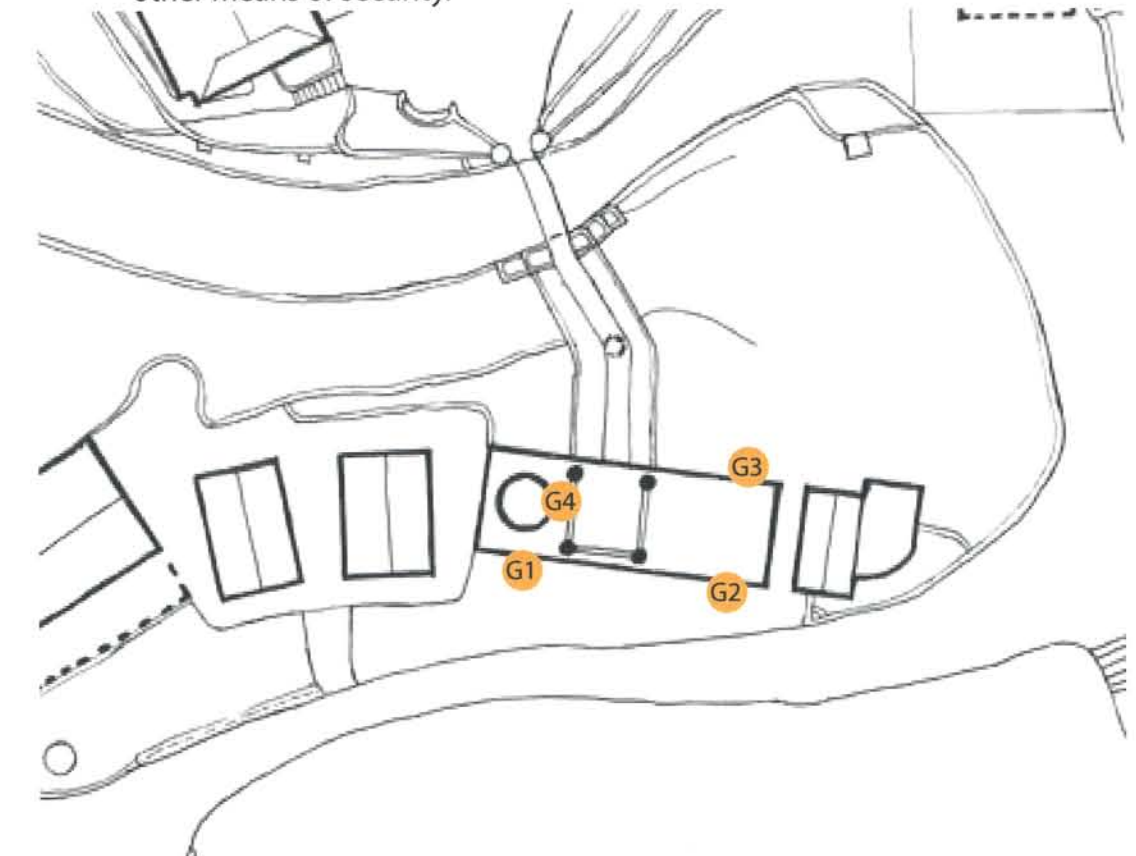
1. Kiln openings require cleaning, restoration
2. Plaque missing/removed from wall; stone masonry damaged; clean and restore.
3. Undefined landscape/ boundary at base. Determine needs for accessible path and delineate if needed.
4. Plant growth damaging historic features; remove source of growth or prohibit future growth and restore masonry where needed.
5. Existing electrical service; recommend removing or relocating
6. Smokestack vandalized near overlook; install preventative guardrail or other means of security.
