EVALUATION OF COOL PAVEMENT SURFACE TREATMENTS USING FRICTION, TEXTURE AND ADHESION PROPERTIES

PREPARED FOR:
City of San Antonio

REPORT DATE
February 12, 2024

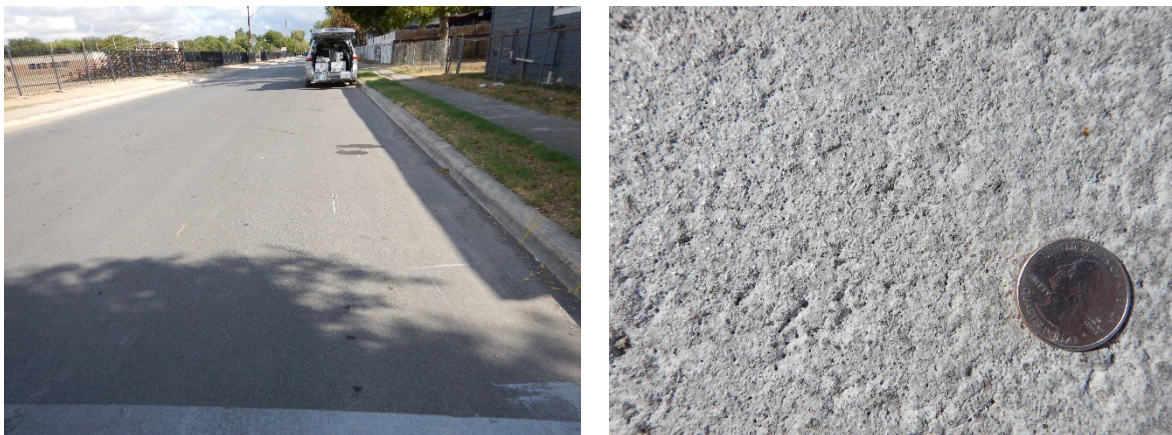
Figure 17. Photos of SW 21st St. treatment with Seal Master.

In high traffic areas (e.g. SW 21st St.) recent visual inspection have shown signs of delamination and removal of the applied Seal Master treatment at various locations in the pavement surface. It appears that the delamination is primarily near the curbs with no traces of parked vehicles. This may be attributed to the presence of moisture from runoff or alike. That is not the case for other sites treated with Seal Master (e.g., Mountain Star) which suggests the impact of moisture on the treatment long-term bonding with existing pavement.

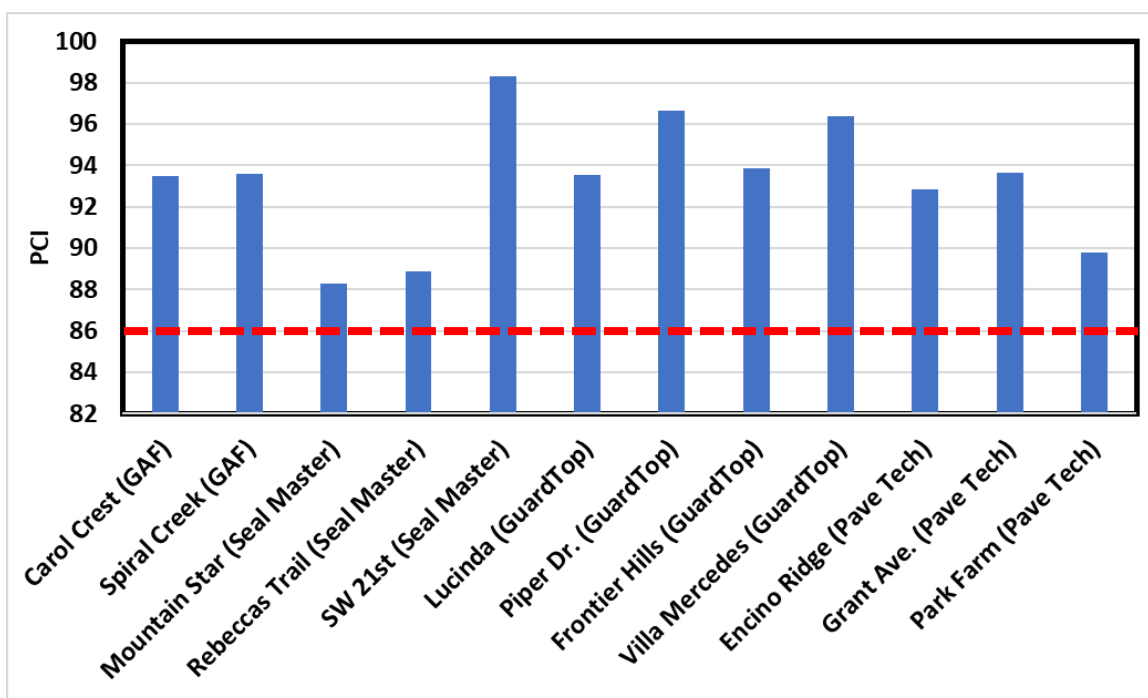
Comparing the pavement sites on the basis of their surface performance in terms of texture and friction characteristics is dependent on the existing structural conditions. Pavement with poor structural conditions would reflect lower surface performance in which applied treatment will have minimal impact to improve. Therefore, the structural conditions assessed through the Pavement Conditioning Index (PCI) are utilized in the purpose of comparing the sites performance among each other. Every three years Public Works performs a pavement condition assessment of the City's Street network through determining the PCI scores. The PCI is a numerical rating of the pavement condition of the street, ranges from 0 to 100 with 100 representing the best possible condition and zero representing fully deteriorated conditions. The PCI is measured for each roadway in segments. The average PCI value for all segments is combined and averaged to determine the overall roadway condition. In this study, PCI was obtained to be used as a base for comparing conditions among the sites and to navigate existing conditions to the treatment applications. Table 55 presents the PCI for the tested sites prior to the treatment applications and Table 56 presents the thresholds of the pavement condition and the PCI scores. PCI of all sites ranging from 88.27-96.62 suggest that pavements are in excellent conditions prior to the treatment application. Therefore, data suggests that the existing pavement conditions have minimal or no impact on the surface treatment performance.

Figure 30. Summary of the projects PCI

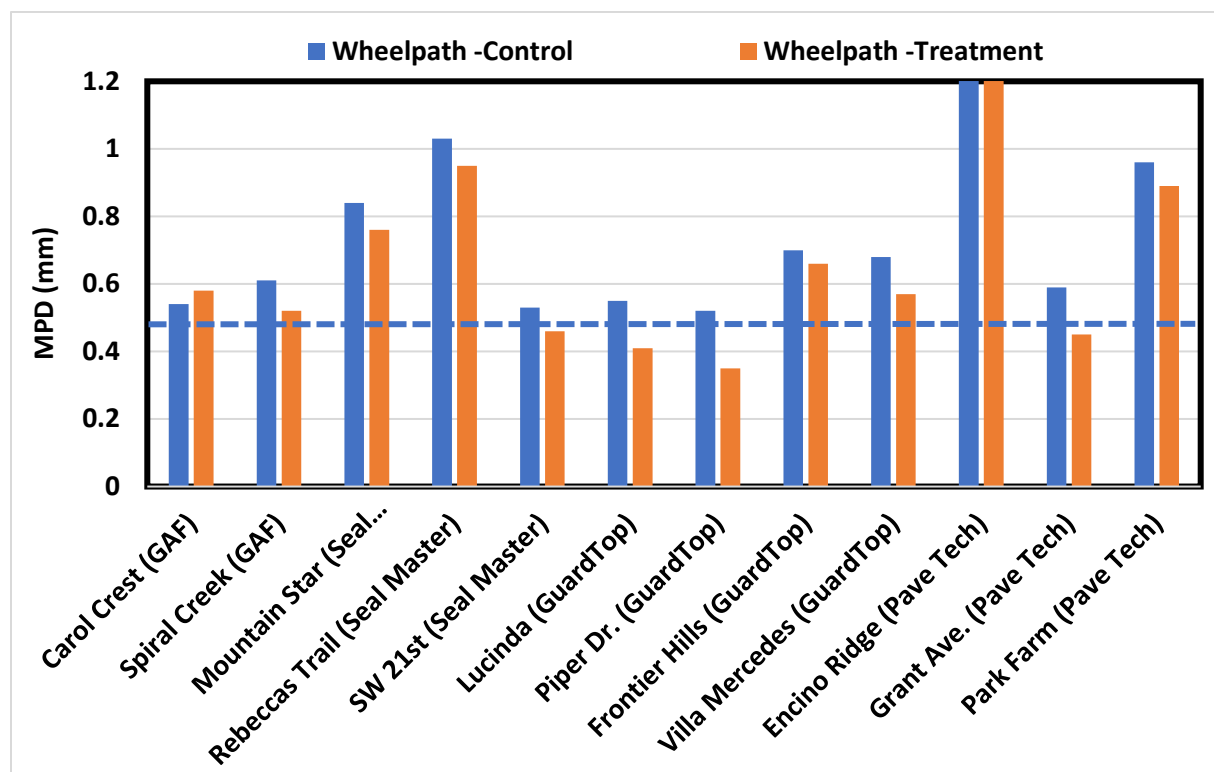
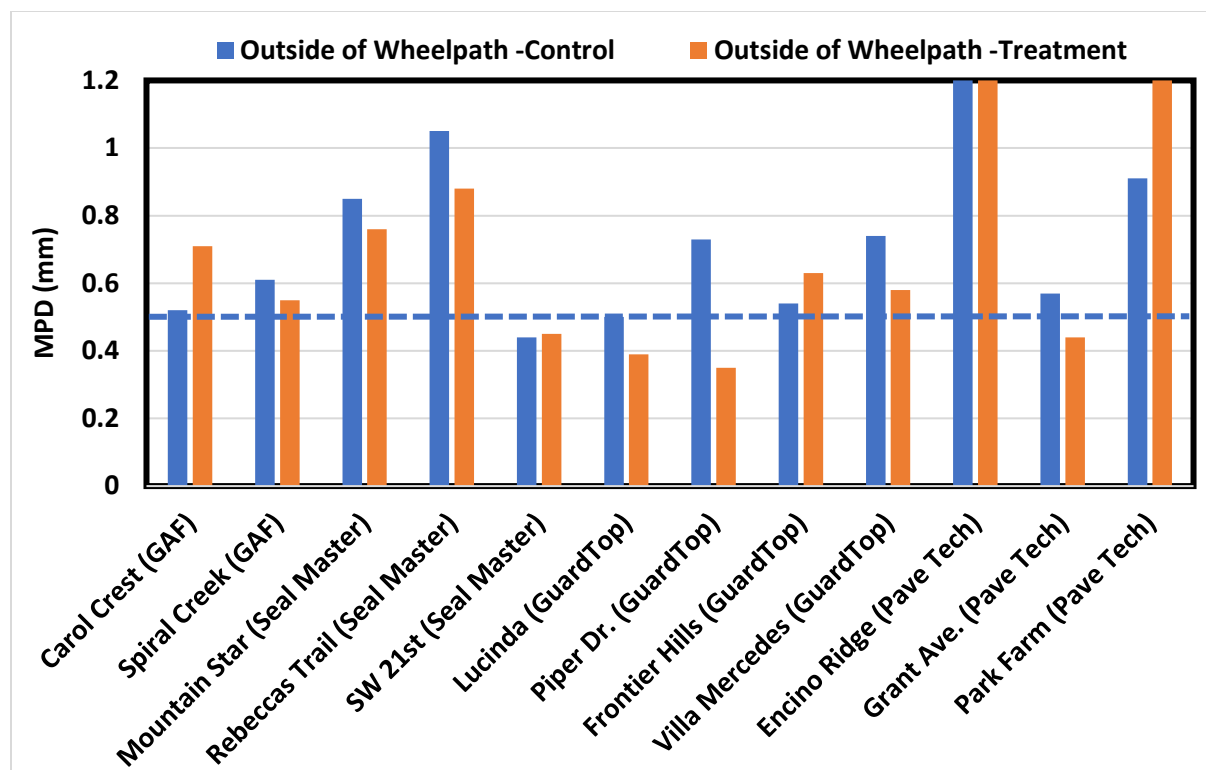
On the contrary, Pave Tech had an increase surface texture of 5% on average with less sensitivity to traffic impact at and outside wheelpath. This treatment is a penetrating technology in which it does not create a shield surface treatment separating between tires and pavement compared to the other three products. There is light application of sand on the treated sites which is recommended after installation. The sand layers may have contributed to the slight increase in texture. This is in agreement with other pilot studies conducted by the suppliers at Punta Gorda and Largo, Florida which showed a 3-20% increase in friction after 24 hours. While others show a reduction of 13-15% in 41 days after installation.

On another observation, GAF treatment has shown a reversal texture reduction from one site to another. However, it is suggested that after about 46 days of application, the texture in the wheel path reduced by about 12% due to traffic as compared to outside wheelpath. This reduction in texture may suggest a sensitivity of the product to traffic over time.

Figure 31. Summary of the texture measurements (MPD) for all projects.

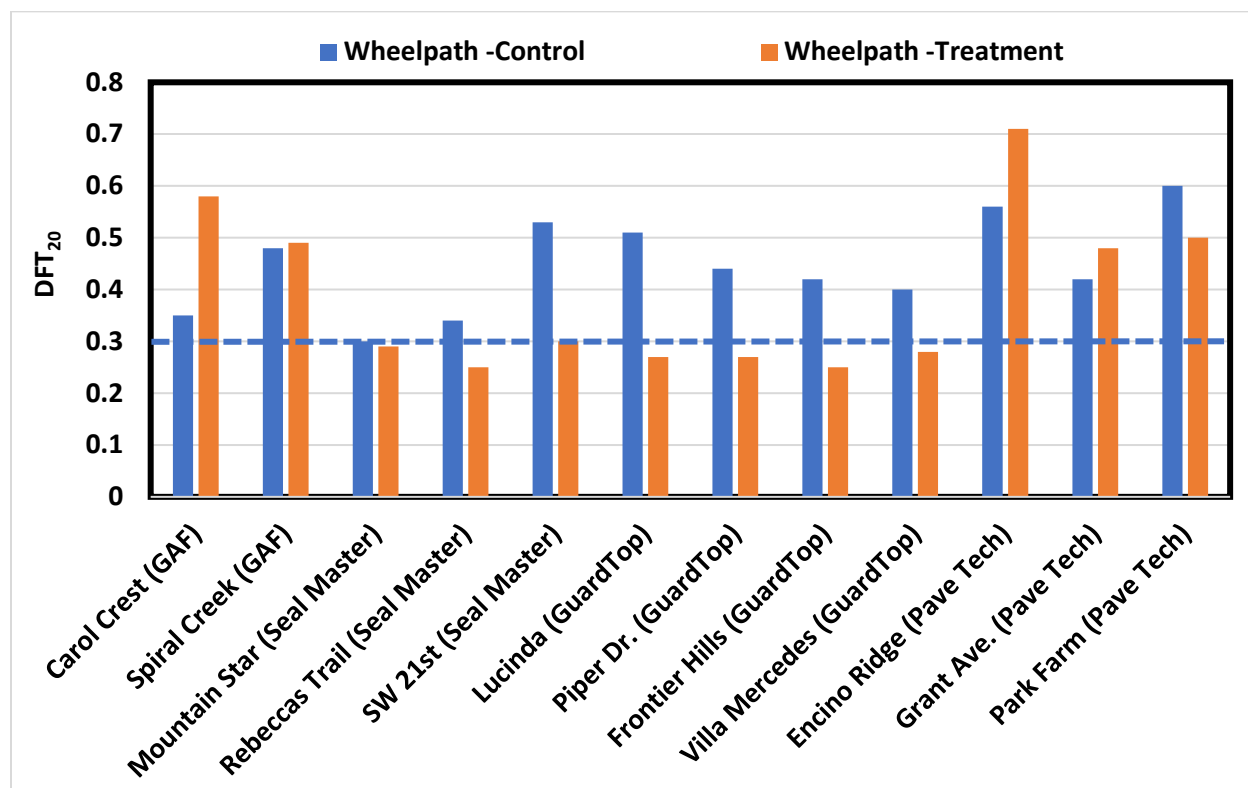
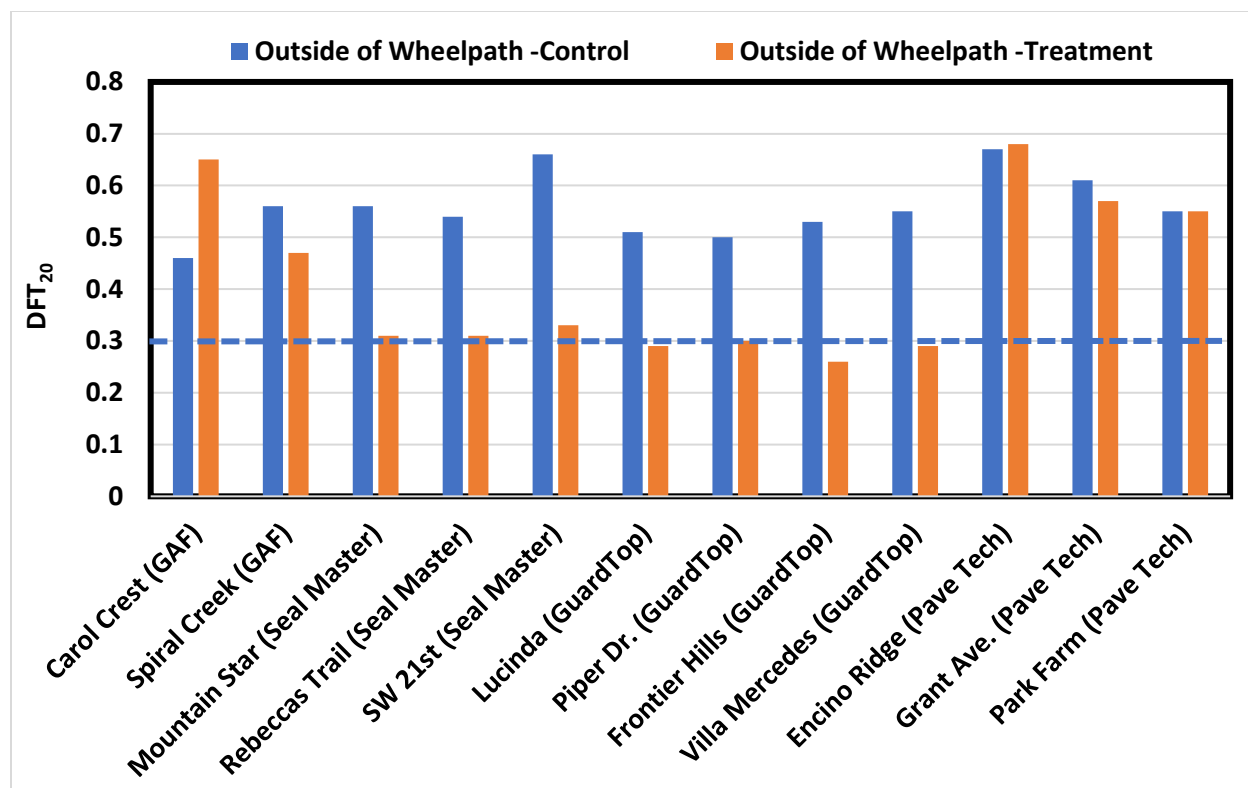
Generally, the GAF and Pave Tech have maintained the recommended minimum thresholds of 0.30 suggested by literature, in all areas of treated surfaces (at wheelpath and outside wheelpath). On the contrary, GuardTop and Seal Master treatment have dropped the friction to the threshold level and slightly below.

Figure 32. Summary of the friction measurements (DFT₂₀) for all projects.

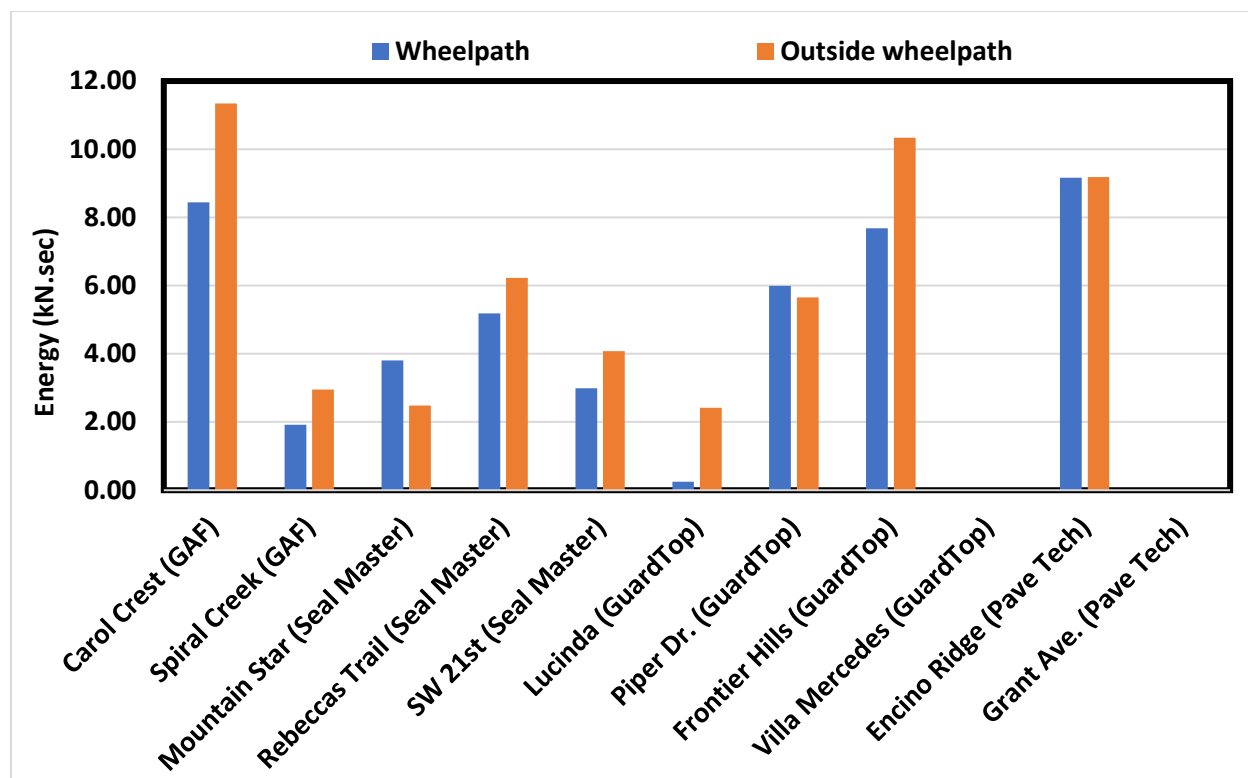
A summary of the adhesion energy in all sites is shown in Figure 35. It is suggested that traffic will deteriorate the adhesion strength of the treated layer over time. As shown in the figure, all sites experienced a reduction in the adhesion energy. The summary of the reduction in adhesion is shown in Table 60. The data suggests that Seal Master has the least reduction in adhesion energy while GuardTop has the highest reduction over the performance period. It was not determined to calculate the adhesion strength of Pave Tech due to the nature of the applied penetrating treatment where a substrate coating layer does not exist.

Figure 36. Summary of the Adhesion Energy for all projects

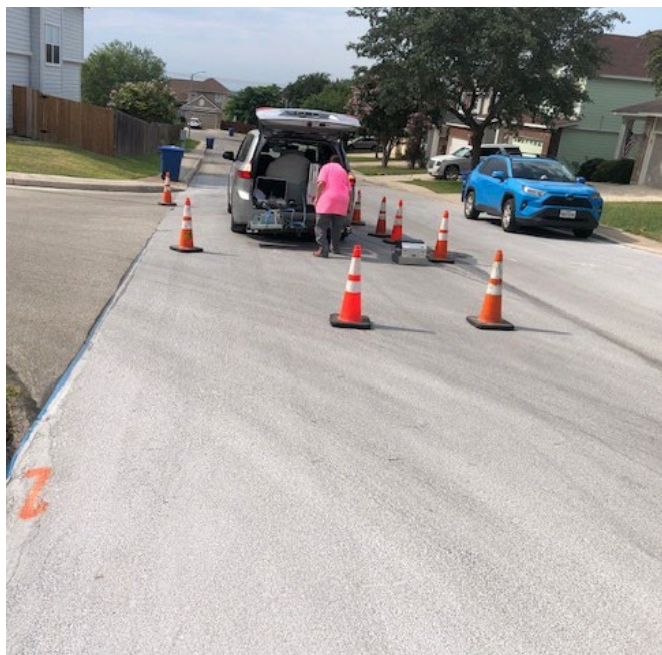
GAF, Seal Master and GuardTop provided a seal coat application that covers the pavement surface with its unique light color characteristics. They function similarly to any surface treatment applications that provide homogeneous appearance, fill all surface cracks, adhere firmly to the existing pavement surface, and build sufficient cohesion to resist abrasion due to traffic. During the visual inspection, the treated sites appeared to be distinct than their counterparts control sites from the surface color point of view. There were signs of tire marks along the wheel path (Figure 36). The extent of the tire marks is more pronounced in these products due to their light color as compared to conventional black surface treatment products.

Figure 37. Tire marks causing discoloration over treated site at Rebeccas Trail.

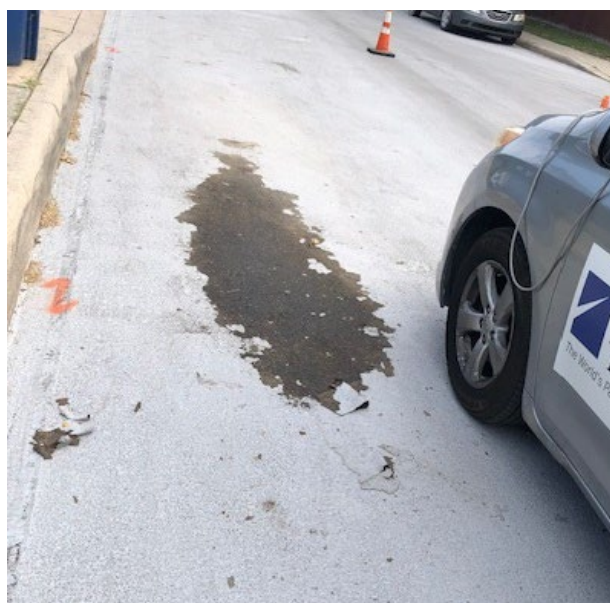
In a few areas, oil spills from parked vehicles along the curbs have negatively impacted the integrity of the sealcoat treatment due to separation and debonding with pavement surface. While the surface has been cleaned from dust and debris as part of the site preparation, oil spills seem to be a challenge to remove that ultimately affect the quality of the final surface appearance and bonding. Example of the oil spills is at Rebeccas Trail site (Figure 36).

Figure 38. Oil spill causing delamination at Rebeccas Trail.

Visual inspection on the treated sites provided more insight on the constructability, longevity and appearance of the tested products. For instance, presence of moisture along the curbs from runoff could wash off the product. Also, site contamination (e.g., oil spills) may prevent adhesion to surface and delamination of surrounded coating. Tire marks tracking appear to incrementally convert the wheelpath areas to same dark surface color as of control sites which may affect solar reflectance and the purpose of using these cool pavement products over time. More importantly, old pavements in near proximity to treated sites seem to have a lighter color due to the oxidation which naturally occur overtime for asphalt pavement surface. It is however of great importance to note that application of surface treatment coating is a major pavement preservation practice to maintain and preserve roadways performance and extend their service life and COSA is highly recommended to continue this practice.
