Japanese Tea Garden Master Plan

Japanese Tea Garden
Master Plan
San Antonio, Texas

June 2007

SWA Group
Project Landscape Architect
Houston, Texas

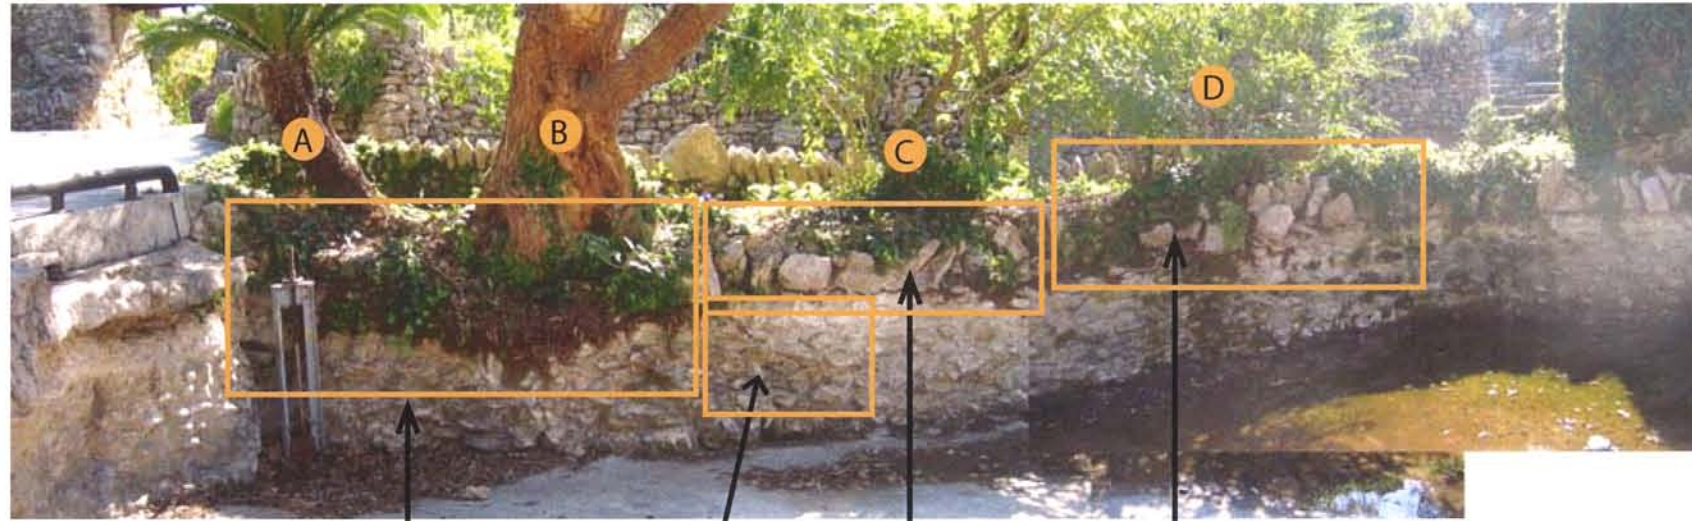
1 TREE ENCROACHING ON WALL. CAP MISSING ENTIRELY. WALL CRACKED TREE ENCROACHING ON WALL AND CAP. TREE ENCROACHING ON WALL AND CAP.

1. Trees have damaged the wall between the pedestrian bridge and arched bridge. The cap is disintegrating or missing in much of this portion. The pressure from the surrounding vegetation has also caused the wall to crack below the stone cap in portions. The City of San Antonio does not generally support the removal of trees on the property. Trees A, B, C and D. should be evaluated for aesthetics, safety, health, etc. by various City staff, the consultants, and contractors involved in Master Plan implementation to determine the best for the facility. Replace wall as necessary.

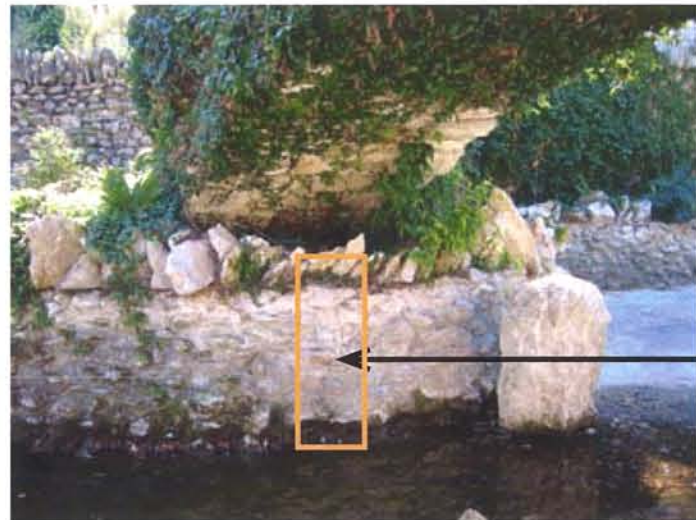
2

2. The wall below the dragon bridge closest to the pavilion is in good condition. There is a crack in one area. The bridge is covered in ivy, which needs to be removed. All roots should be removed from the rock face. Repair wall as necessary.

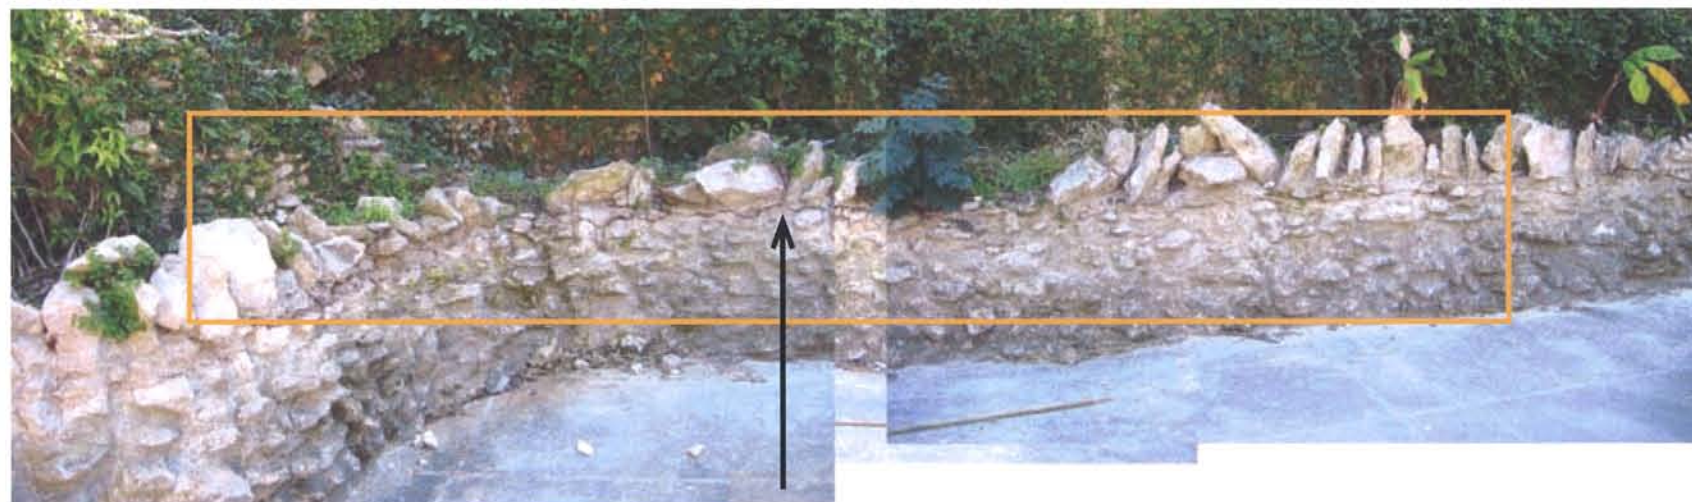
3 CAP CRACKED, DETERIORATING OR MISSING.

3. There are a couple areas where the wall cap is cracked, deteriorating or missing. When replacing the stone cap, the size of the rock used should be similar to the historic wall cap. Larger rock has been used in some areas where the stone cap has been replaced and does not match the predominate vertical arrangement. Stone cap should be replaced with historic vertical stone cap treatment.

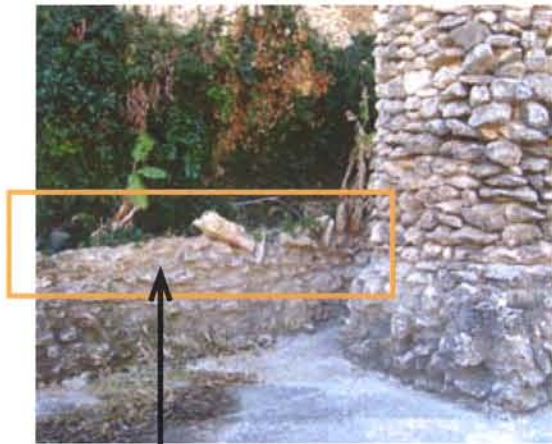
4 CAP MISSING.

4. The cap is missing entirely in this section. Replace stone cap.
5. Wall and cap in good condition beginning behind Pavilion column.
6. Wall and cap in good condition beginning behind Pavilion column. Cap appears to have been fixed recently. Stones in the cap appear larger than some of the more historic caps. Replace large stones with historic vertical stone cap treatment.

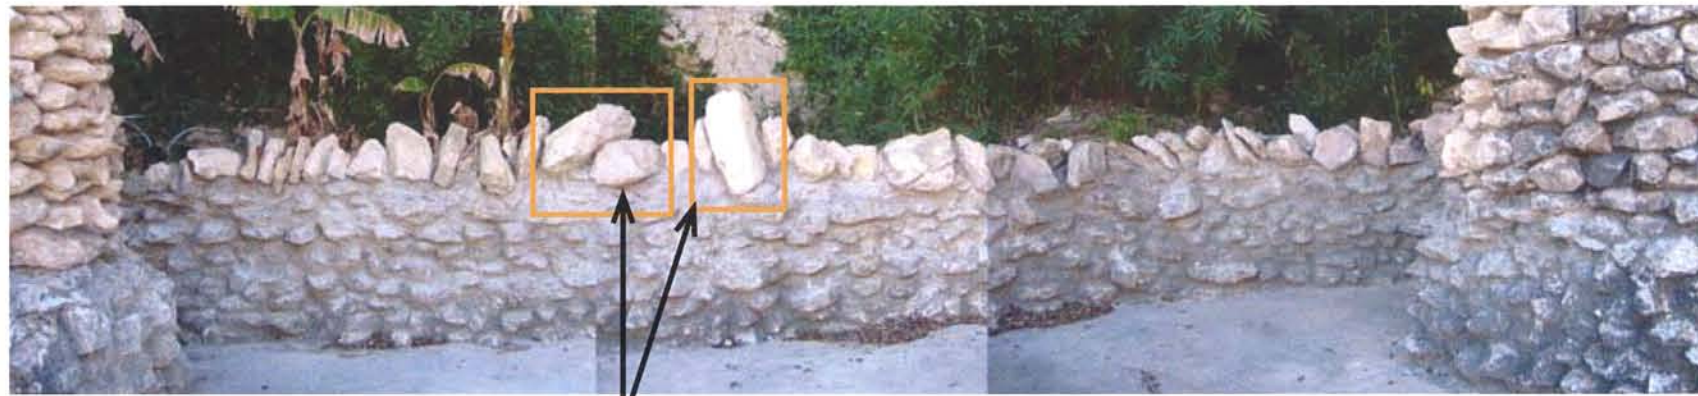
6 STONE OUT OF CHARACTER FROM HISTORIC STONE CAP STONE SIZE.

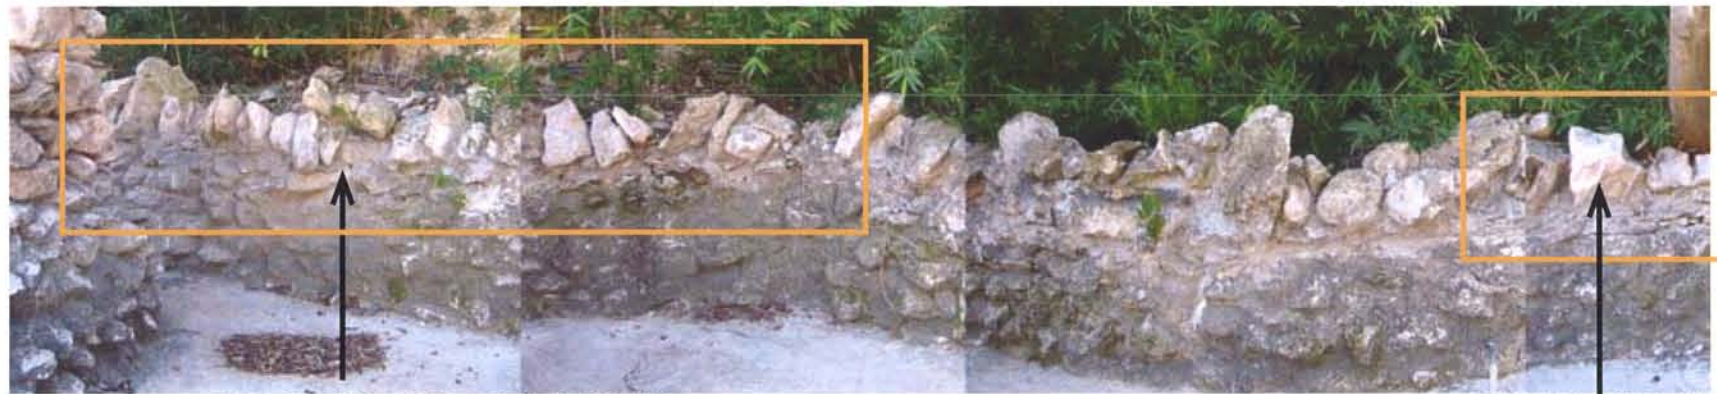
7 CAP CRACKED AND DETERIORATING OR MISSING.

CAP CRACKED AND DETERIORATING .

7. The wall is in good condition in this area. There are a couple areas where the stone cap is missing or deteriorating. Replace stone cap.
8. There are a couple areas where the cap is cracked or deteriorating. The wall is cracked in one area, close to a tree. There is also a rock that has fallen from above. Replace stone cap. Remove fallen rocks and use for restoration projects. Trees were not historically planted in the pond beds, except for banana trees. Consider removing trees A and B. The City of San Antonio, however, does not generally support the removal of trees on the property. Trees A and B should be evaluated for aesthetics, safety, health, etc. by various City staff, the consultants, and contractors involved in Master Plan implementation to determine the best for the facility.

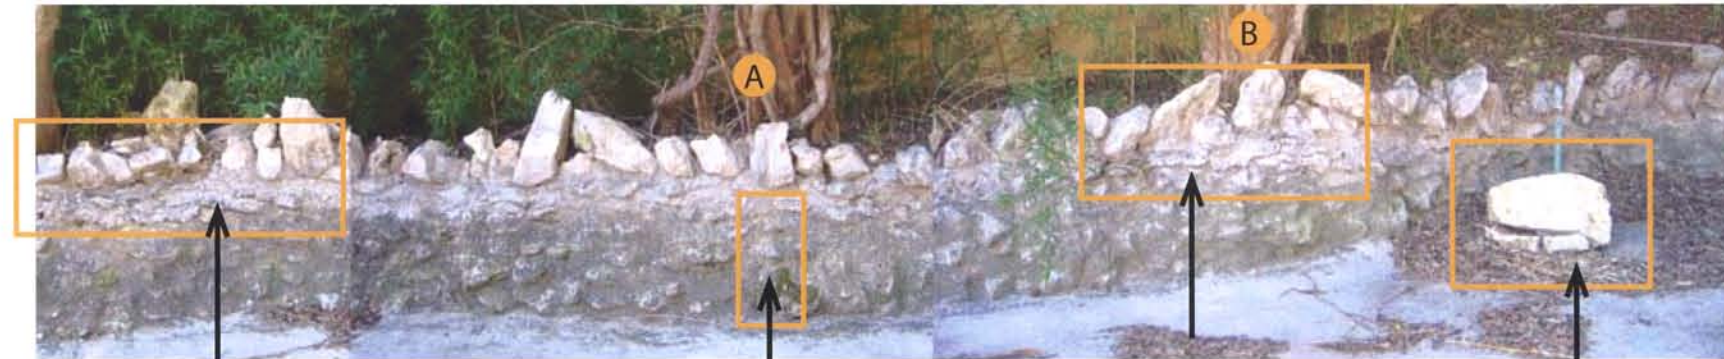
8 CAP CRACKED AND DETERIORATING OR MISSING.

WALL CRACKED

CAP CRACKED AND DETERIORATING .

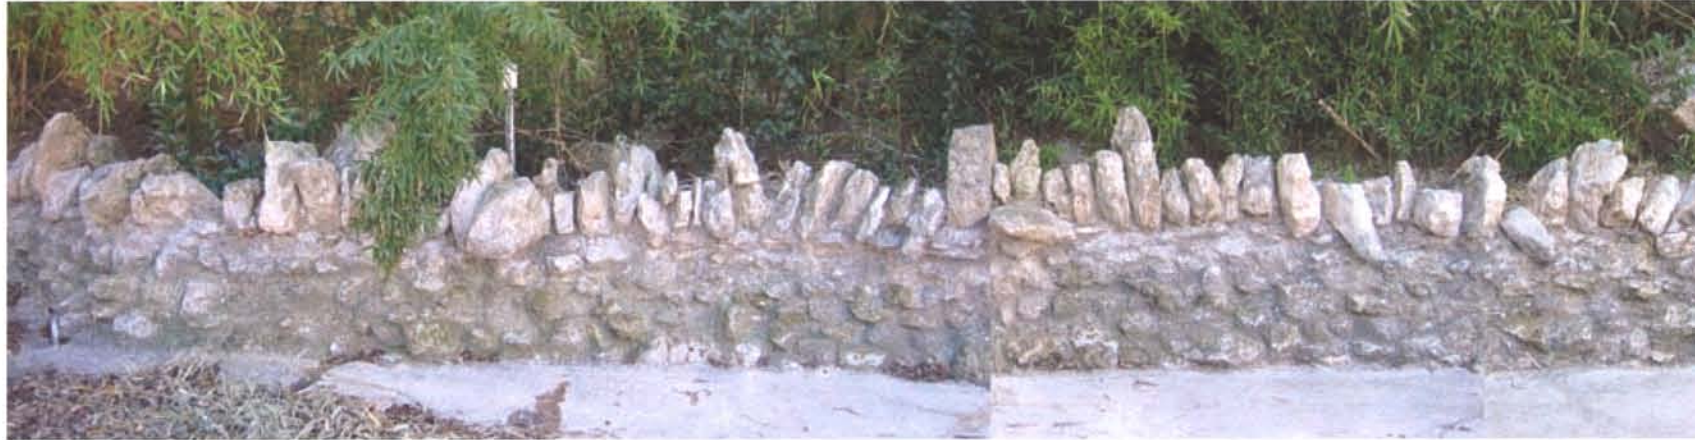
9

9. Wall in good condition

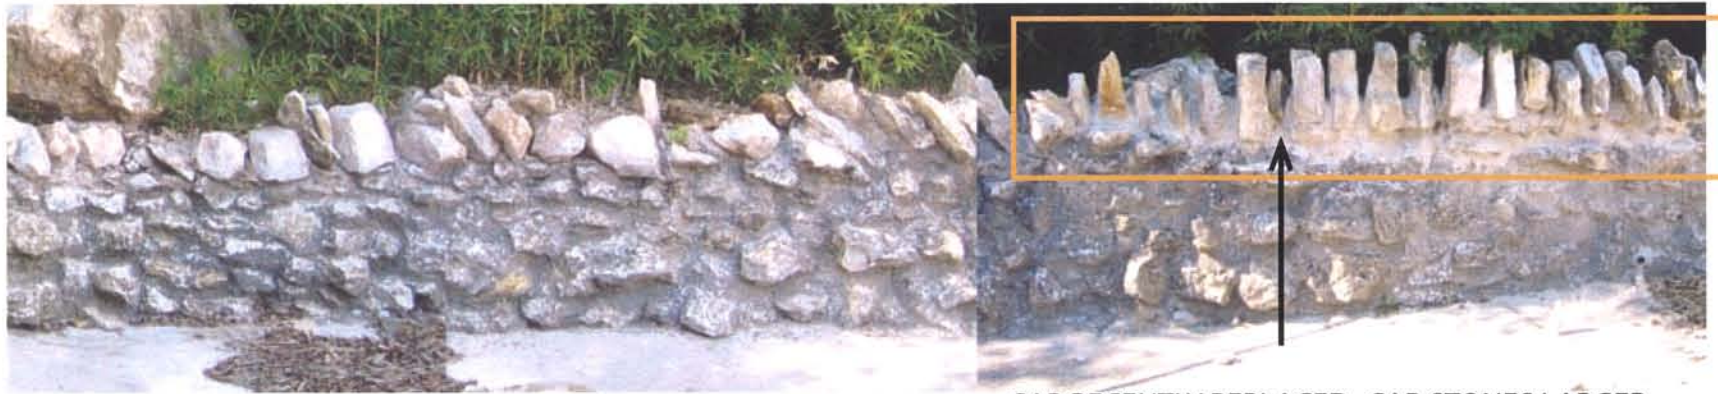
10

CAP RECENTLY REPLACED. CAP STONES LARGER THAN MORE HISTORIC CAP.

10. Generally, the wall is in good condition. In one portion, it appears the stone cap has been recently replaced. The cap stones used appear larger than some of the more historic caps.

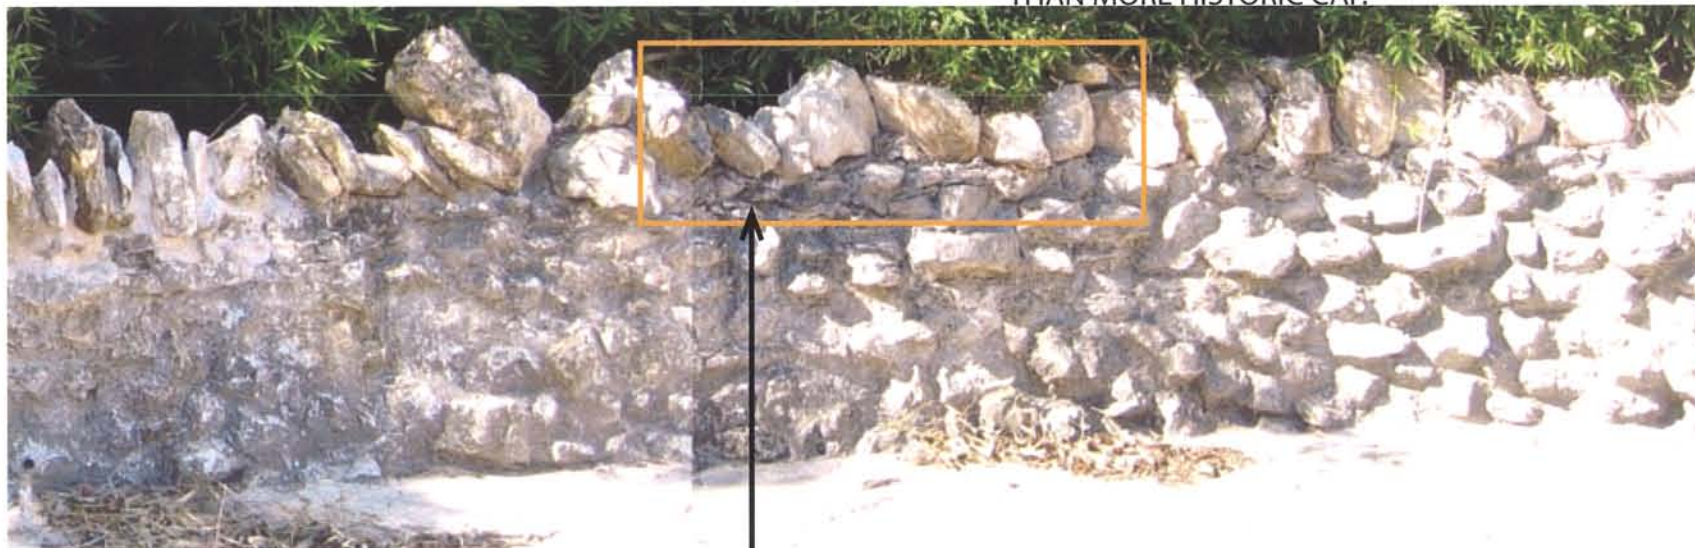
11

CAP CRACKED AND DETERIORATING OR MISSING.

11. Generally, the wall is in good condition. There is one portion where the stone cap is cracked and deteriorating. Replace stone cap.

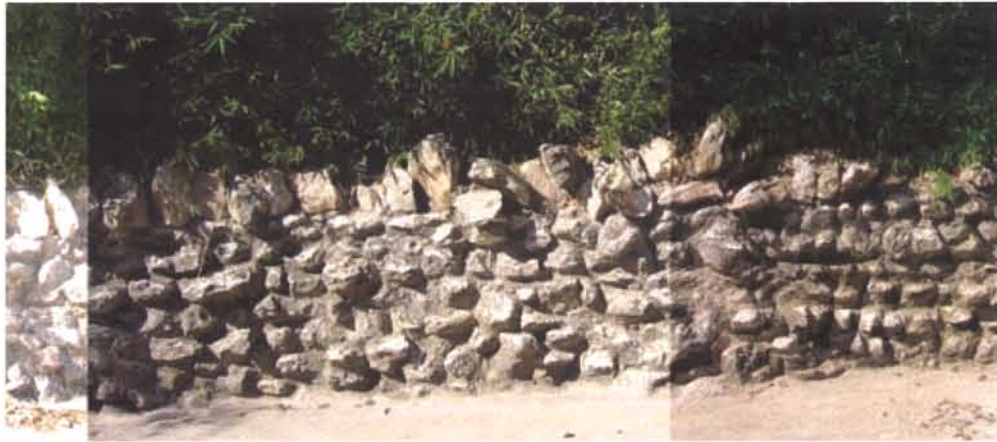
12

- 12. Wall and cap in good condition.
- 13. The back wall of the quarry wall at the Pavilion pond is compromised by the invasive and overgrown bamboo planting in the beds behind the wall. The bamboo roots have formed a thick mat and are pushing out stones in the cap. The bamboo should be eradicated (see vegetation analysis) Remove unused piping.
- 14. This portion of wall continues to be compromised by the invasive and overgrown bamboo planting in the beds behind the wall. The bamboo roots have formed a thick mat and are pushing out stones in the cap. The bamboo should be eradicated (see vegetation analysis).

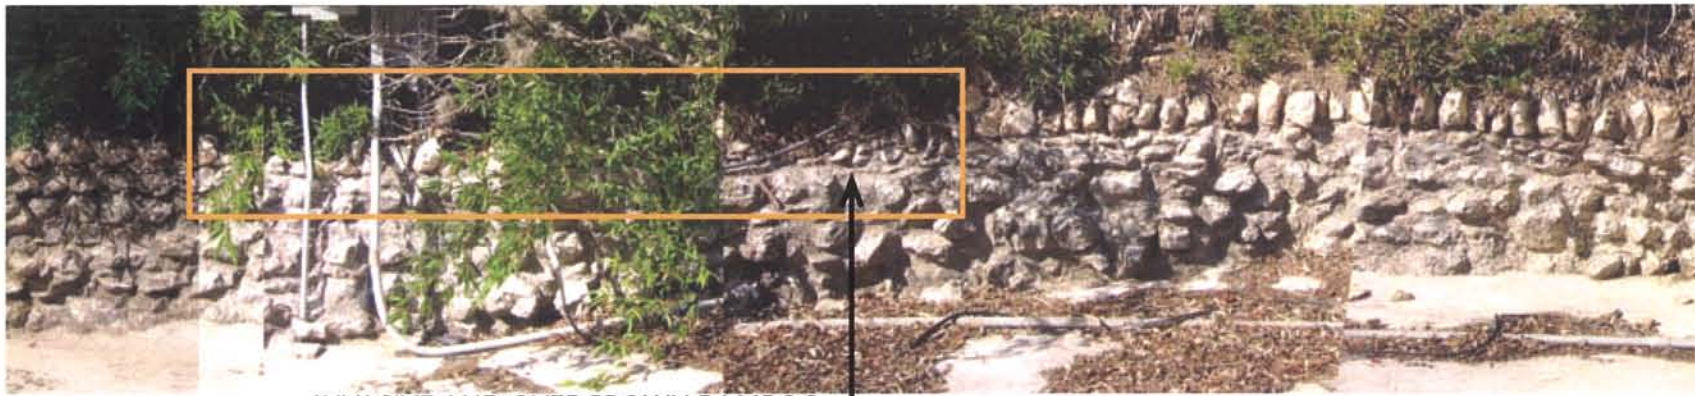
13

INVASIVE AND OVERGROWN BAMBOO COMPROMISING STONE CAP.

Replace wall as necessary. This should be completed prior to pond liner installation.

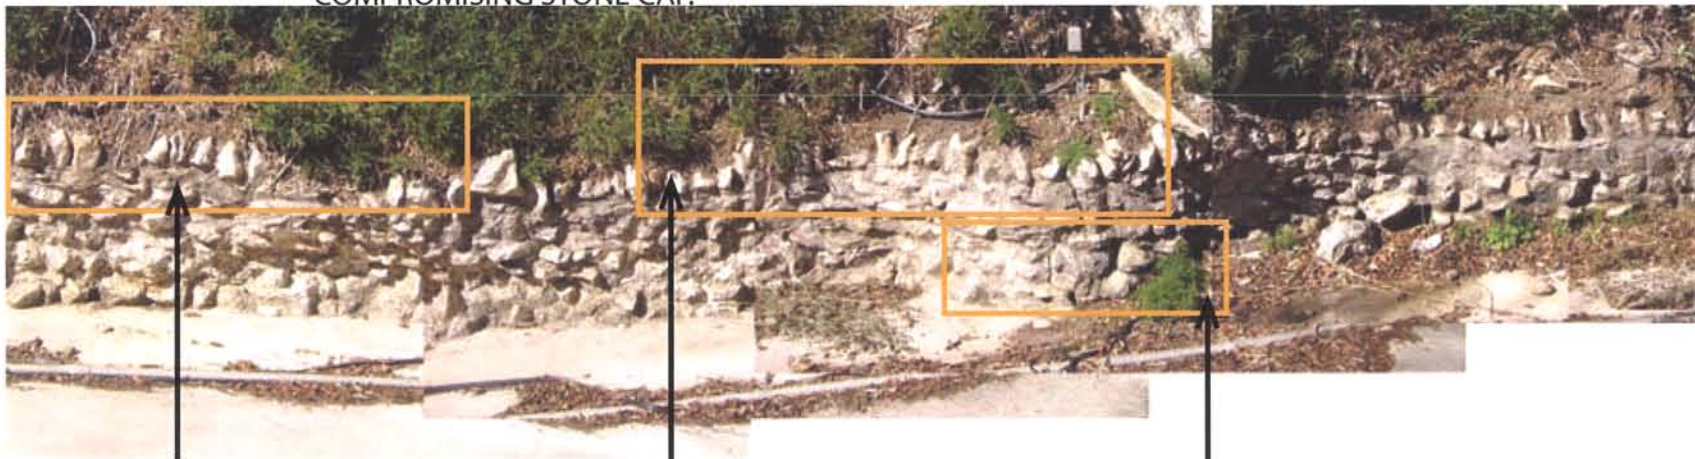
14

INVASIVE AND OVERGROWN BAMBOO COMPROMISING STONE CAP.

WALL CRACKED AND DETERIORATING.

The wall is also cracked in one area.

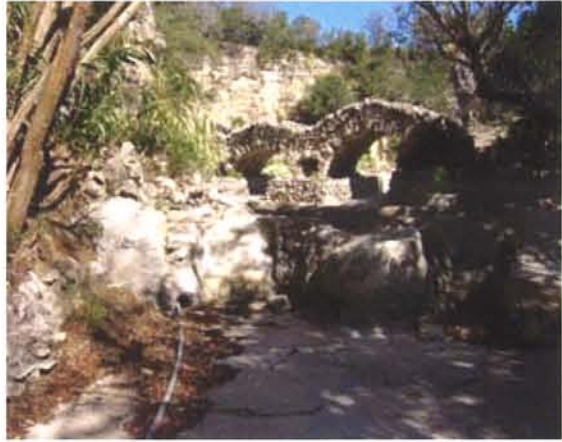
15

- 15. This portion of the wall is part of the weir. It is not as decorative as other portions of the stone walls. There are no noticeable problems.
- 16. This portion of the wall is part of the weir. It is not as decorative as other portions of the stone walls. There are no noticeable problems.
- 17. One of the larger trees is pushing out the wall at the beginning of the weir. The wall is compromised. There is also a portion of the weir where the stone cap is missing.

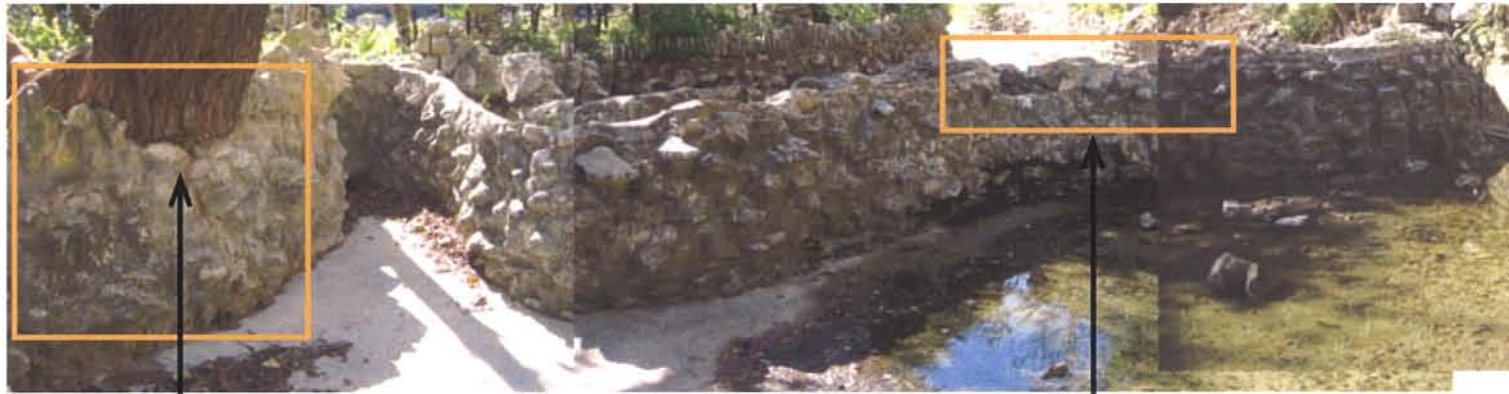
17 TREE PUSHING OUT AND COMPROMISING WALL.

STONE CAP MISSING.

Consider removing tree. The City of San Antonio does not generally support the removal of trees on the property. The imposing trees should be evaluated for aesthetics, safety, health, etc. by various City staff, the design consultants, and contractors involved in Master Plan implementation to determine the best for the facility. Replace stone cap.

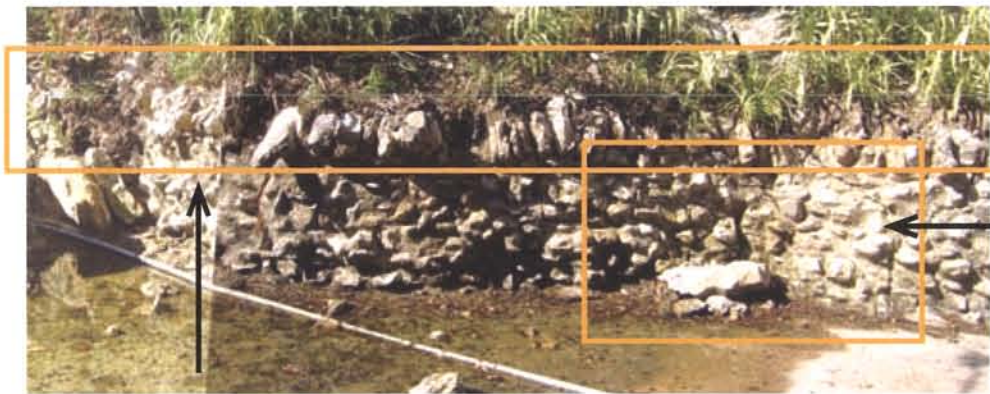
18 INVASIVE AND OVERGROWN CANE COMPROMISING STONE CAP. WALL IMPACTED BY ROCK SLIDES.

WALL CRACKED AND DETERIORATING.

- 18. Between the weir and the dragon bridge, much of the stone wall and cap in this area is compromised by invasive and overgrown cane. The cane should be eradicated and the wall reconstructed. There are also several areas where rock slides have caused damage to the walls and cap. Measures should be taken to secure the walls above and prevent visitors from compromising the wall. (see safety and security analysis) In this portion, there is also noticeable cracking.

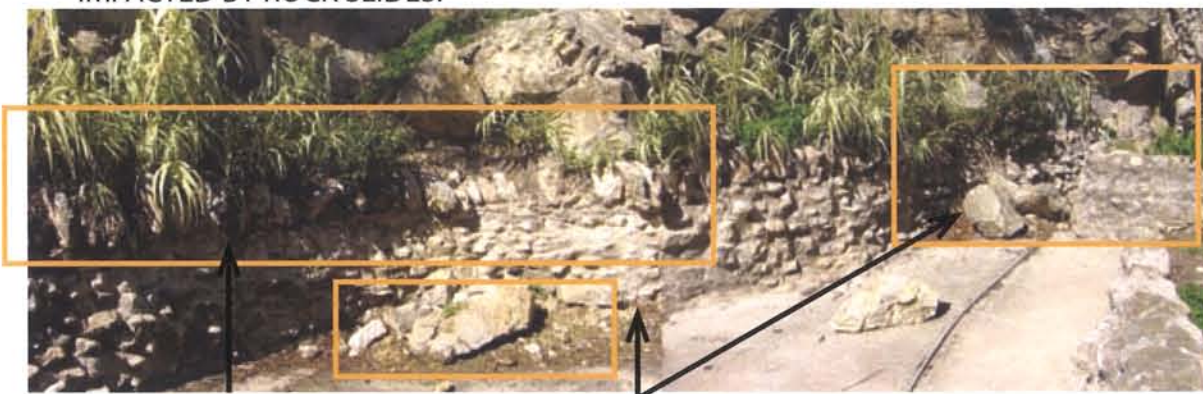
19 STONE CAP COMPROMISED

WALL IMPACTED BY ROCK SLIDES.

- 19. This portion of the wall and cap is compromised by overgrown and invasive cane. The wall is cracked and deteriorating. The cane should be eradicated and the wall reconstructed. The wall is also impacted by rock slides from above. Measures should be taken to secure the walls above and prevent visitors from compromising the wall (see safety and security analysis).

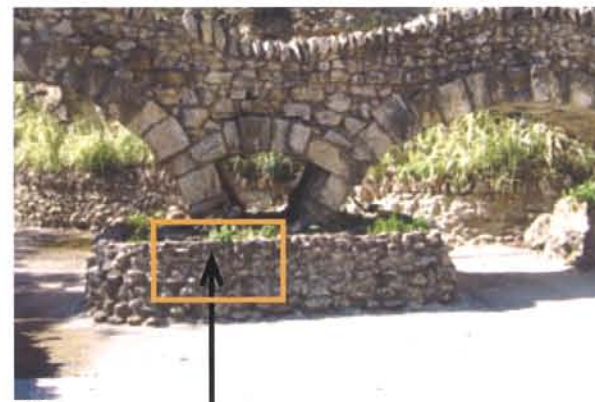
20

WALL CRACKED AND DETERIORATING.

- 20. In the center of the dragon bridge, the pond wall is cracked and deteriorating. Replace wall as necessary. This should be completed prior to pond liner installation.

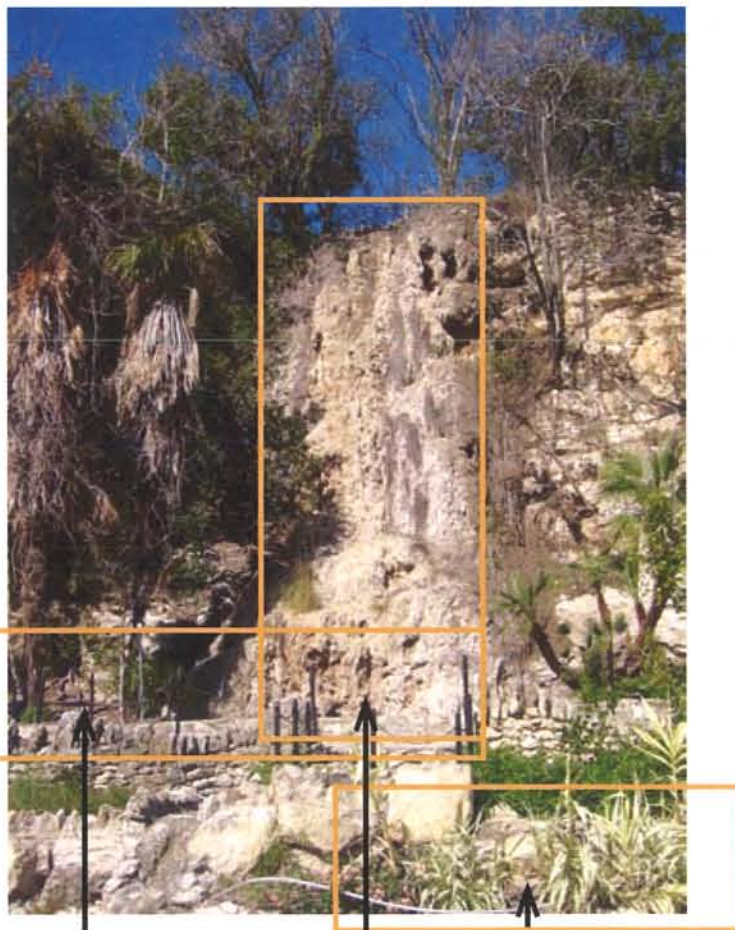
NON-HISTORIC SAFETY RAIL

HISTORIC WATER FALL WITH DRIED MOSS .

Currently, the wall is covered with dried moss and lichen. However, it is believed that once the water is restored to the park, the wall will come to life with lush, moisture loving lichens and moss. There is an overlook in front of the waterfall, which is a great picture spot. It also allows visitors to get closer to the ponds and therefore should be maintained. The black non-historic railing is not necessary if the ponds are re-graded so the railing is not a required safety measure.

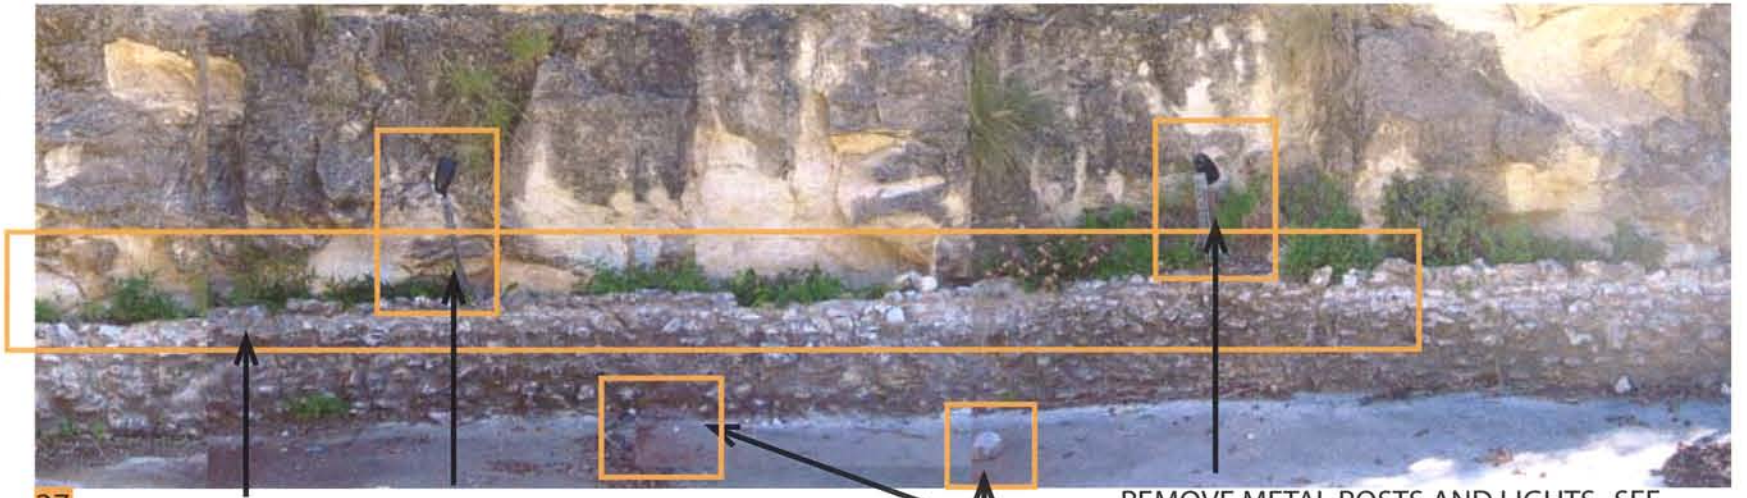
27 STONE CAP MISSING OR DETERIORATING. REMOVE METAL POSTS + LIGHTS. SEE LIGHTING ANALYSIS FOR REC. FALLEN ROCK REMOVE METAL POSTS AND LIGHTS. SEE LIGHTING ANALYSIS FOR RECOMMENDATIONS.

27. The stone cap is missing in much of this portion. Repair stone cap. The area is also impacted by rock slides from above. Securing Alpine Drive from above will be a great step towards this measure (see safety and security analysis). All exposed piping, conduit and electrical panels should be hidden with either planting or placed in a non-conspicuous location. All unused piping should be removed.

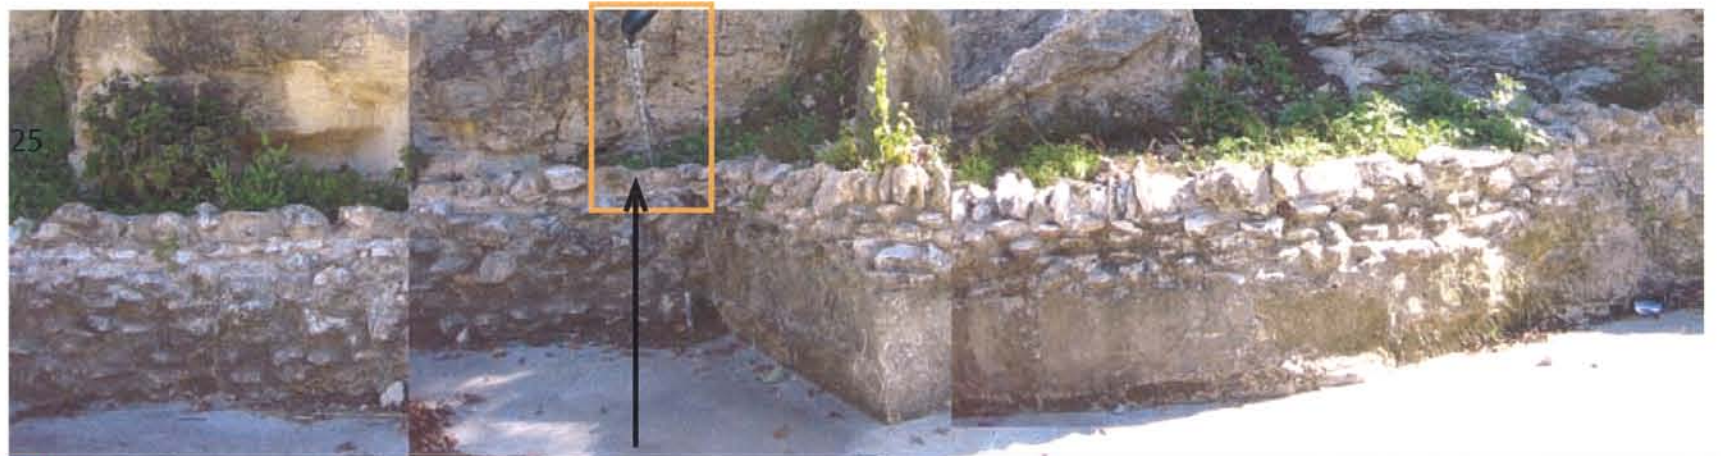
28 REMOVE METAL POSTS AND LIGHTS. SEE LIGHTING ANALYSIS FOR RECOMMENDATIONS.

28. The area is impacted by rock slides from above. Securing Alpine Drive from above will be a great step towards this measure (see safety and security analysis). All lights and posts should be removed. See lighting analysis for recommendations.

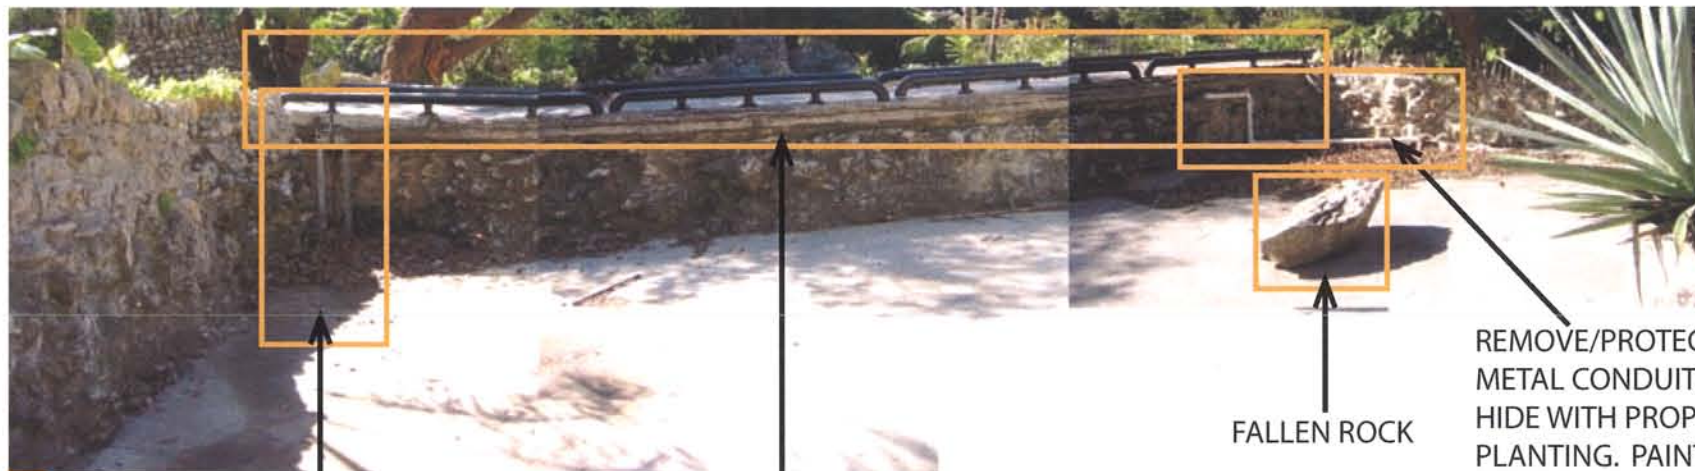
31 REMOVE PIPE. NON-HISTORIC RAILING. FALLEN ROCK. REMOVE/PROTECT METAL CONDUIT/PIPE. HIDE WITH PROPOSED PLANTING. PAINT BLACK.

31. The railing on the pedestrian bridge is non-historic and should be replaced with a more appropriate railing (see safety and security analysis). Also, all piping should be removed if not in use. Future piping should blend in with the pond liner and be inconspicuous.

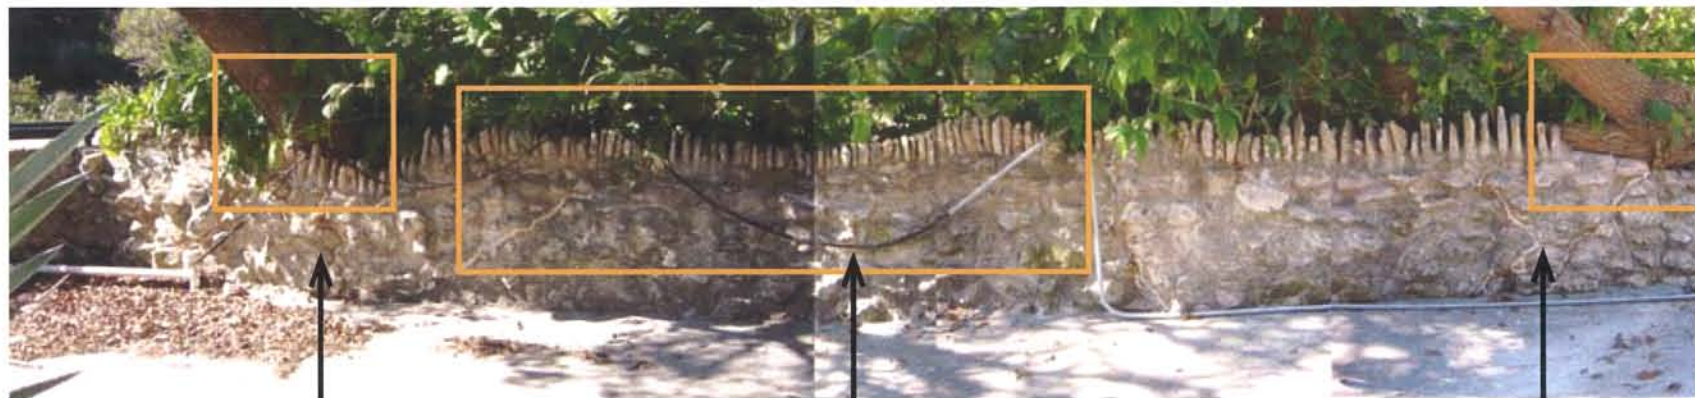
32 TREE ENCROACHING ON WALL. REMOVE CONDUIT. TREE ENCROACHING ON WALL. WALL REPAIRED IN PAST (SEE CRACK WITH MORTAR).

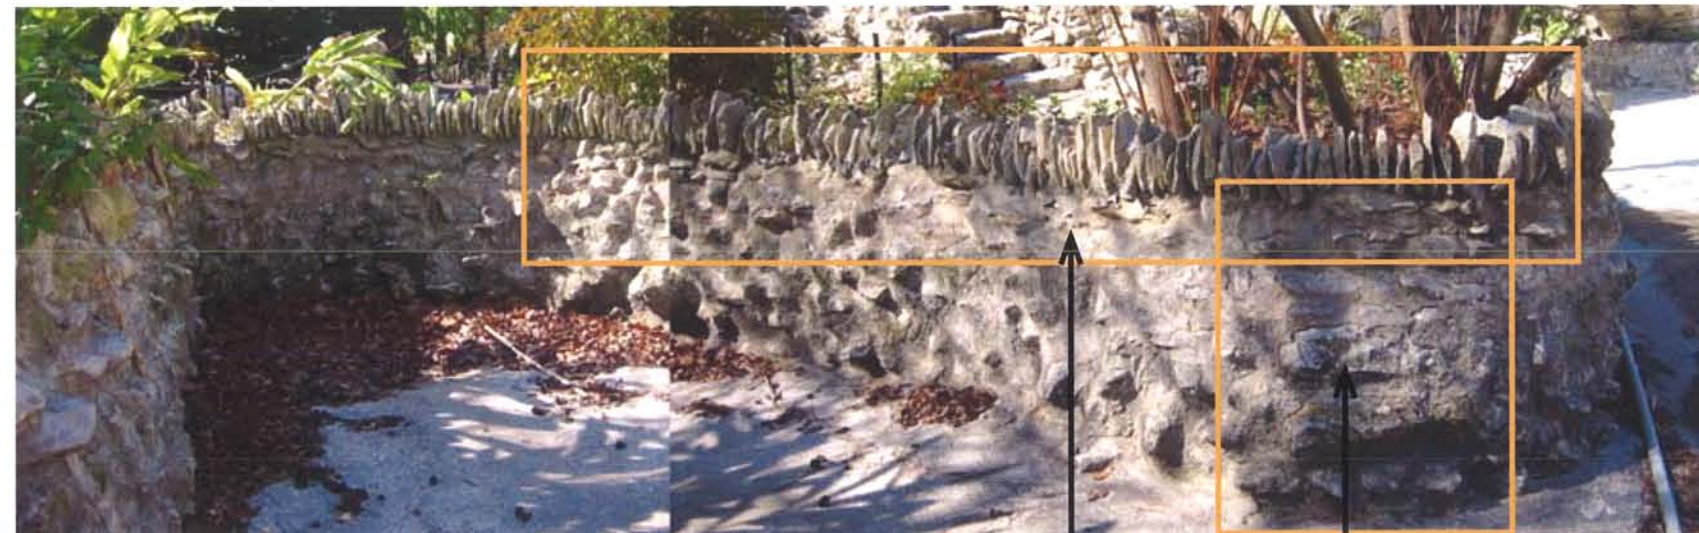
36 EVIDENCE OF PREVIOUS STONE CAP REPAIR.

WALL CRACKED AND DETERIORATING.

- 36. Generally, the wall in this location is in good shape. One spot has some cracking, which might be from the tree located in the planting bed behind the wall. There have been repairs to the cap, but it looks to be in good condition. Consider removing trees. The City of San Antonio does not generally support the removal of trees on the property. All trees to be removed should be evaluated for aesthetics, safety, health, etc. by various City staff, the consultants, and contractors involved in Master Plan implementation to determine the best for the facility.

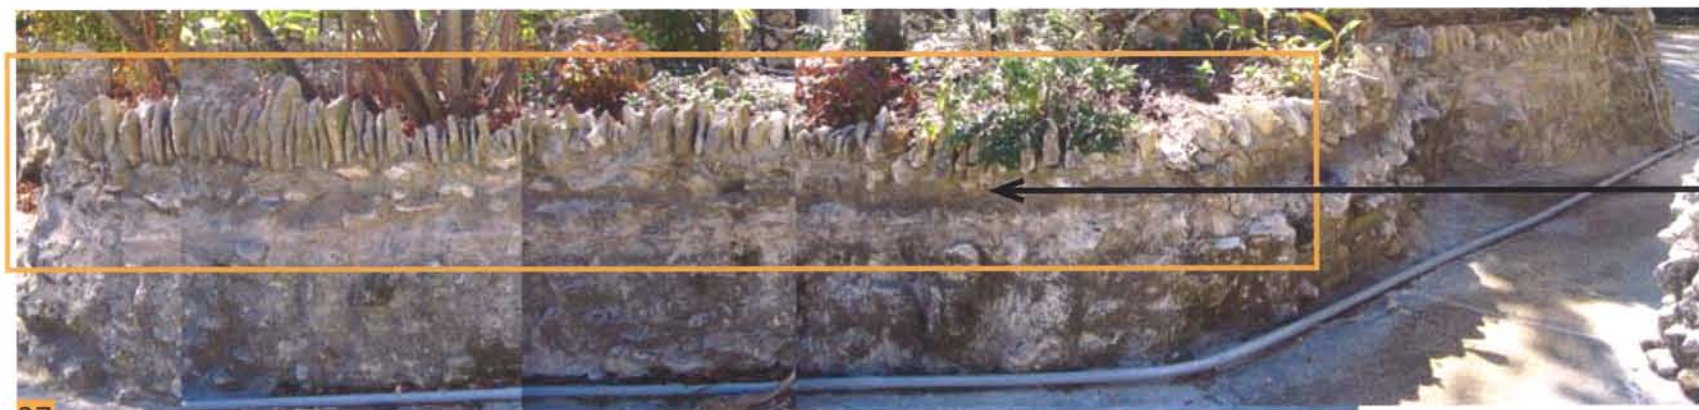
37 EVIDENCE OF PREVIOUS STONE CAP REPAIR.

- 37. There have been repairs to the cap, but it looks to be in good condition. All piping should be removed or replaced with systems that are inconspicuous, preferably placed underground or are completely hidden.

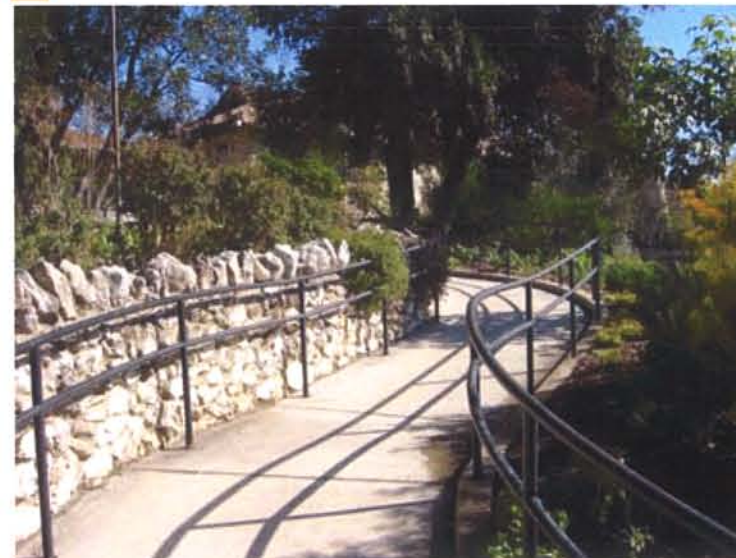
6

- 3. Accessible ramp entry located to the northwest of the torii gate completed in 1998. The ramp was approved by the Historic and Design Review Commission and the State of Texas Department of Licensing and Regulation. The slope of the ramp is ???. The handrails were a requirement of the State, most likely because of a slope above 5%.
- 4. Railing and curb along northern edge of the ramp. The curb and rail take away from the entry and are not necessary if the slope is less than 5%.
- 5. Railing on south side of accessible ramp. Again, this railing takes away from the impact of the entry and is not necessary on the wall side.
- 6. Accessible ramp at main entry.

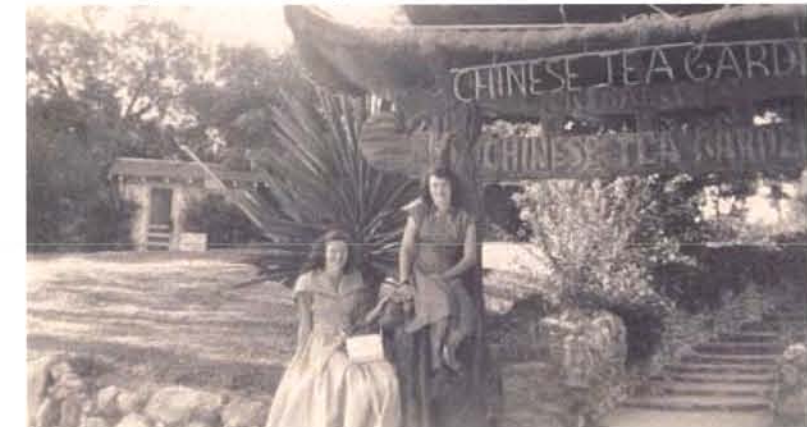
Historic image of Chinese Tea Garden Gate. The stairs appear to be constructed of stacked limestone with a layer of concrete. It is difficult to tell for certain because of the image resolution.

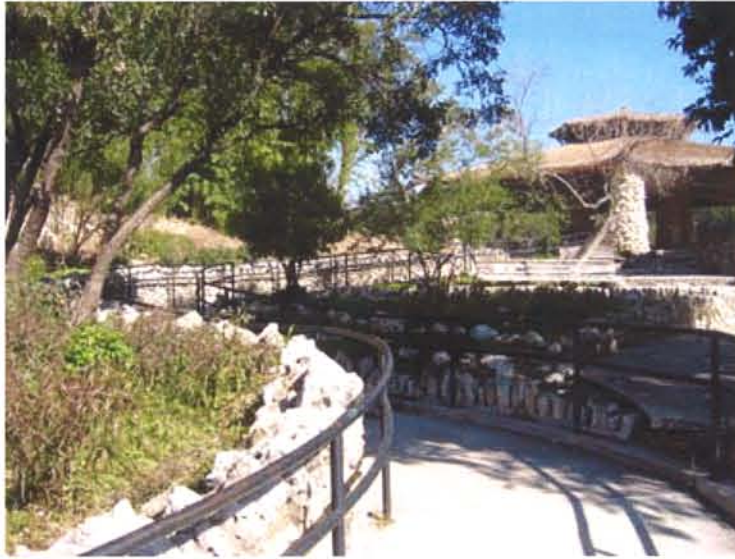
7

7. Accessible ramp.
8. Part of the existing and historical path system was interrupted to accommodate the accessible ramp. If the ramp is to remain, this remnant path should be removed.
9. Entry steps at Torii gate. The steps are not direct and help to pull visitors up and into the park.
10. Concrete at entry steps cracking and deteriorating. These steps should be fixed, but resemble historic steps throughout the Pavilion area.
11. Main entry steps to Pavilion.
12. Landing off Main Entry stair asphalt should be removed. Stairs might not be historic.

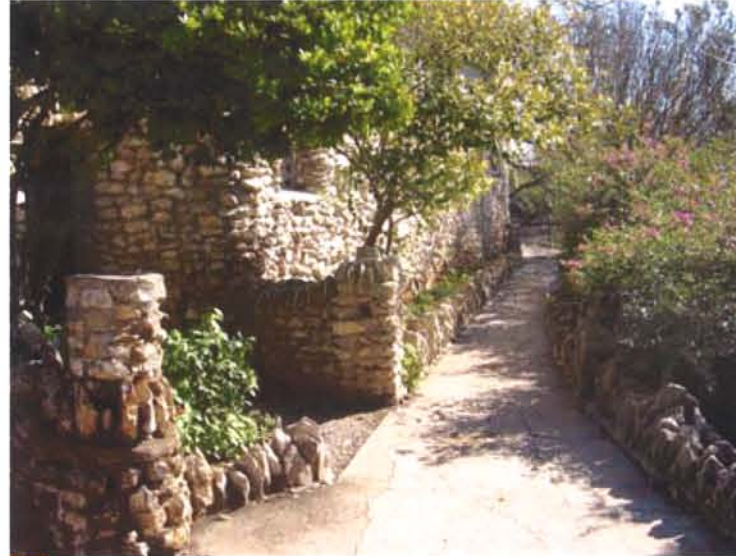
14

- 13. Landing before Pavilion level.
- 14. Pathway to the lower level of the Jingu house. Remove all asphalt.
- 15. Pylon detail, typical. The pylons typically were lighting structures. It is not clear if the pylons near the Pavilion were restored to accommodate planters or if they were never designed with lighting infrastructure.
- 16. Planter wall with wooden bench. Benches need to be replaced.
- 17. Landing near Pavilion. Asphalt is not historic and has been patched over the year. It should be replaced.
- 18. View from landing near Jingu house lower level to Pavilion. The pylons typically were lighting structures. It is not clear if the pylons near the Pavilion were restored to accommodate planters or if they were never designed with lighting infrastructure.

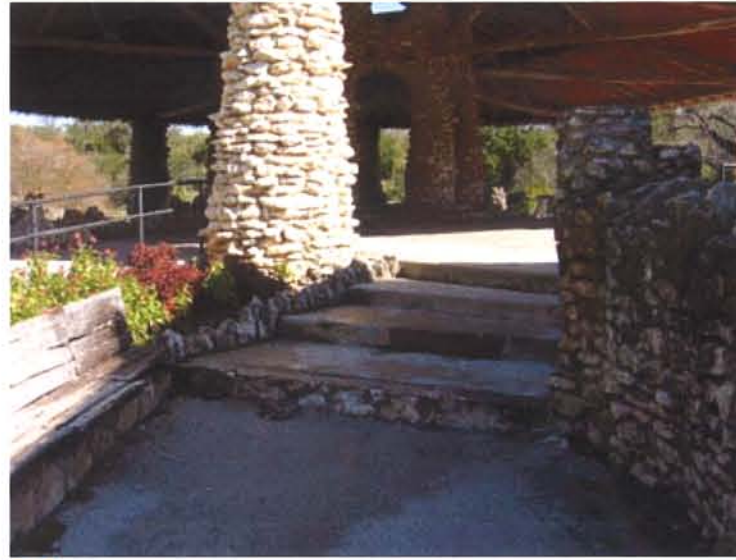
20

- 19. Detail of wooden bench structure. A second bench is in the background.
- 20. Final steps to Pavilion. Another wooden bench is to the left and should be replaced.
- 21. Landing at Pavilion. Concrete cracked.
- 22. Pathway to Skyride site. Railing to the left is not historic.
- 23. Steps up to Skyride. Limestone bands with asphalt. Asphalt is not historic.
- 24. Fence around Skyride site.

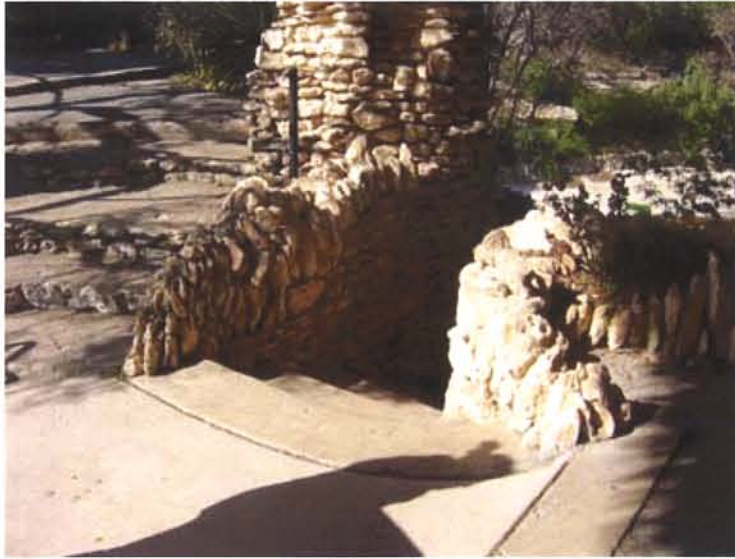
25

- 25. Steps from Pavilion level to lower level of Pavilion. Landing steps made of concrete, which was not a historic material.
- 26. Lower level at Pavilion.
- 27. Stairs down to landing. The stairs are in good condition, however, they are not sympathetic to historic construction.
- 28. Limestone bench built into the wall at the lower level of the Pavilion. The bench is in good condition. Protect historic bench in place.
- 29. View up the stair at lower level landing to Jingu house.

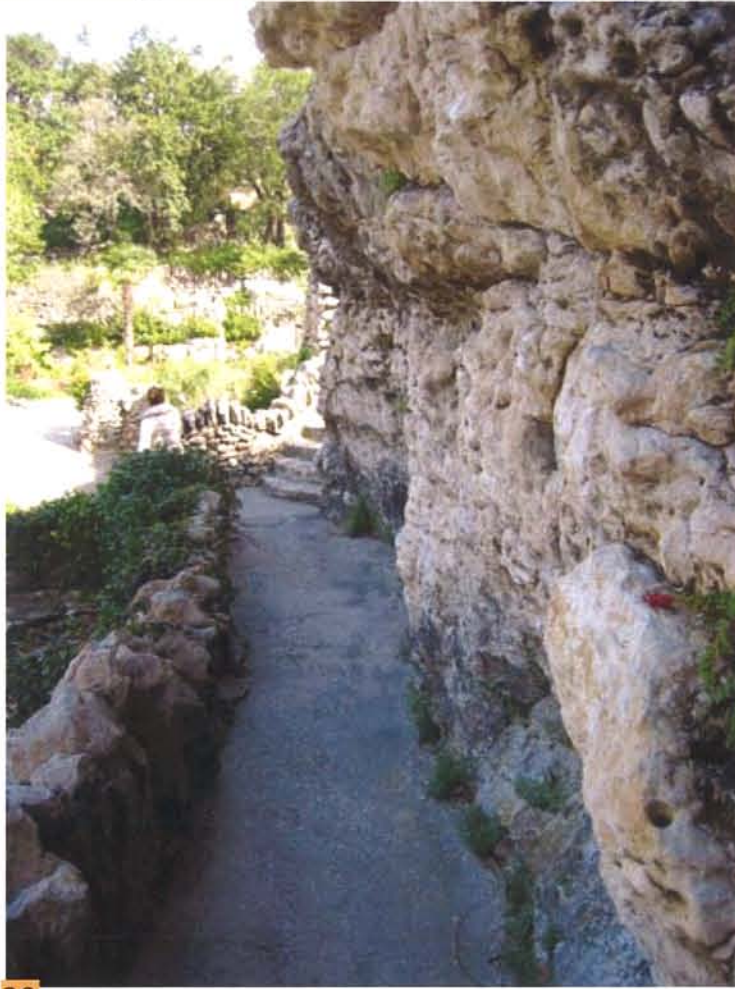
30

- 30. Walkway below Pavilion. Asphalt is not historic and should be removed.
- 31. Hidden steps in Pavilion pond.
- 32. Steps to arched bridge near Pavilion. Historic steps were likely limestone. Arched bridge covered with fig ivy, The ivy should be removed to expose the stone masonry.
- 33. Flagstone limestone paving on arched bridge near Pavilion.
