Japanese Tea Garden Master Plan

Japanese Tea Garden
Master Plan
San Antonio, Texas

June 2007

SWA Group
Project Landscape Architect
Houston, Texas

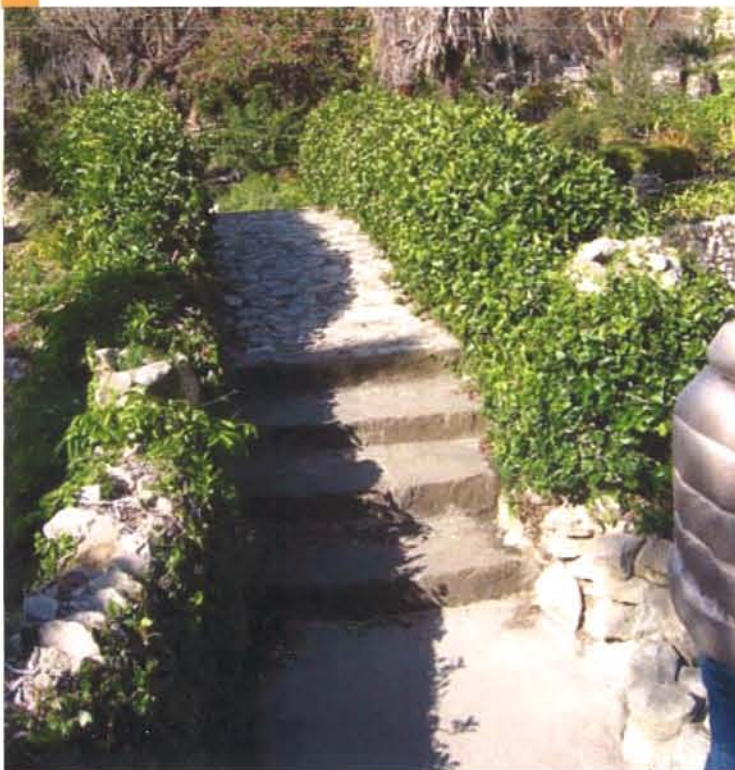
32

- 30. Walkway below Pavilion. Asphalt is not historic and should be removed.
- 31. Hidden steps in Pavilion pond.
- 32. Steps to arched bridge near Pavilion. Historic steps were likely limestone. Arched bridge covered with fig ivy, The ivy should be removed to expose the stone masonry.
- 33. Flagstone limestone paving on arched bridge near Pavilion.

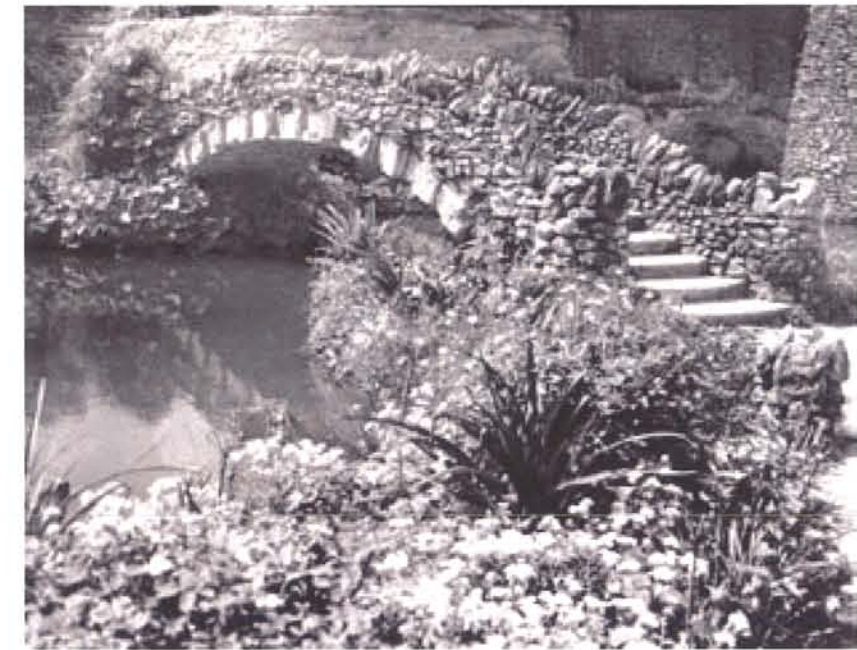
Historic image of Arched Bridge. Steps were historically large slabs of limestone, rather than concrete as they are today. It is not clear if the limestone flagstone at the curved portion of the bridge is historic. It does however, resemble the flagstone used on the Core Island.

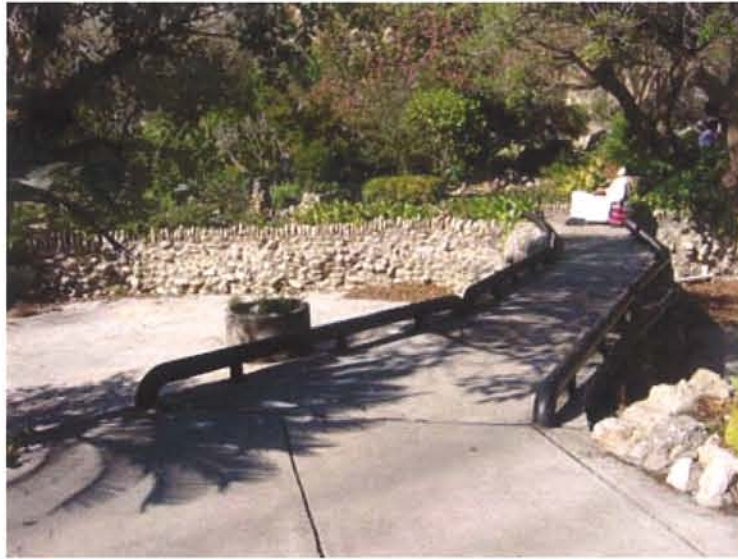
34

- 34. Pedestrian bridge from Pavilion to Core Garden Island. Railing is not historic and could fit in better with the site aesthetics. Rail should be removed.
- 35. Limestone flagstone at Core Garden Island.
- 36. Core Island pathways with limestone header stone edging. (See historic images).
- 37. Header stone edging with pylon.
- 38. Garden wall with stone bench. Protect historic bench in place.
- 39. Detail of stone bench. Protect historic bench in place.

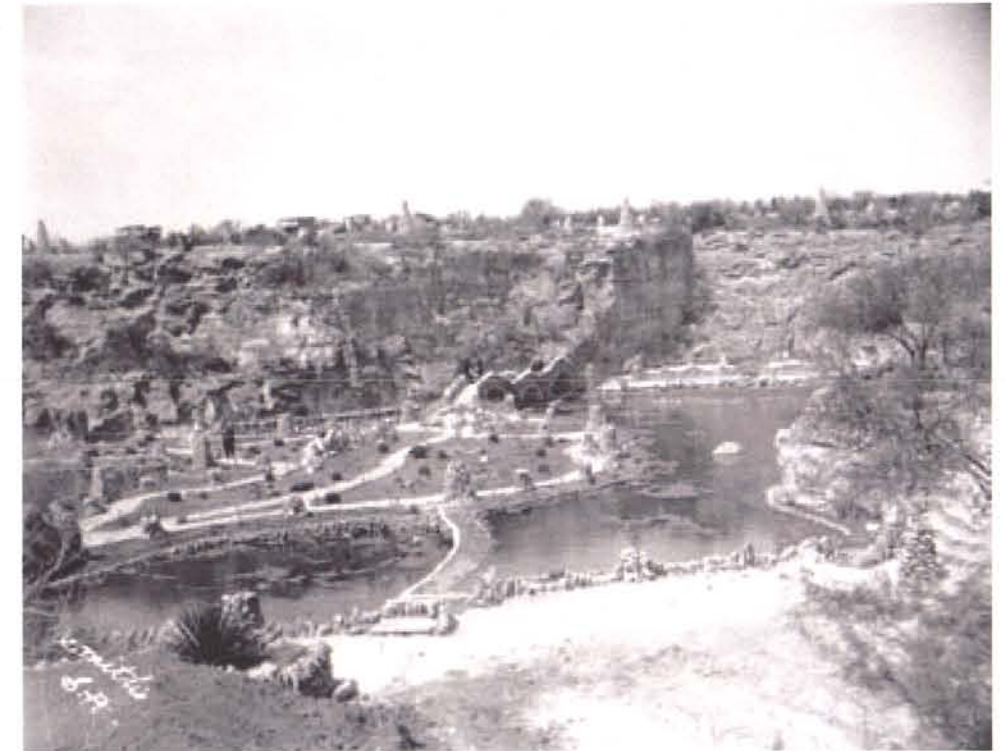
Historic image of Japanese Tea Gardens. The foreground of this historic image shows the location of the historic weir. The accessible bridge was constructed on top of the weir. The accessible bridge is the only accessible entry to the Core Garden Island and should remain, even though it was not historically present during the period of significance.

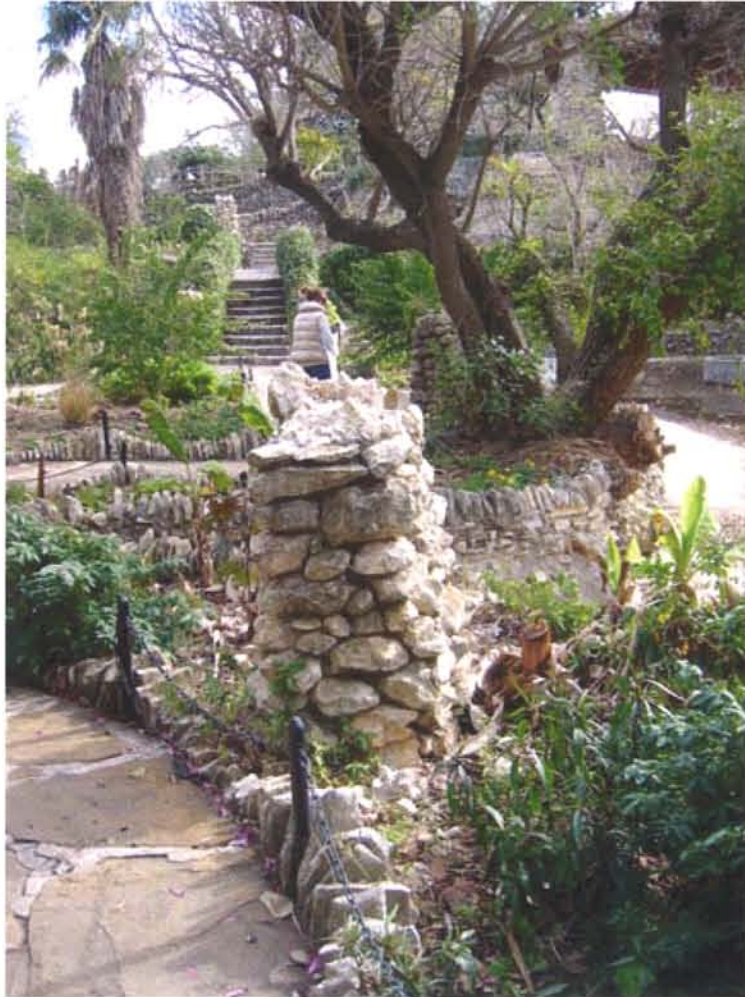
40

- 40. Pylon with missing cap. Black rail not historic and not necessary.
- 41. Core island pathway. Black post and rail not historic and should be removed.
- 42. Pylon detail with interesting stamped concrete leaf.

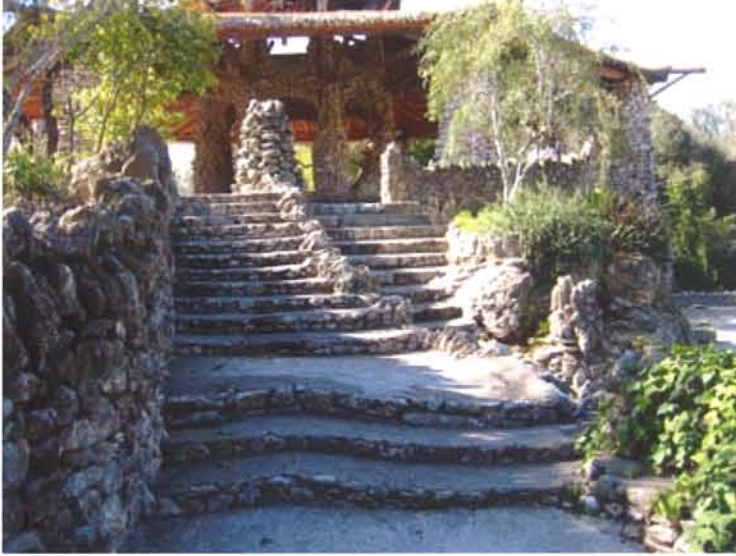
43

43. Steps up from Core Island to Pavilion. Steps are made of rock and concrete/asphalt. The steps were also large slabs of limestone rather than the stacked limestone with concrete veneer. See historic appendix images 2, 5, and 6.

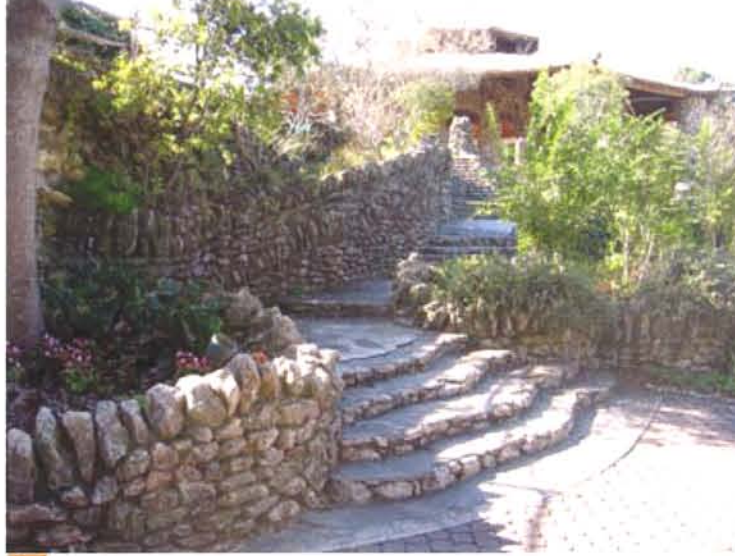
44

44. Steps near Core Island. A concrete band and pavers are located at the bottom of the steps. The pavers are not historic and should be removed. The steps were also large slabs of limestone rather than the stacked limestone with concrete veneer. See historic appendix images 2, 5, and 6.

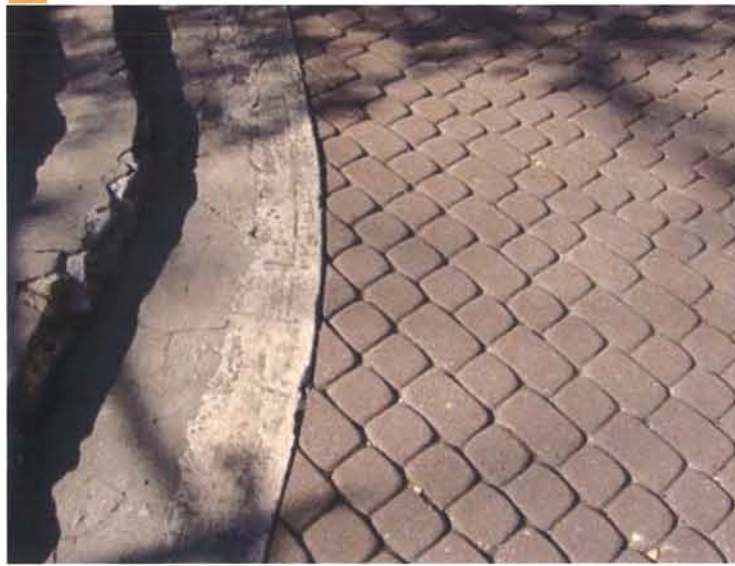
48

48. Pavers to be removed.

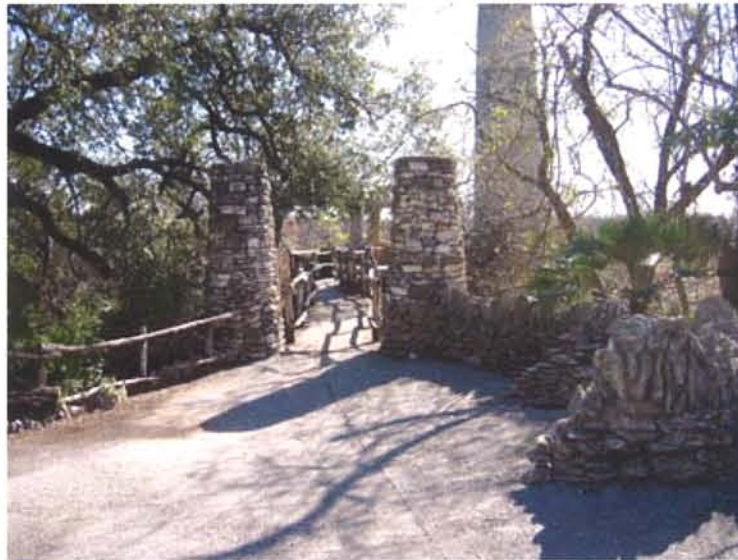
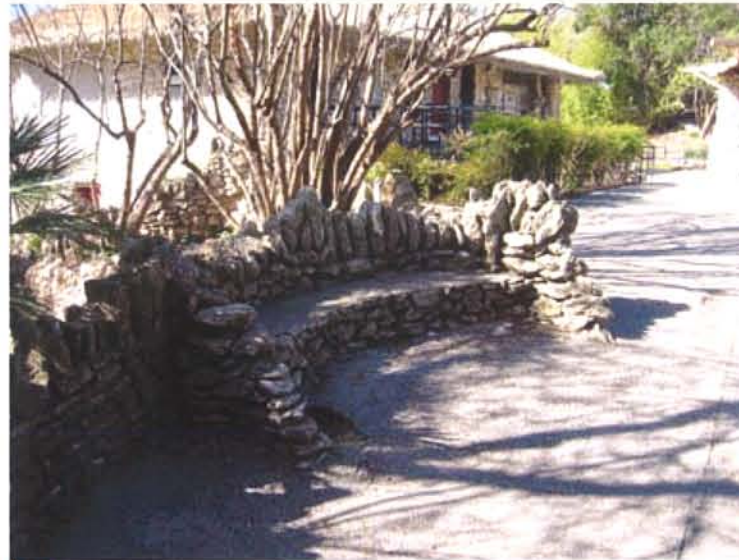
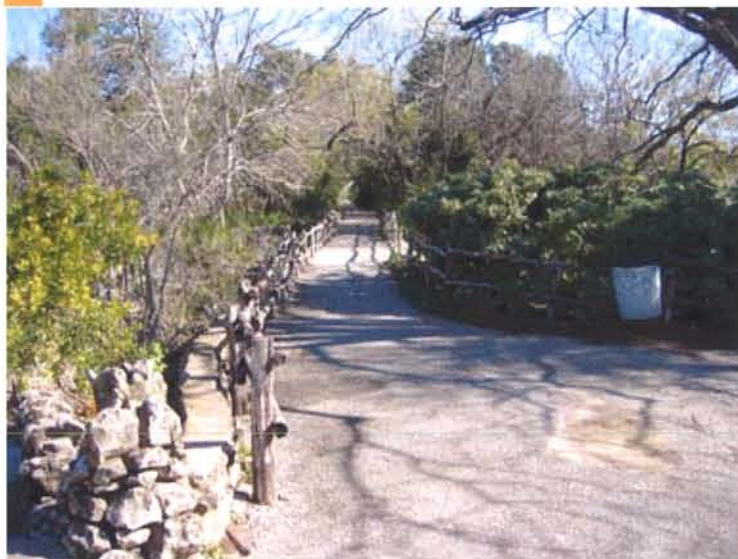
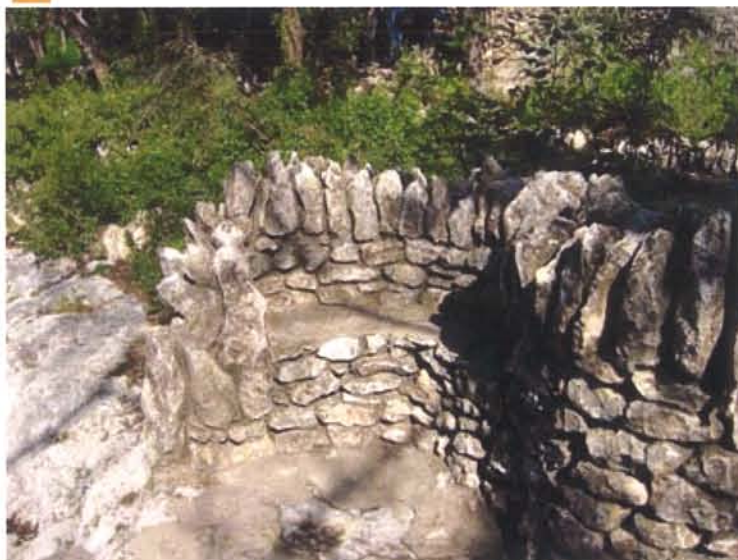
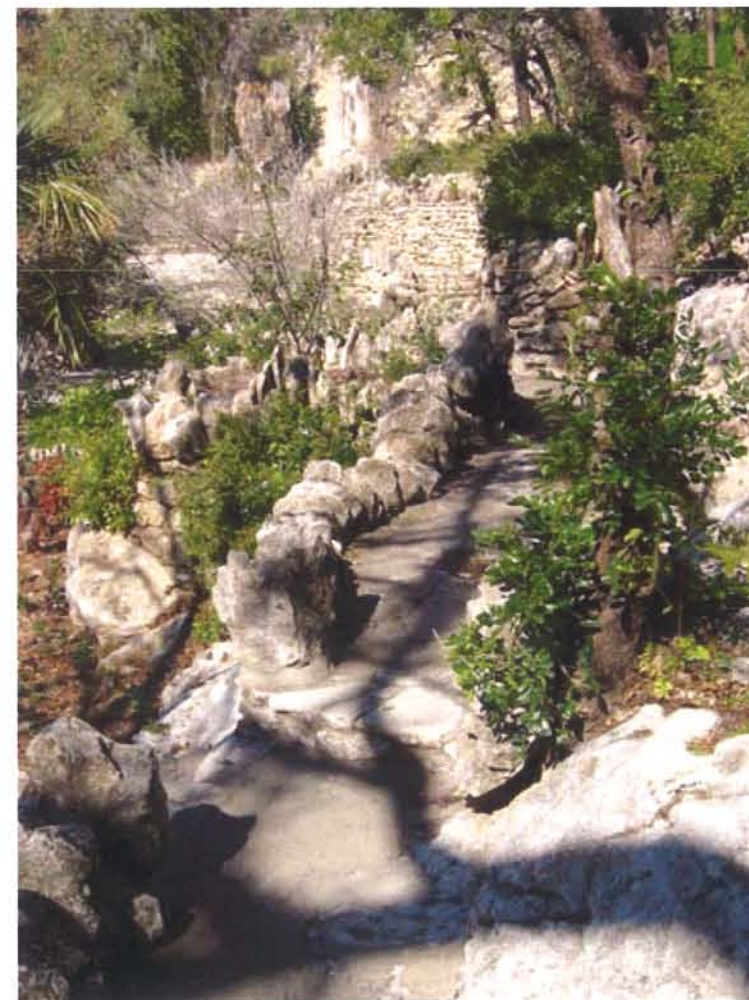
- 49. Historic pylons at Pavilion level marking Scenic Overlook Bridge.
- 50. Historic limestone bench built into wall. Protect historic bench in place.
- 51. Pedestrian path to zoo entry. Asphalt is not historic and should be removed.
- 52. Limestone bench built into wall. Protect historic bench in place.
- 53. Limestone path with limestone header wall around planting bed. This area has been reconfigured to accommodate the accessible bridge. See historic appendix, image 1 and 6.

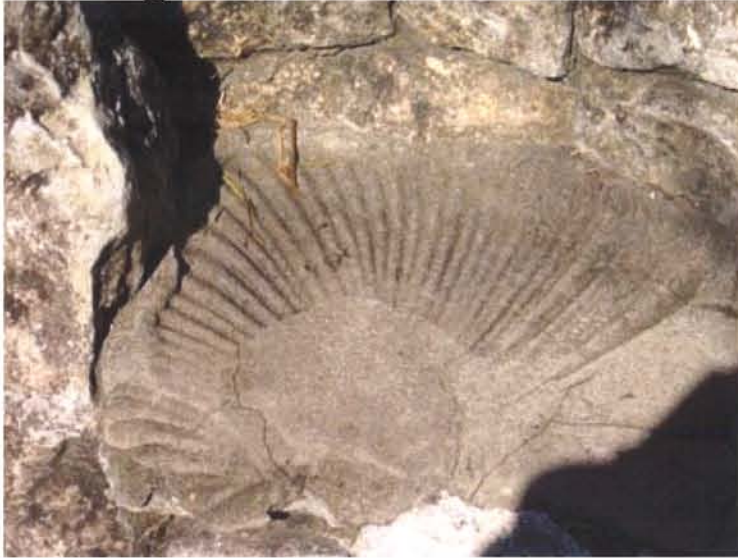
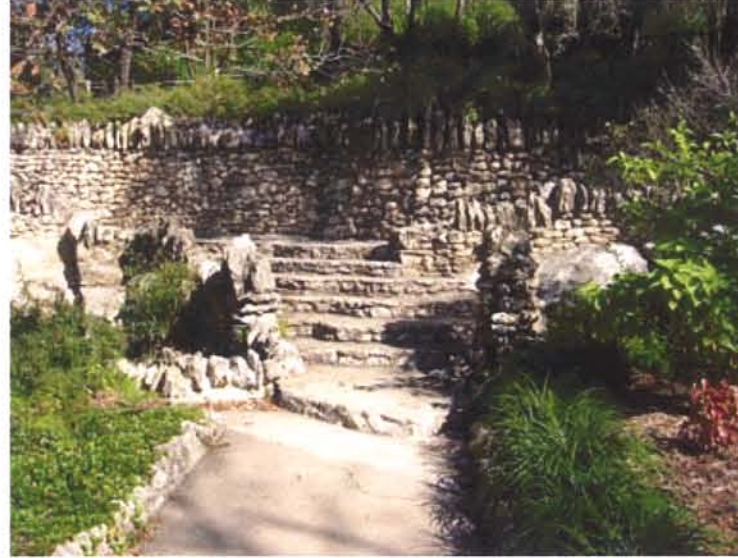
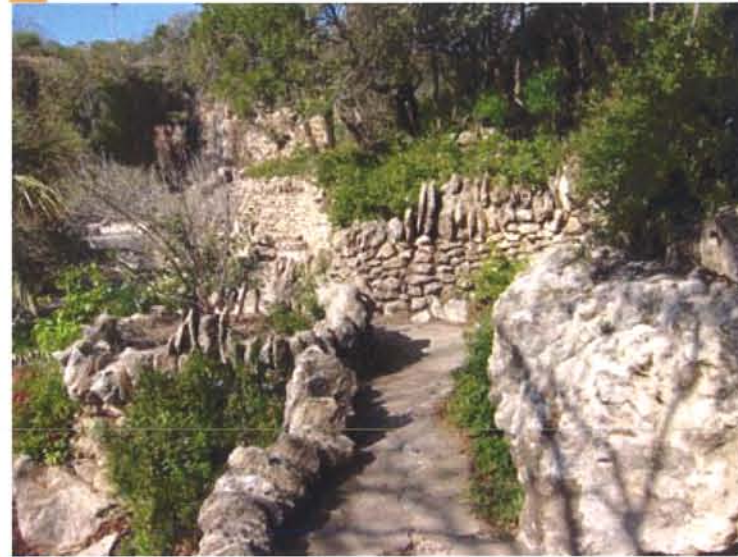
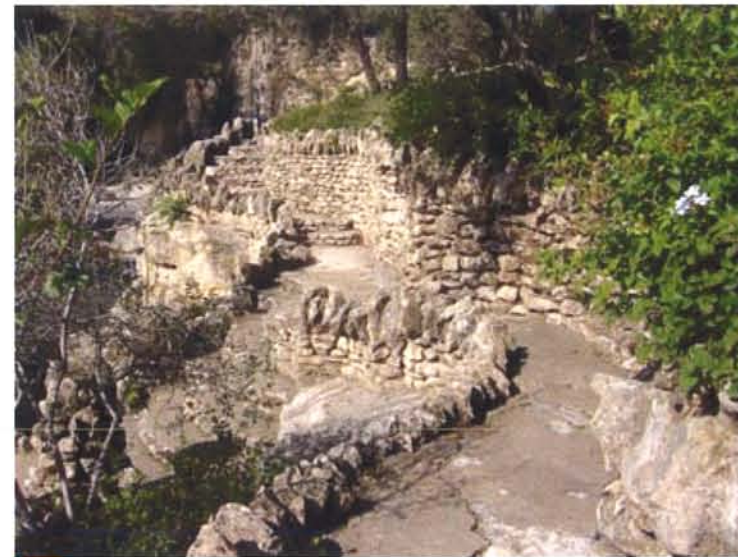
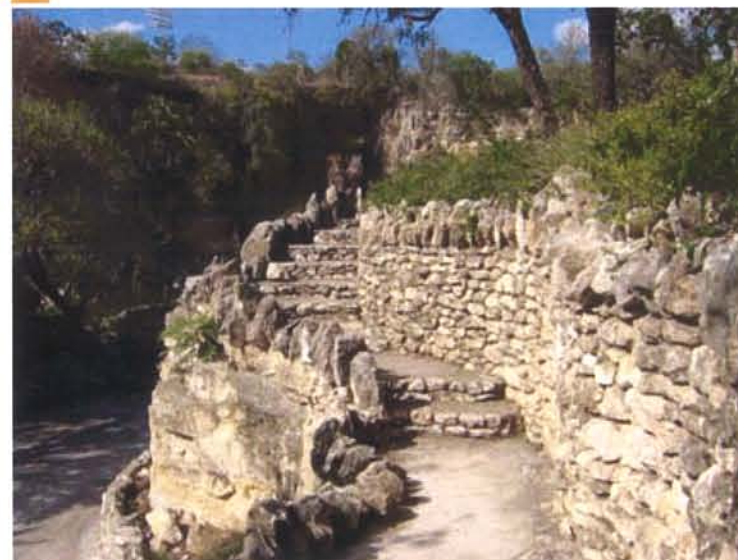
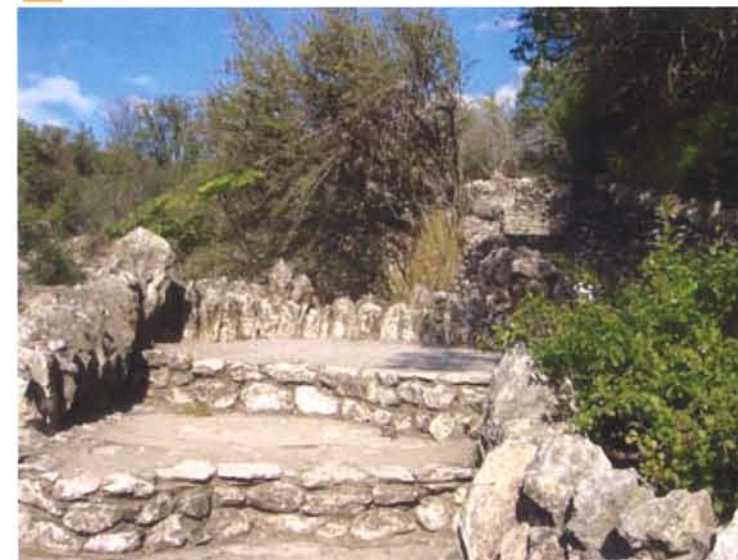
- 54. Historic detail on bench seat. Protect historic bench in place.
- 55. Lower level pathway. This area has been reconfigured to accommodate the accessible bridge. See historic appendix, image 1 and 6. Asphalt not historic.
- 56. Lower level pathway.
- 57. Lower level pathway. Cracked pathway.
- 58. Lower level pathway.
- 59. Lower level pathway.

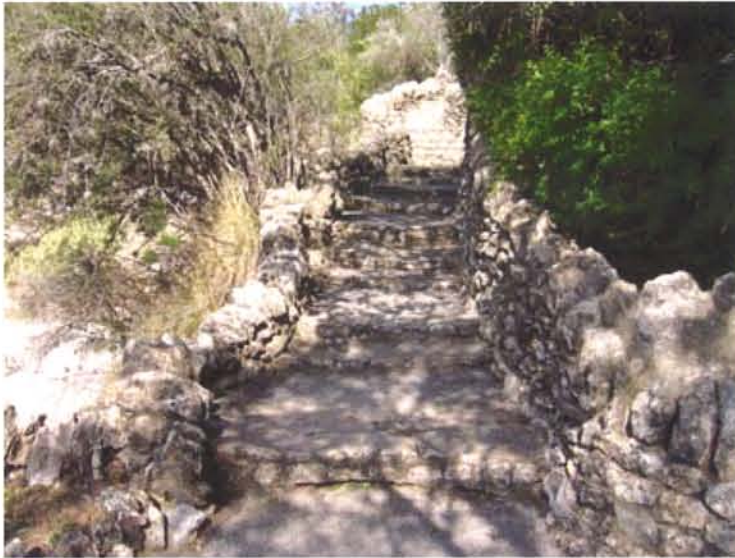
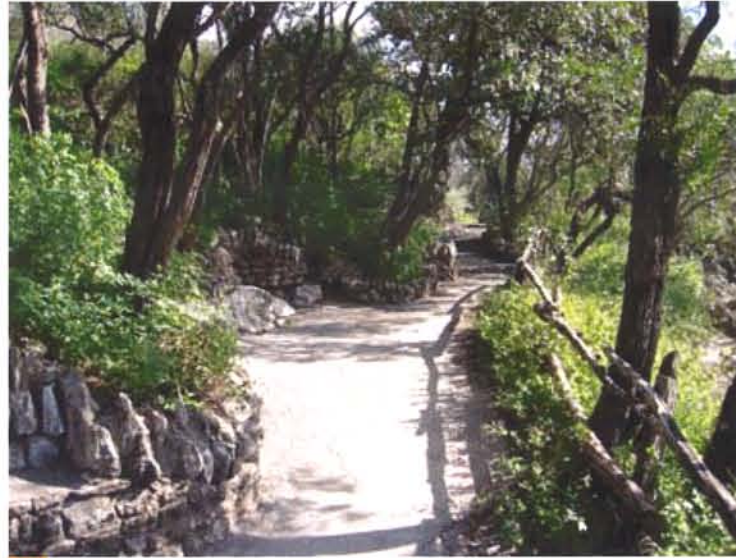
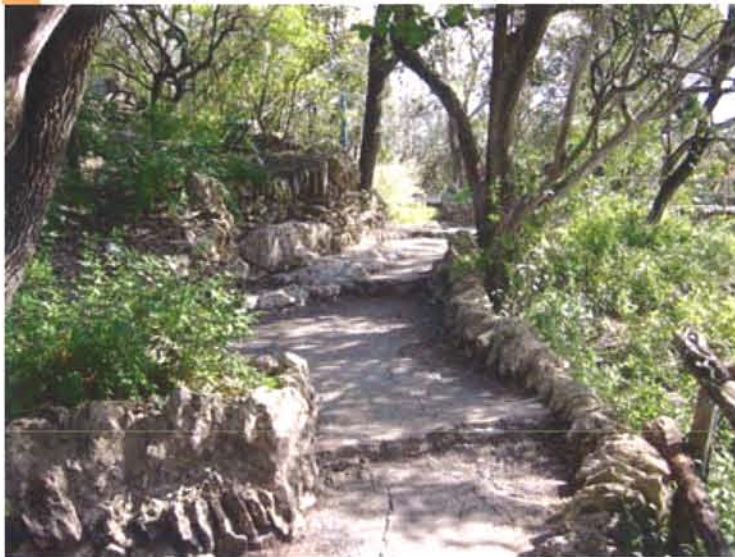
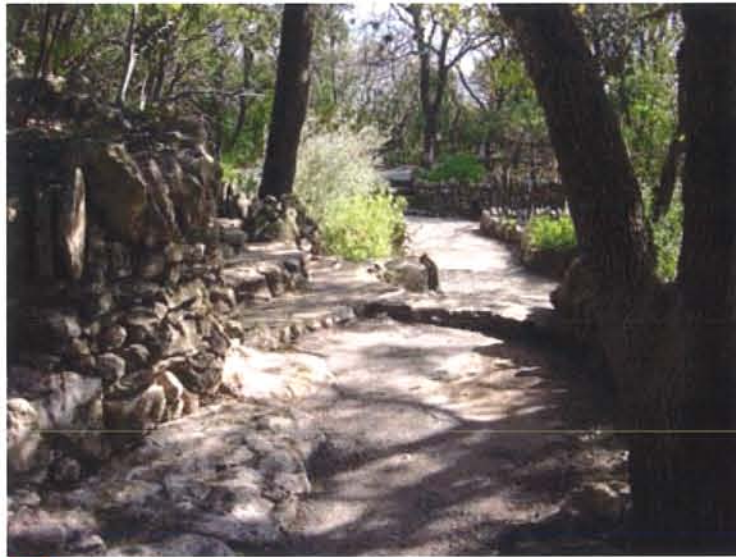
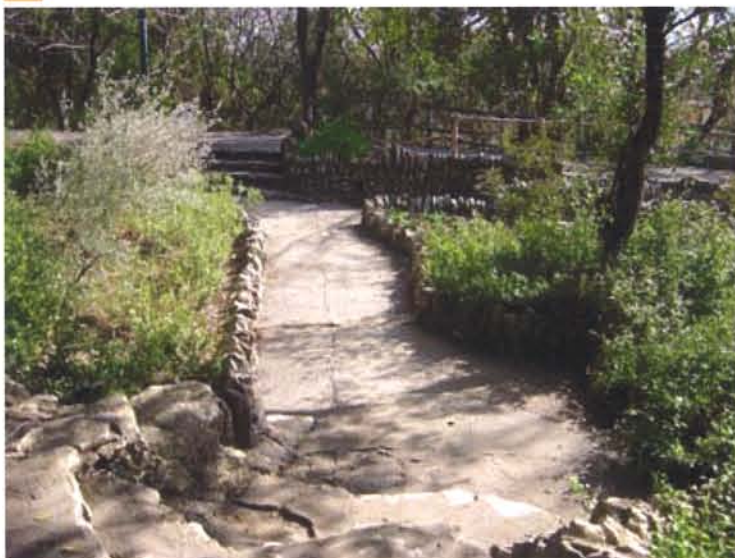
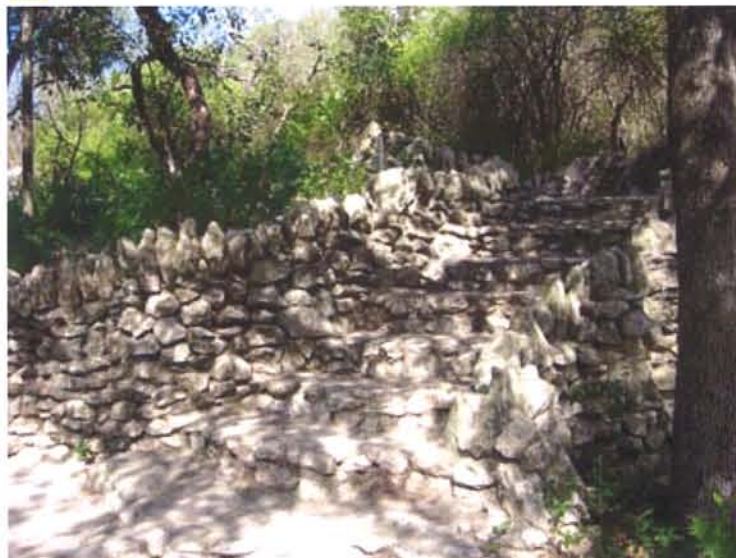
- 60. Steps at lower level path. Asphalt is not historic and should be removed.
- 61. Asphalt path at upper level. Asphalt is not historic and should be removed.
- 62. Asphalt pathway at upper level. Asphalt is not historic and should be removed.
- 63. Pathway and walls and upper level. Walls are in good condition. Asphalt pathway is not historic and should be removed.
- 64. Concrete pathway and planting beds. The pathway is cracked and not likely a historic material.
- 65. Limestone stairs. Stairs are in good condition.

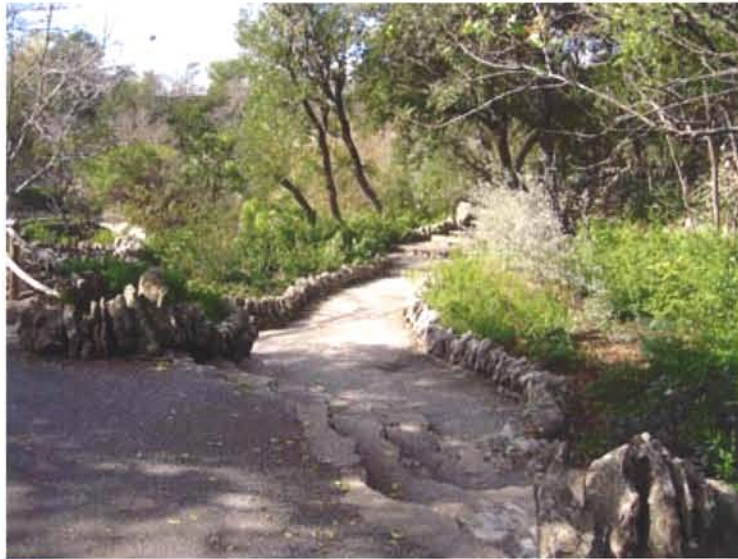
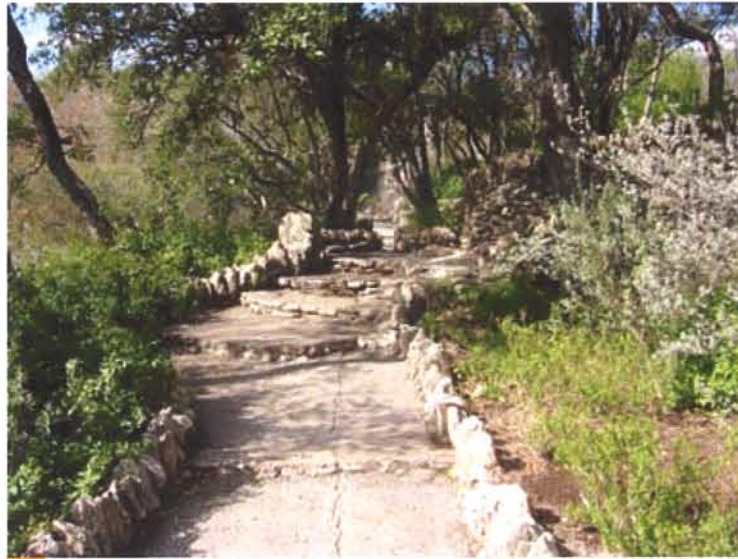
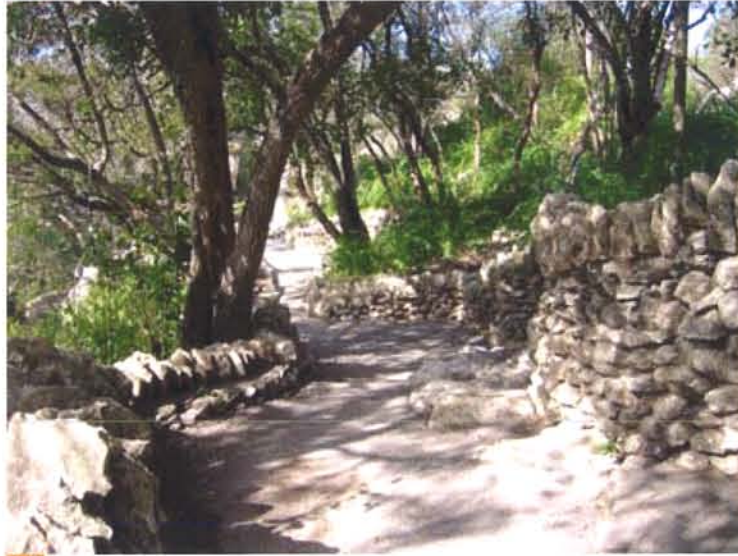
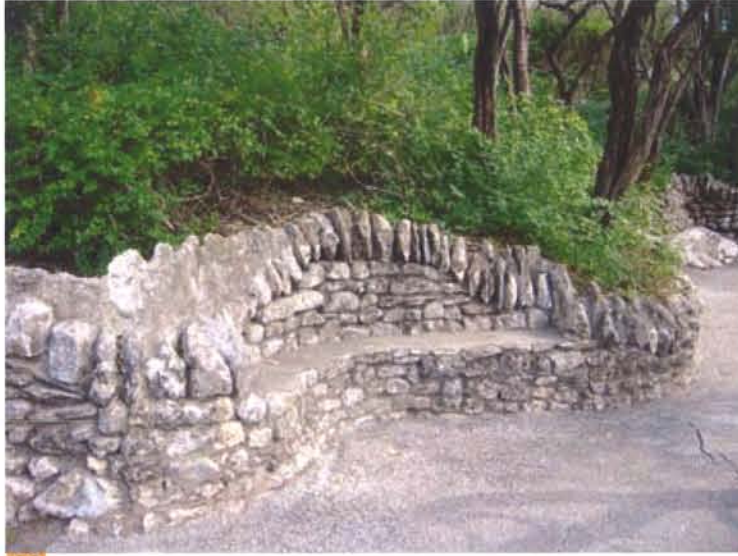
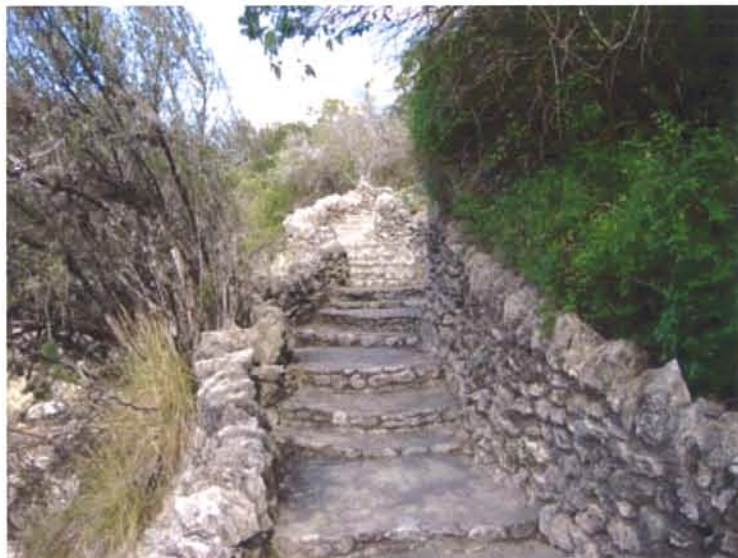
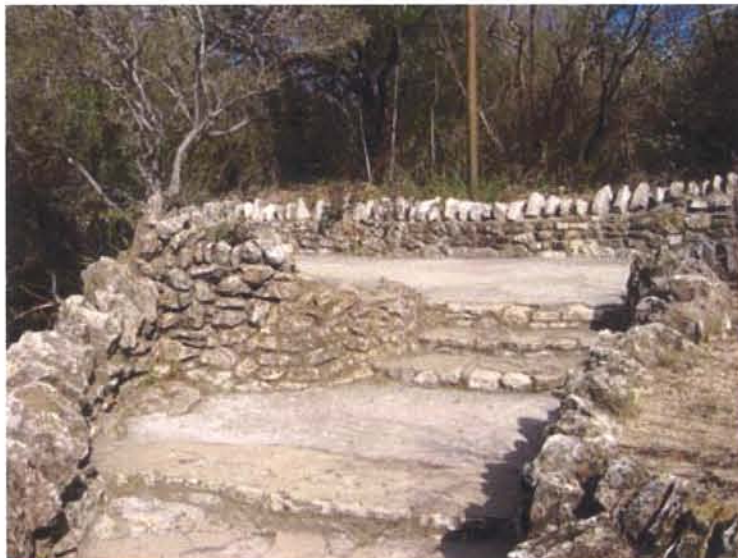
- 66. Landing, stairs and pathway at upper level. Asphalt is not historic material and should be replaced.
- 67. Pathway at upper level. Limestone header walls edge planting beds. Asphalt is not historic and should be replaced.
- 68. Pathway, walls and planter header at upper level. Asphalt is not historic and should be replaced.
- 69. Historic bench built into wall. Protect historic bench in place.
- 70. Stair & wall at upper level.
- 71. Stair at upper level. Asphalt is not historic and should be replaced.

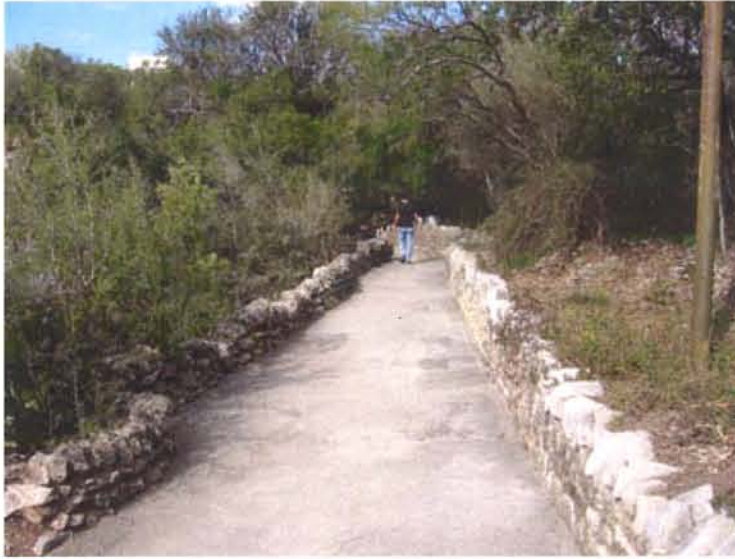
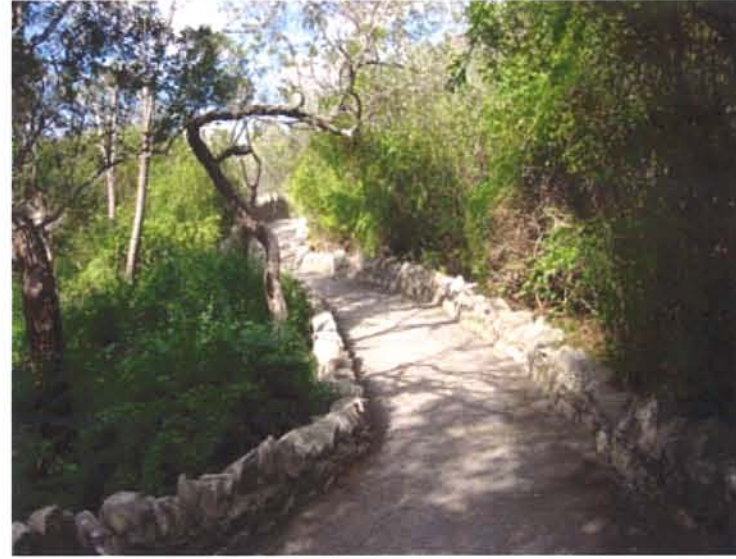
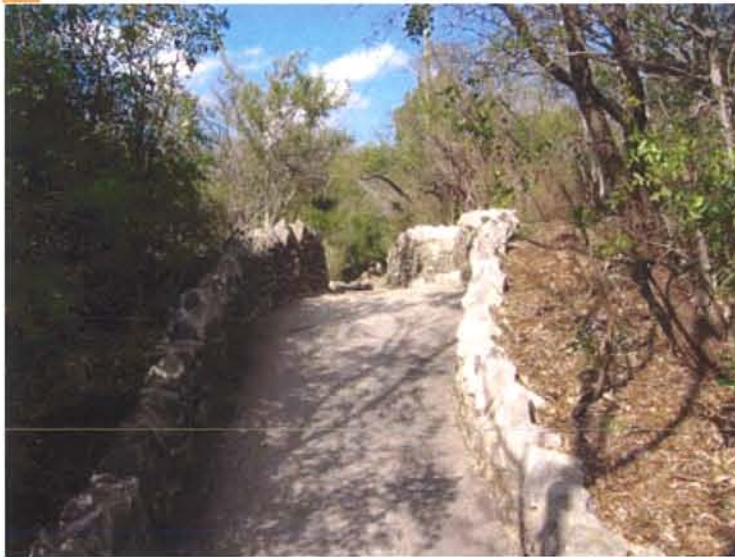
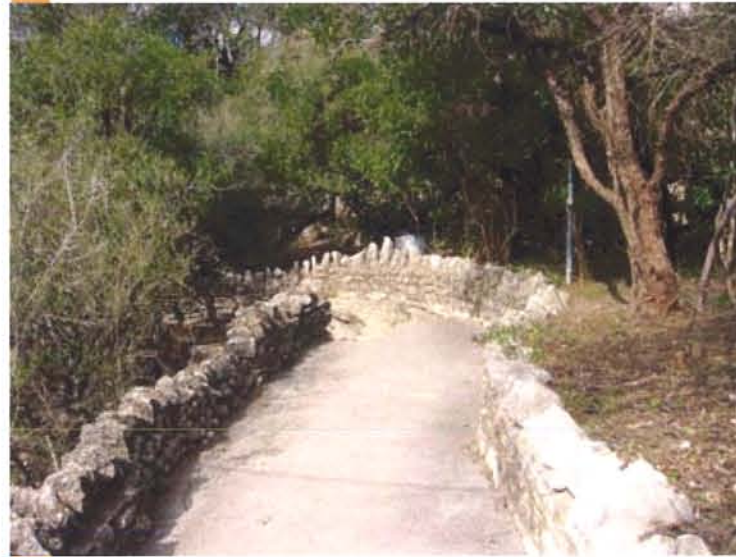
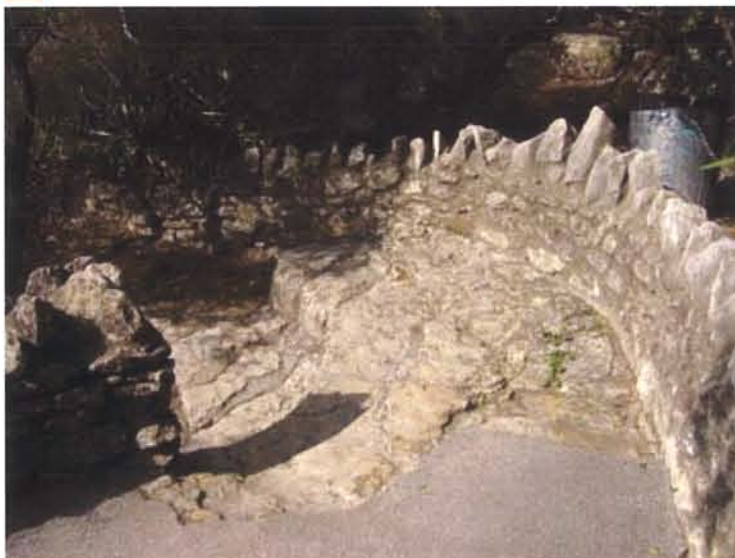
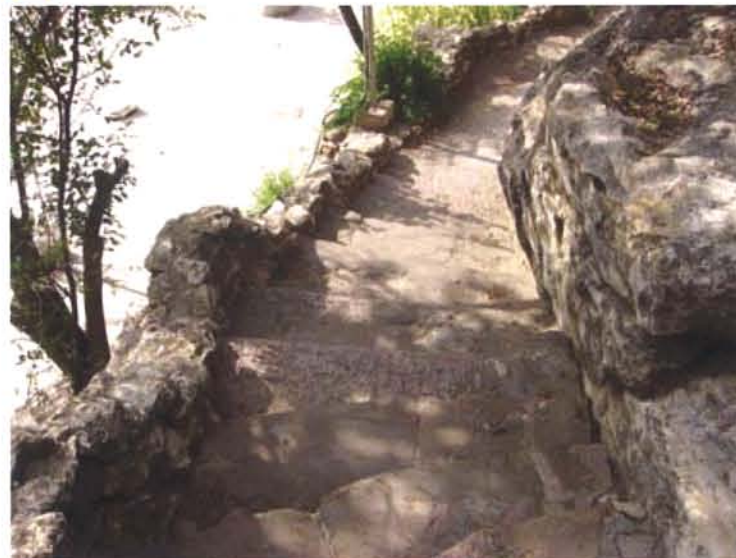
- 72. Pathway at upper level. Asphalt is not historic and should be replaced. Wall in good condition.
- 73. Pathway & wall at upper level pathway. Asphalt is not historic and should be replaced.
- 74. Pathway & wall at upper level. Asphalt is not historic and should be replaced.
- 75. Pathway & wall at upper level. Asphalt is not historic and should be replaced.
- 76. Stair at upper level.
- 77. Stair down to lower level.

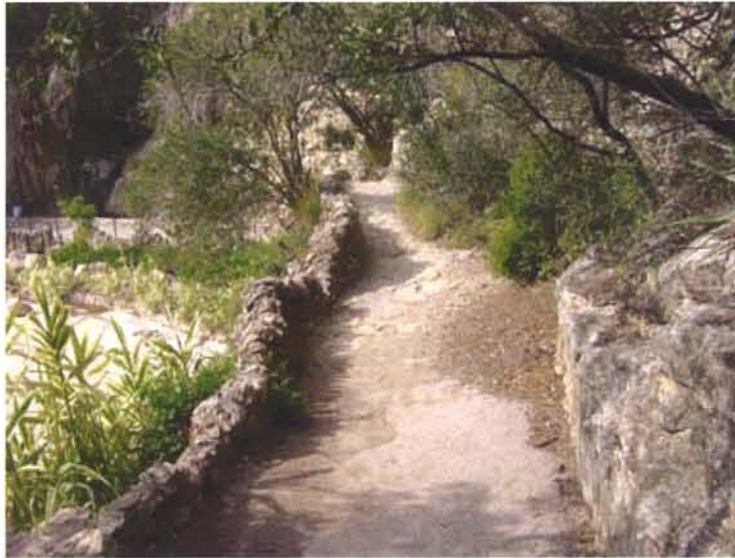
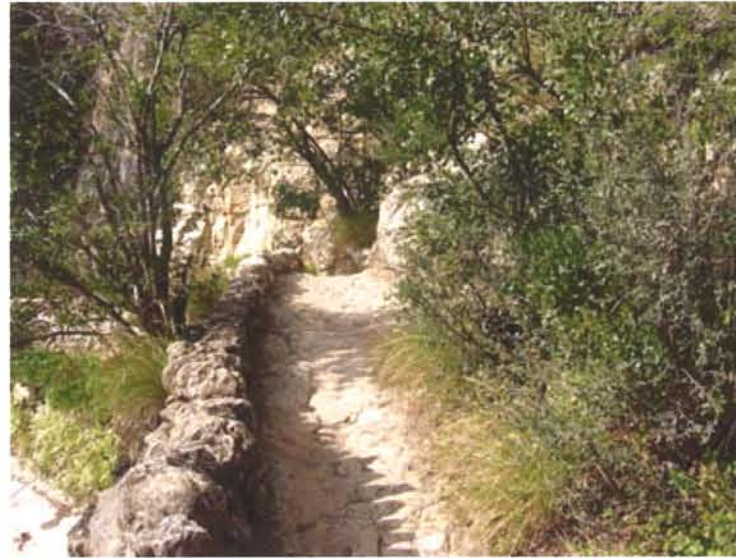
- 78. Lower level path. Asphalt is not historic and should be replaced.
- 79. Lower level walls & pathway. Pathway is decomposed granite, which was a common material used throughout much of the park. The path has not been maintained. It should be reconstructed.

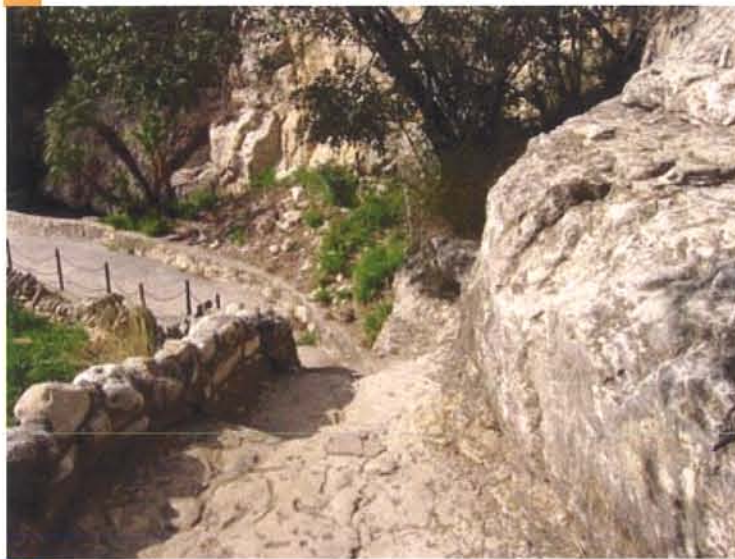
80

- 80. Pathway to waterfall. The lower wall in front of the waterfall is not historic. Historically, there were two levels of paths in front of the quarry wall, which is to the right of the image. Pathway is flagstone pavers. See historic appendix, image 1 and 6.

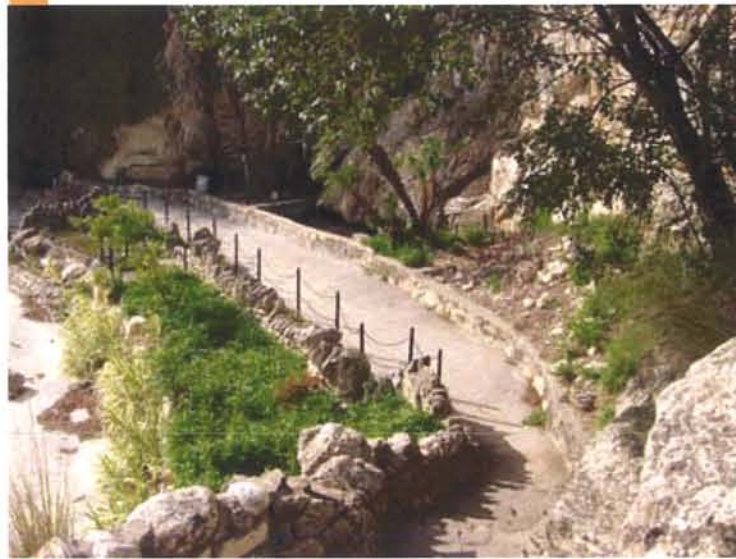
81

- 81. Pathway and walls in front of waterfall. The lower wall in front of the waterfall is not historic. Historically, there were two levels of paths in front of the quarry wall, which is to the right of the image. Black rail and chain is not historic and should be removed. The area in front of the black rail and chain was actually a path at the pond level and should be restored. See historic appendix, image 1 and 6.

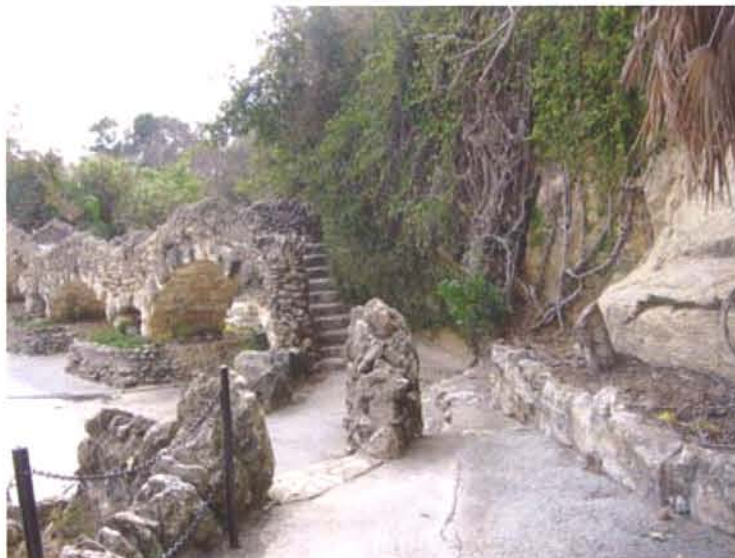
82

- 82. Pathway at waterfall. Asphalt is not historic and should be removed. Historic pylon should be protected. See historic appendix, image 1 and 6.
- 83. Steps up to dragon bridge from waterfall. Historically, these steps were carved limestone slabs.

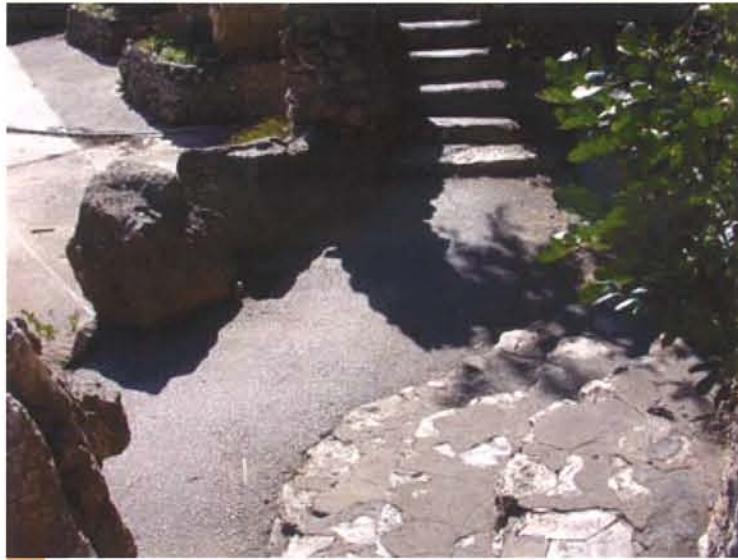
84

- 84. Asphalt and limestone flagstone near island side of dragon bridge. Asphalt is not historic and should be removed.
- 85. Typical detail of how asphalt has been used to patch limestone over the years. Asphalt is not historic and should be removed. Limestone flagstone should be used to denote spatial hierarchy.

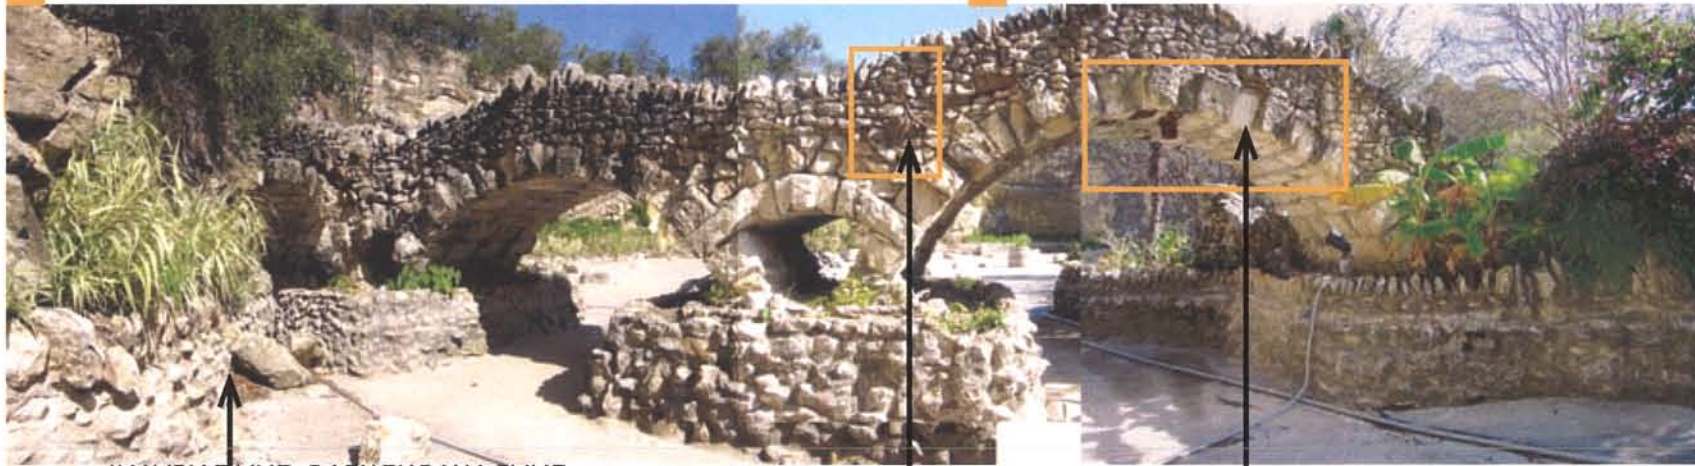
86

- 86. Bridge accent stone missing in several areas. Replace with like stone. Remove residual fig ivy vine roots from bridge face. Fig ivy was not an historic planting treatment and should not be allowed to grow back. The bridge is a helpful barrier in stopping the invasive and overgrown cane.

COMPROMISING STONE CAP. WALL IMPACTED BY ROCK SLIDES.

BRIDGE ACCENT STONE MISSING.

HISTORIC PYLON STONE CAP MISSING

HISTORIC PYLON IN GREAT CONDITION

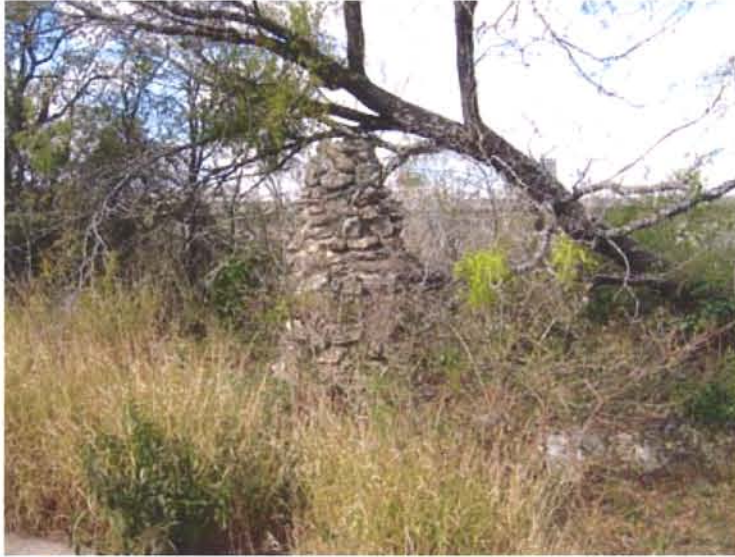
88

- 88. Historic pylon on Alpine Drive. Pylons were light structures. Clear vegetation and restore lighting to pylon.
- 89. Pylons were light structures. Pylon deteriorated and should be restored. Clear vegetation and restore lighting to pylon.
- 90. Historic pylon on Alpine Drive. Clear vegetation and restore lighting to pylon.
- 91. Historic pylon on Alpine Drive. Pylons were light structures. Clear vegetation and restore lighting to pylon.
- 92. Historic pylon on Alpine Drive. Clear vegetation and restore lighting to pylon.
- 93. Historic pylon on Alpine Drive. Pylons were light structures. Clear vegetation and restore lighting to pylon.

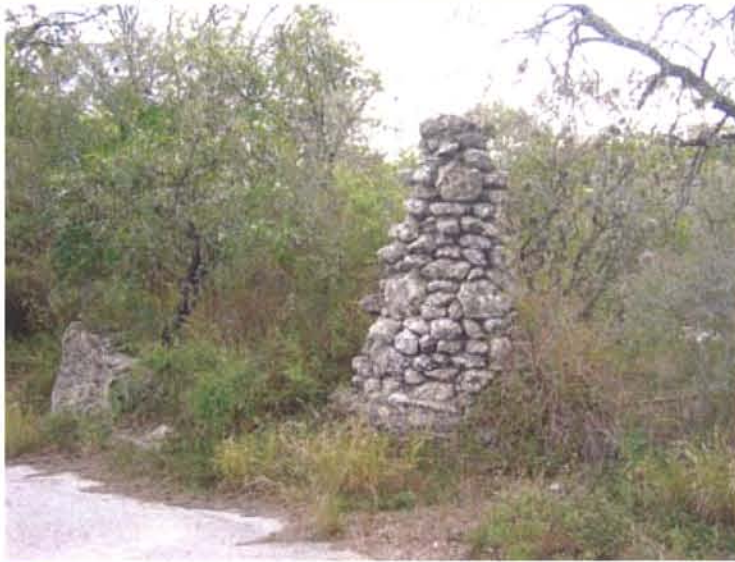
94

- 94. Historic pylon along Alpine Drive. Pylons were lighting structures. Clear vegetation and restore lighting to pylon.
- 95. Wall along Alpine Drive.
- 96. Base of wall and clearing in #93.
- 97. Steps down to scenic overlook on Alpine Drive.
- 98. Pathway at Alpine Drive scenic overlook. Asphalt not historic and should be removed.
- 99. Limestone steps at scenic overlook along Alpine Drive.
