Japanese Tea Garden Master Plan

Japanese Tea Garden
Master Plan
San Antonio, Texas

June 2007

SWA Group
Project Landscape Architect
Houston, Texas

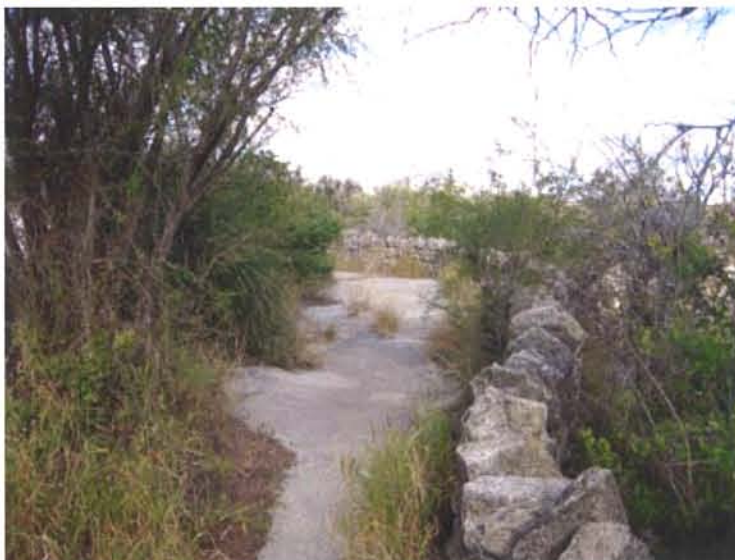
98

- 94. Historic pylon along Alpine Drive. Pylons were lighting structures. Clear vegetation and restore lighting to pylon.
- 95. Wall along Alpine Drive.
- 96. Base of wall and clearing in #93.
- 97. Steps down to scenic overlook on Alpine Drive.
- 98. Pathway at Alpine Drive scenic overlook. Asphalt not historic and should be removed.
- 99. Limestone steps at scenic overlook along Alpine Drive.

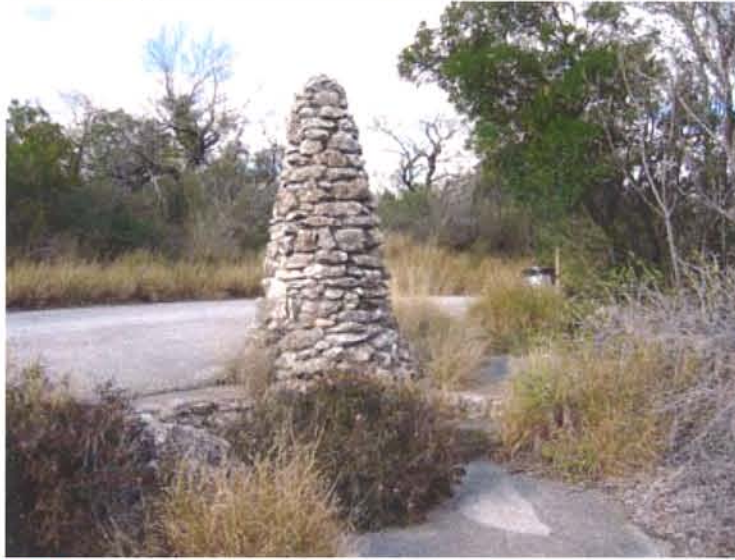
100

- 100. Historic pylon on Alpine Drive at scenic overlook. Pylons were traditionally lighting structures. Vegetation should be cleared to allow pylon to read.
- 101. Historic pylon along Alpine Drive. Pylons were traditionally lighting structures. Vegetation should be cleared to allow pylon to read.
- 102. Historic pylon along Alpine Drive. Pylons were traditionally lighting structures. Vegetation should be cleared to allow pylon to read.
- 103. Historic pylon along Alpine Drive. Pylons were traditionally lighting structures. Vegetation should be cleared to allow pylon to read.
- 104. Historic pylon along Alpine Drive. Pylons were traditionally lighting structures. Vegetation should be cleared to allow pylon to read.
- 105. Historic pylon along Alpine Drive. Pylons were traditionally lighting structures. Vegetation should be cleared to allow pylon to read.

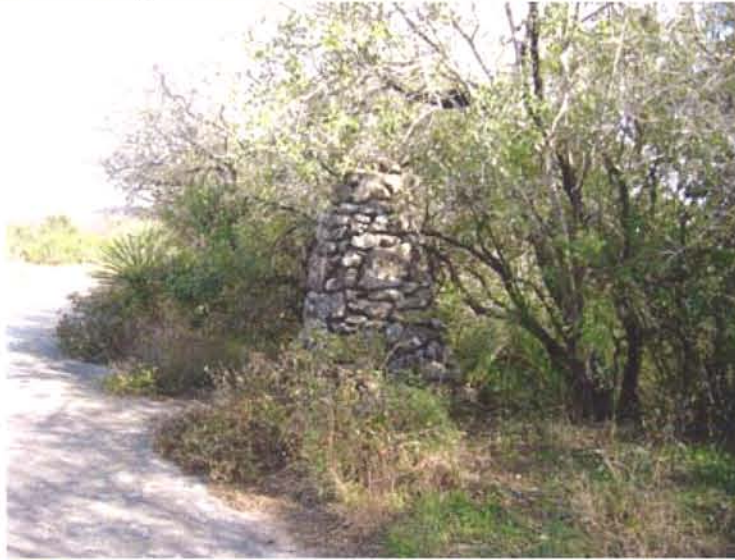
106

- 106. Historic pylon along Alpine Drive. Pylons were traditionally lighting structures. Vegetation should be cleared to allow pylon to read.
- 107. Historic pylon along Alpine Drive. Pylons were traditionally lighting structures. Vegetation should be cleared to allow pylon to read.
- 108. Foundation for Skyride. The Skyride dates later than period of significance and should be removed.
- 109. Historic pylon along Alpine Drive. Pylons were traditionally lighting structures. Vegetation should be cleared to allow pylon to read.
- 110. Historic pylon along Alpine Drive. Pylons were traditionally lighting structures. Vegetation should be cleared to allow pylon to read.
- 111. Historic pylon along Alpine Drive. Pylons were traditionally lighting structures. Vegetation should be cleared to allow pylon to read.

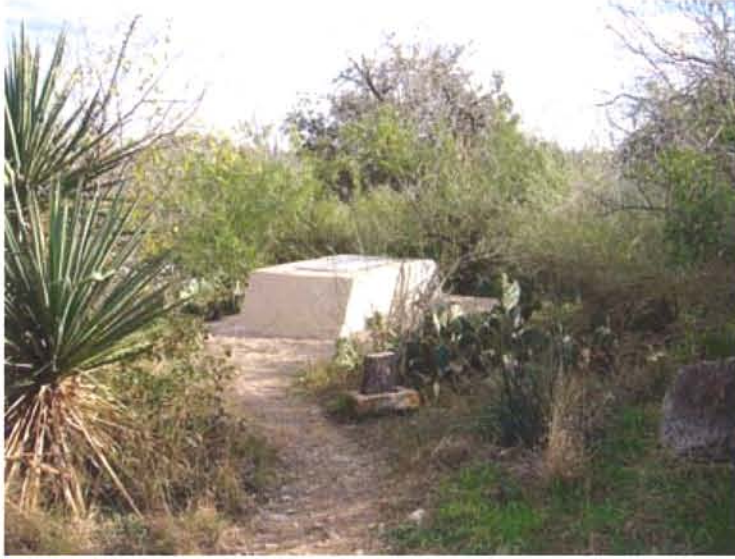
112

- 112. Foundation for Skyride. The Skyride dates later than period of significance and should be removed.
- 113. Historic pylon along Alpine Drive. Pylons were traditionally lighting structures. Vegetation should be cleared to allow pylon to read.
- 114. Steps up from zoo entry.
- 115. Historic pylon along Alpine Drive. Pylons were traditionally lighting structures. Vegetation should be cleared to allow pylon to read. Non historic wall at the edge of Animal Control property.

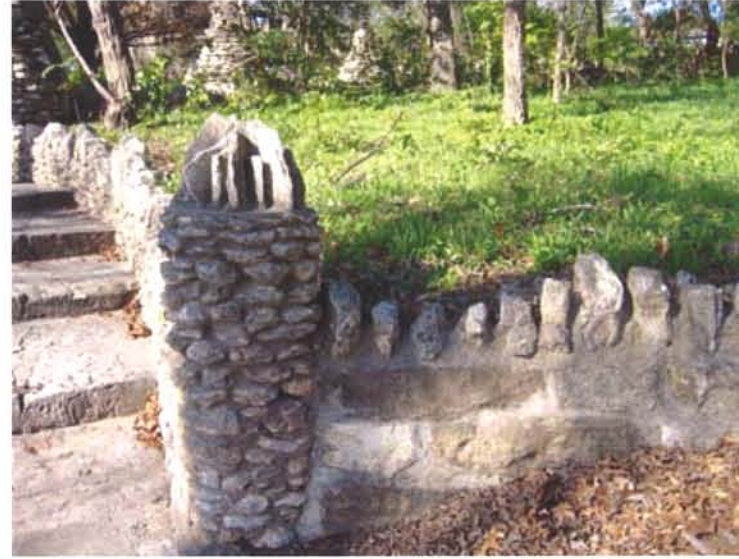
2. Stone cap missing. Replace and match surrounding cap stone size.
3. Historic pylon cap missing. See image 2 for correct cap detail.
4. Pylon with light figure. Fixture not historically accurate. Protective covering will probably be necessary in to protect the proposed light fixtures.
5. Stone cap missing. Replace and match surrounding cap stone size.
6. Wall cracked. Replace wall as necessary.

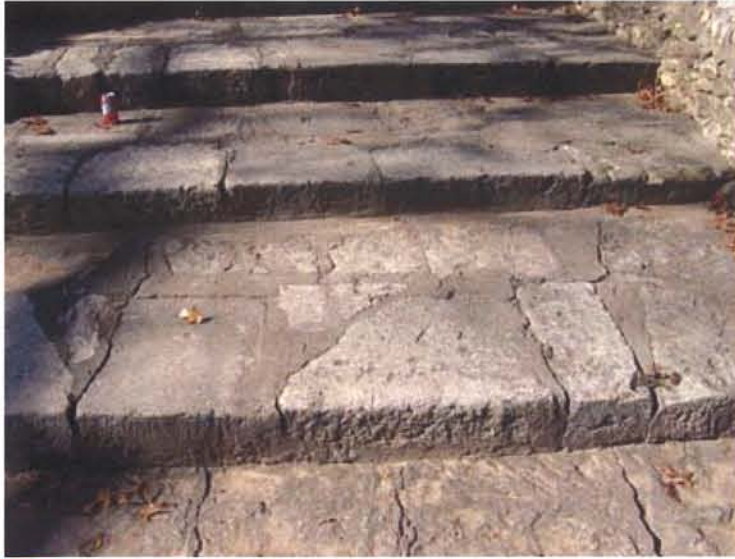
7

- 7. Typical limestone flagstone paving at Mexican Village entry along St. Mary's Street. Stair is in good condition.
- 8. Limestone edging along St. Mary's entry.
- 9. Limestone stair at Mexican Village Entry along St. Mary's Street. Concrete is cracked.

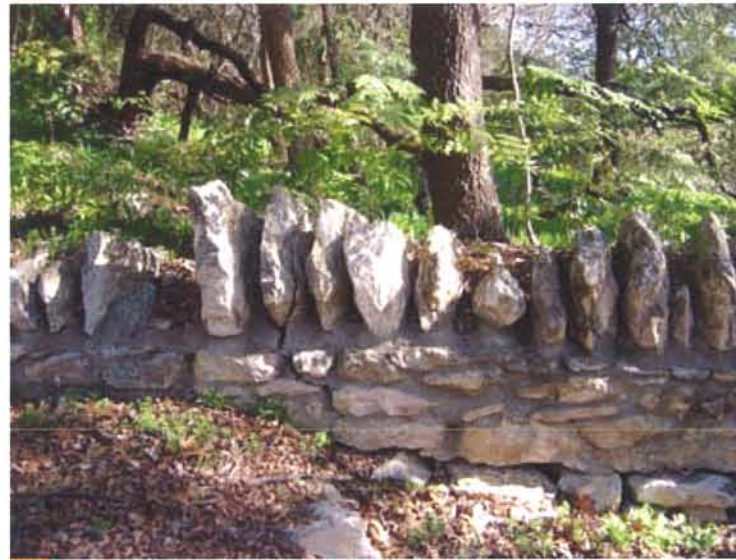
10

Replace concrete as necessary.
- 10. Limestone wall at Mexican Village entry. The wall is cracked.

Replace wall as necessary.
- 11. Brick path at Mexican Village casitas. The path connects the landing around the casitas to the drive. Brick was not used elsewhere in the gardens and should be replaced with limestone flagstone.
- 12. Covered well at Mexican Village, date unknown. The well is currently covered, but contains trash and should be cleaned out.

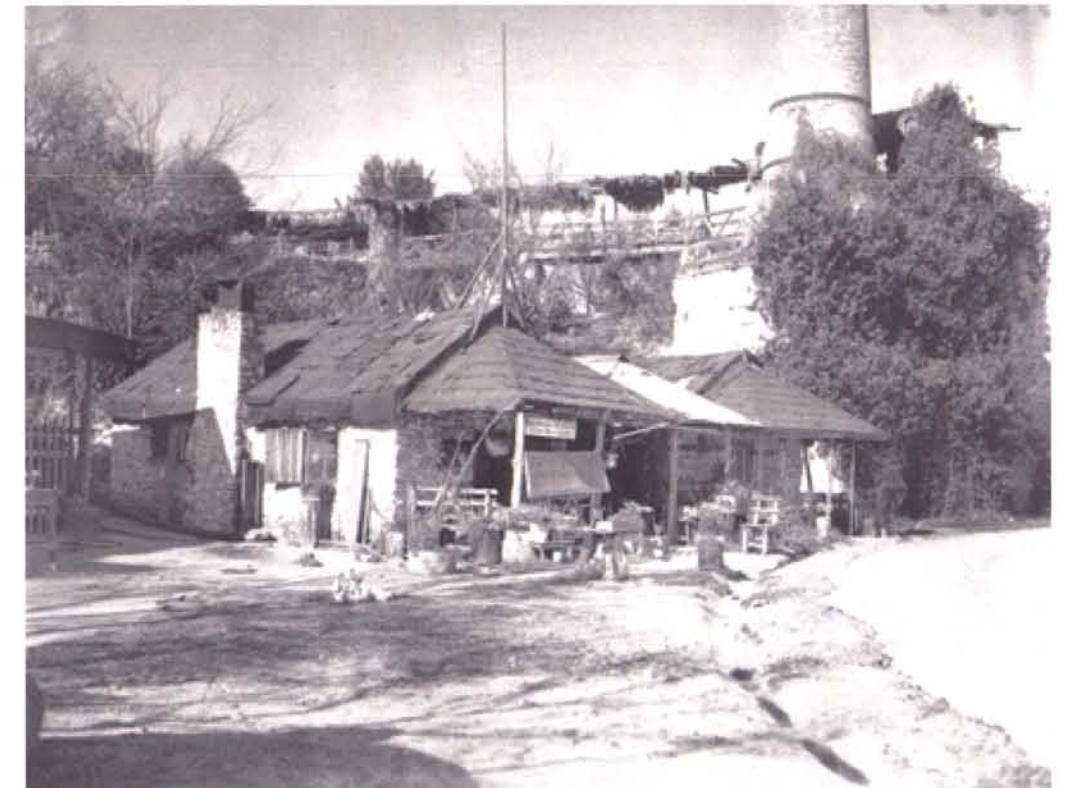
Historic image 12 shows the Mexican Village Casitas. Most of the paving was decompose granite gravel or limestone.

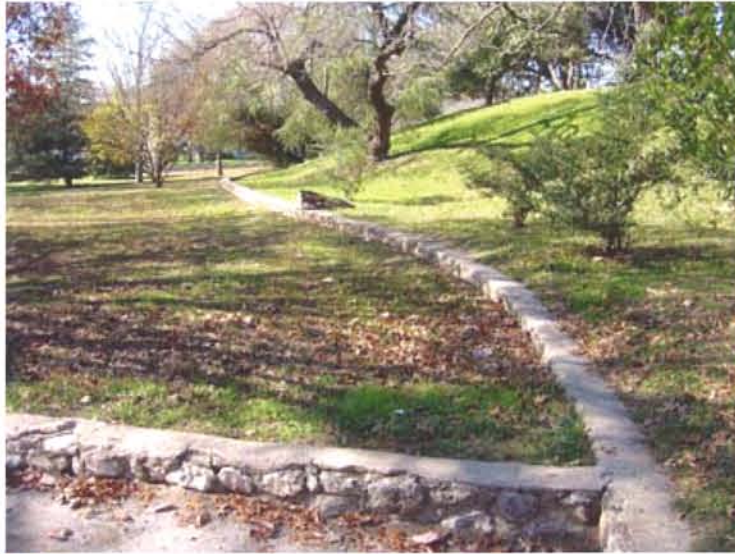
13

- 13. Stone wall running through landscape near Mexican Village.
- 14. Limestone flagstone at Mexican Village pathway to Main Entrance level. The paving is cracked and stones are loose or missing in areas. Secure loose limestone pavers and fix path as necessary. This pattern should be used to delineate areas of high foot traffic or major pathways.
- 15. Stair from Mexican Village Parking lot to Mexican Village casitas.
- 16. Stair from Mexican Village casitas to Main Entry level.
- 17. Tree impacting stone cap & header wall above Mexican Village casitas. Remove tree. The City of San Antonio does not generally support the removal of trees on the property. All trees to be removed should be evaluated for aesthetics, safety, health, etc. by various City staff, the consultants, and contractors involved in Master Plan implementation to determine the best for the facility.

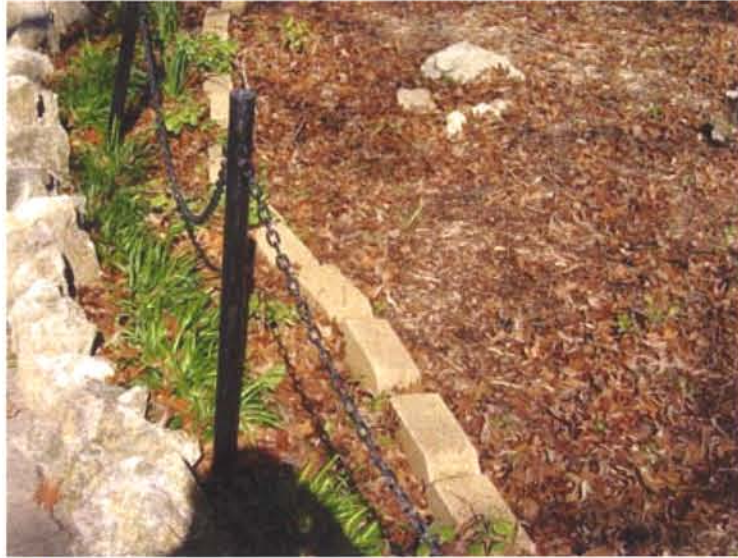
19

- 19. Concrete edging along path above Mexican Village. The concrete edging is not historic and should be removed.
- 20. Limestone cap missing and should be replaced.
- 21. Limestone cap missing and should be replaced.
- 22. Concrete path above Mexican Village. Path is cracked. Repair path as necessary.
- 23. Detail of cracked path.
- 24. Asphalt accessible path above Mexican Village. Asphalt is not historic material and should be removed. This route will need to remain accessible.

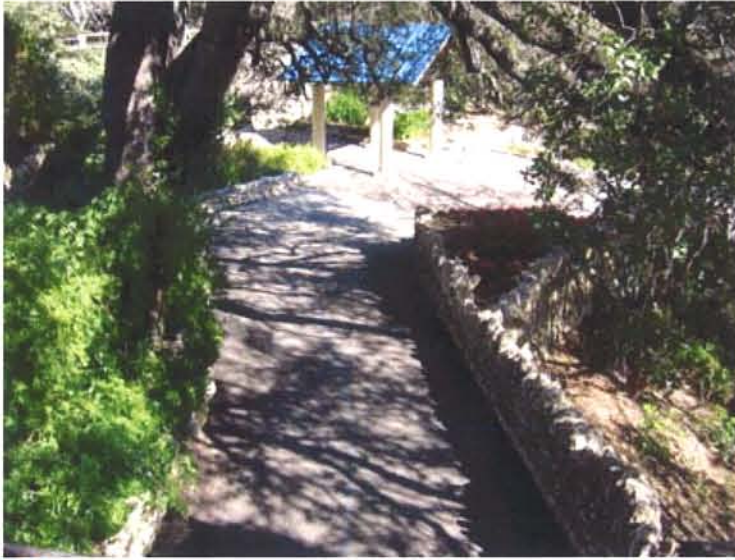
25

- 25. Accessible path above Mexican Village. Limestone walls separate planting beds and are in good shape. Asphalt is not historic and should be removed.
- 26. Accessible path above Mexican Village. This view is from the current Blue Pavilion Gate.
- 27. Planting beds framed by limestone walls near Blue Pavilion entry. Walls were recently reconstructed and are in good condition. The cap detail is not historic and should reference existing historic site walls.

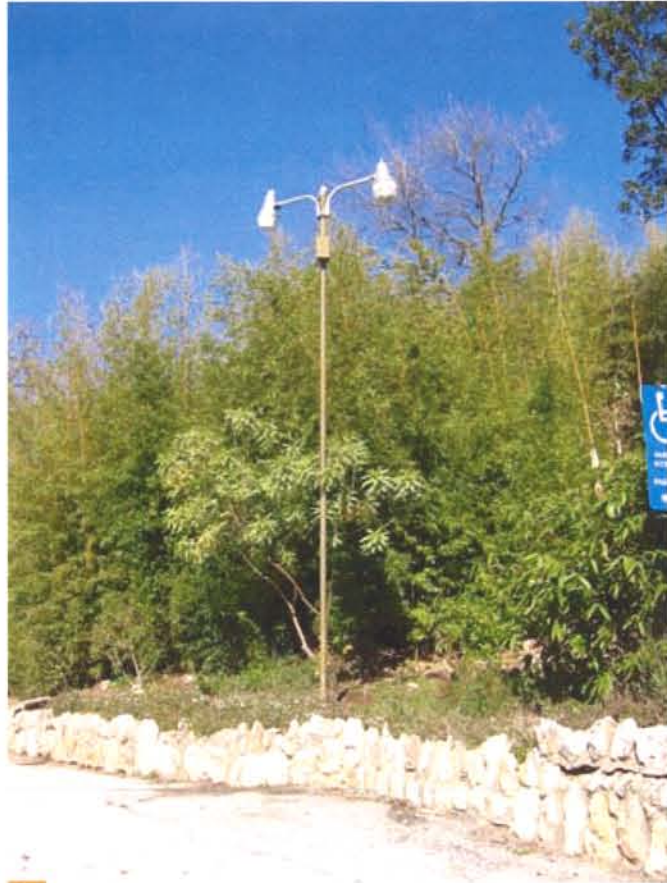
1

1. Outdated light pole near Main entry. Replace light pole with updated light standard.
2. New electrical power outlet at the base of the Pavilion pylons.
3. New electrical power outlet at the base of the Pavilion pylons.
4. Electric transformer near accessible ramp. Hide electrical panel with landscaping.
5. New electrical power outlet at the base of the Pavilion pylons.

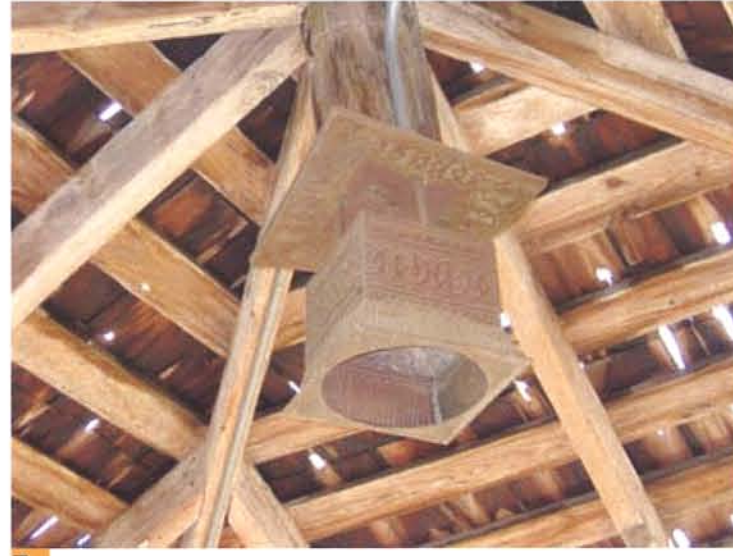
7

- 6. Historic pylons
- 7. Historic light fixture by Isaac Maxwell in the Kiln Overlook. It is the only historic light remaining at the gardens. Because it is made out of copper, it should be removed for safe keeping until there is a stronger security presence at the gardens.
- 8. Close up at historic pylon with electrical socket visible. No images exist of what the light fixture looked like.
- 9. Tree light. Replace tree lights as necessary.
- 10. Conduit on Old Kiln. Conduit should be painted to match kiln.
- 11. Old electrical outlet.

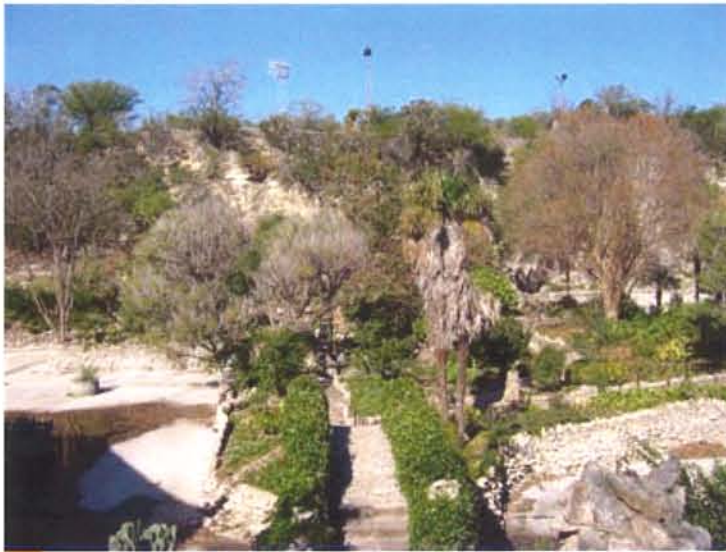
12

12. Views of Alpine Drive from the Core Garden. Lights are visible and not attractive. The lights should be removed and replaced with less obtrusive lighting.
13. Another view of Alpine drive from the Core Garden with the lights visible. The lights should be removed and replaced with less obtrusive lighting.
14. Lights under the Zoo Path Bridge. Replace any unused lighting.
15. Lights under the Zoo Path Bridge. Replace any unused lighting.
16. Uplight in planting bed. Not in use. The light fixture is obtrusive and should be replaced with a more discreet light, preferably one that is flush or easily hidden by planting.
17. Existing uplight not in use. Replace any unused lighting as necessary.

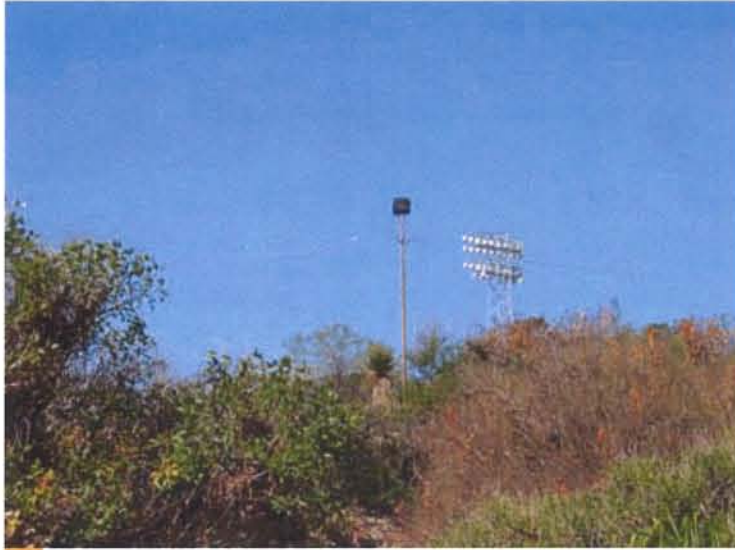
18

- 18. Overhead lights on Alpine Line are visible from the Core Garden. These lights are unattractive and should be replaced with a more suitable light.

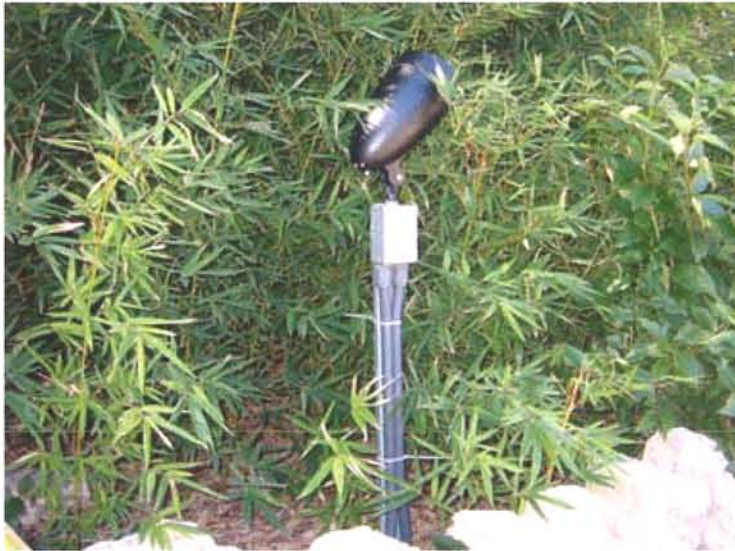
20

- 20. Uplights at Pavilion pond wall. Lights do not work and are missing significant parts. Lights should be replaced and future lights should be hidden in planting or buried underground.

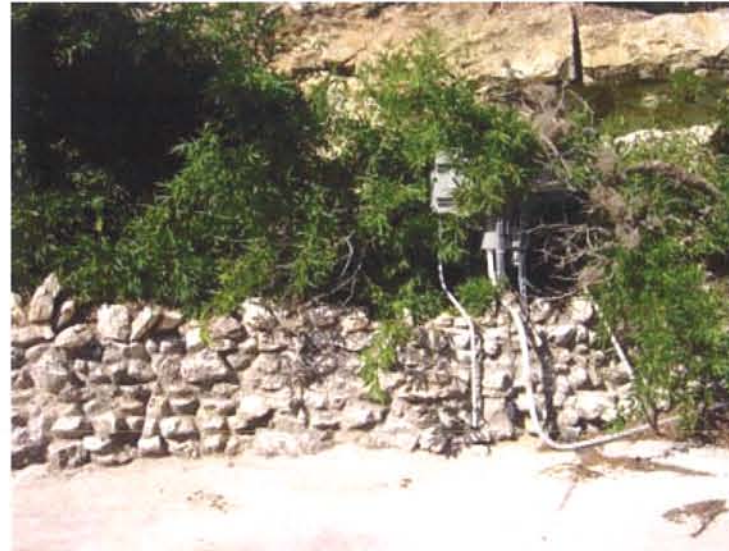
21

- 21. Junction box at Pavilion pond wall. Box is not functioning and missing significant pieces. Junction box should be replaced and future junction boxes should be hidden in the planting.

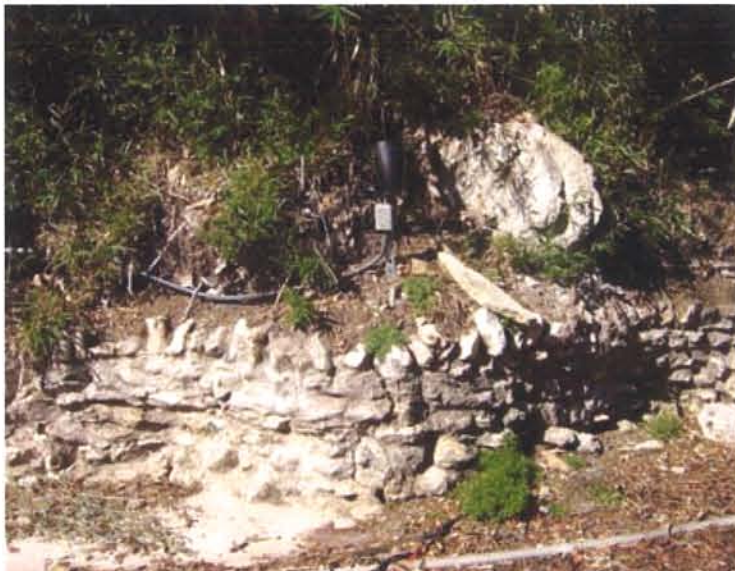
22

- 22. Uplights at Pavilion pond wall. Lights do not work and are missing significant parts. Lights should be replaced and future lights should be hidden in planting or buried underground.

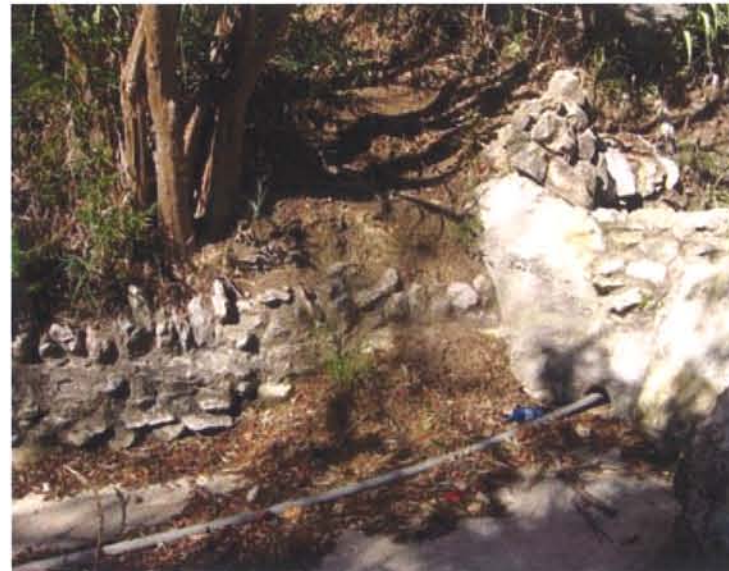
23

- 23. Conduit from Pavilion pond goes through the slot in the weir to the Old Quarry pond. All unused or damaged conduit should be removed.

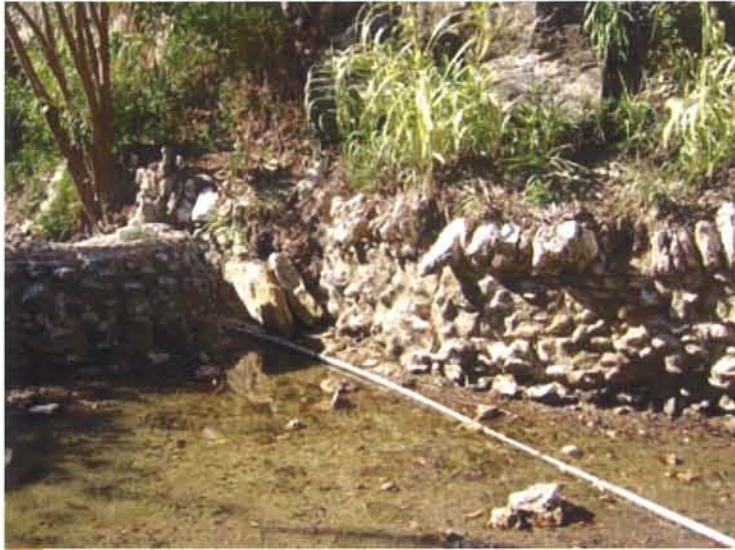
24

- 24. Conduit running through weir to Quarry Pond. All unused or damaged conduit should be removed.
- 25. Uplights in planting bed near Dragon Bridge. Lights do not work and are missing significant parts. Lights should be replaced and future lights should be hidden in planting or buried underground.

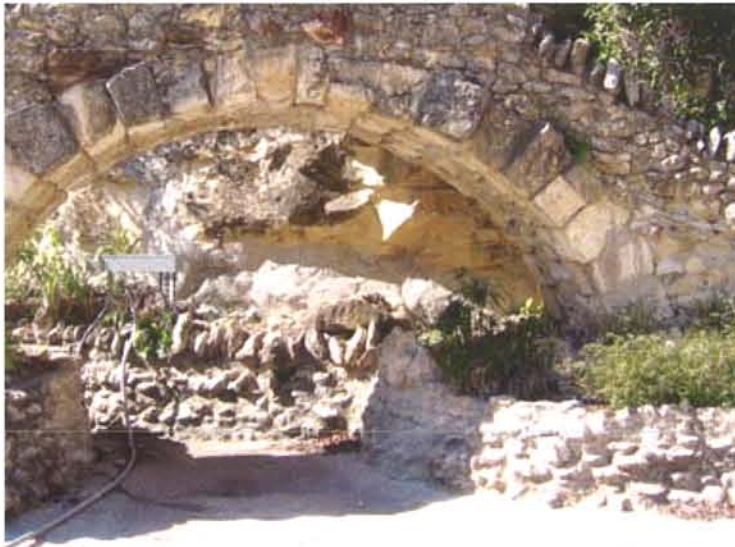
26

- 26. Conduit to junction box behind Dragon Bridge. Box is not functioning and missing significant pieces. Junction box should be replaced and future junction boxes should be hidden in the planting. Conduit from this junction box runs across the pond floor to the junction box at the Core Island.

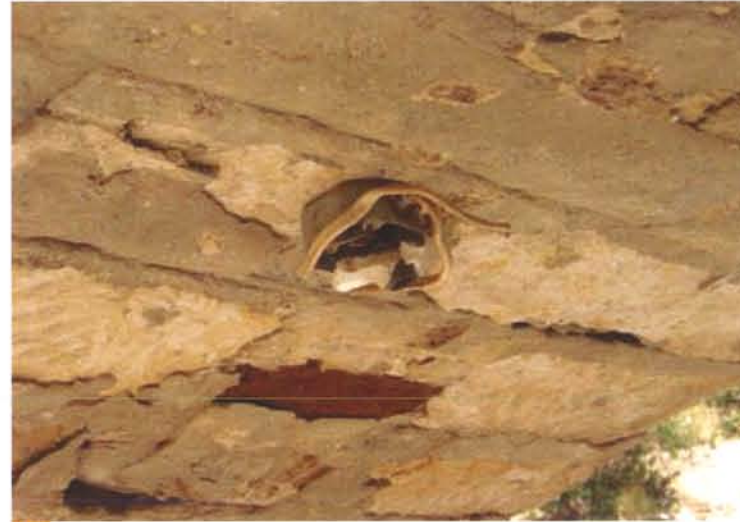
27

- 27. Missing lighting underneath Dragon Bridge. Historic images do not show lighting underneath the bridge. (see historic appendix, image 13, 39, and 42).

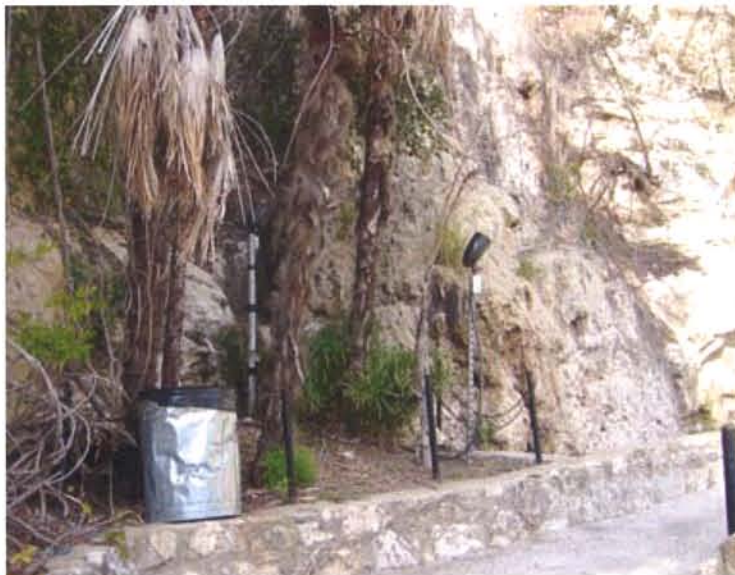
28

- 28. Uplights at Old Quarry wall. Lights do not work and are missing significant parts. Lights should be replaced and future lights should be hidden in planting or buried underground.

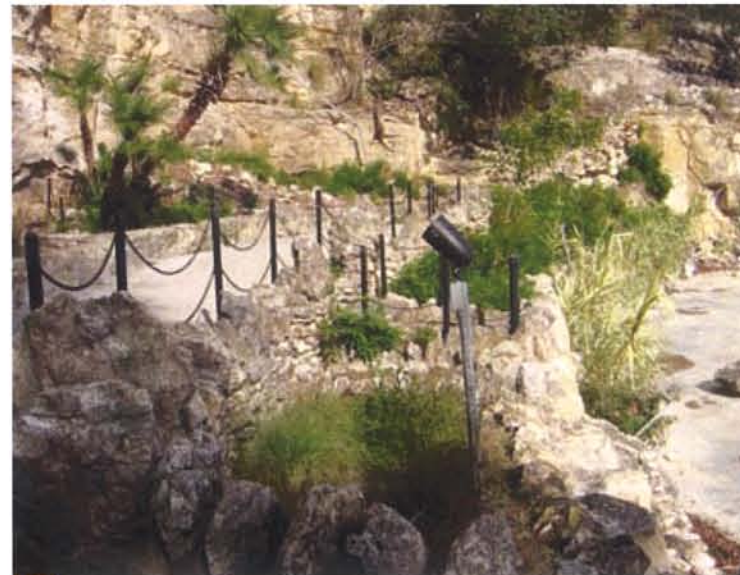
29

- 29. Uplights at Old Quarry wall. Lights do not work and are missing significant parts. Lights should be replaced and future lights should be hidden in planting or buried underground.

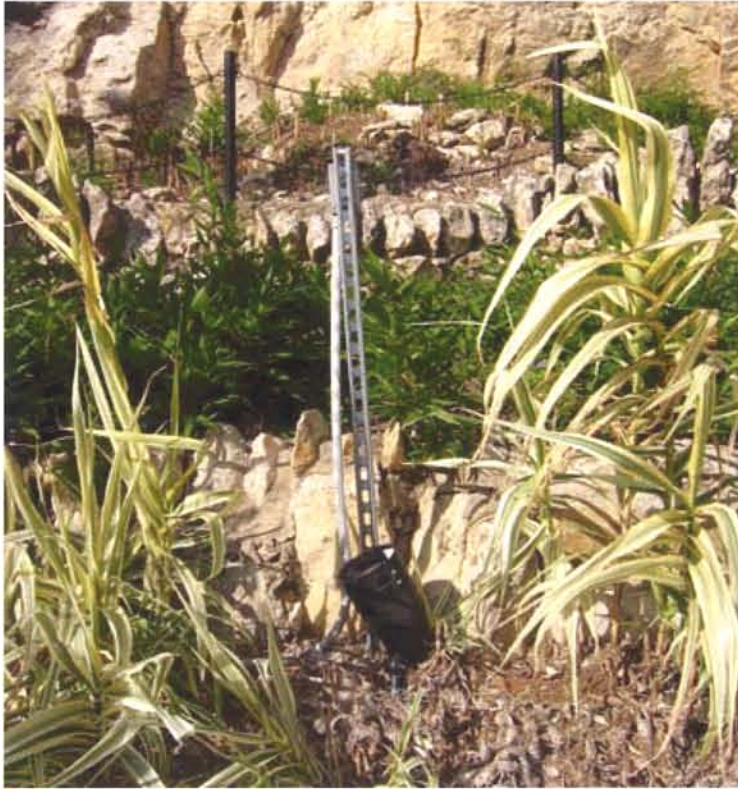
30

- 30. Uplight at Old Quarry wall. Light does not work and is missing significant parts. Light should be replaced and future lights should be hidden in planting or buried underground.
- 31. Water line and pumps at quarry pond. Abandoned systems should be removed. If systems are necessary, they should be hidden from visitor views and accessibility.
- 32. Water line from Alpine Drive to quarry pond. Line is obtrusive. If the water line is necessary, it should be hidden in planting. If it is not necessary, it should be removed. Existing pipe will likely need to be replaced.
- 33. Electrical panel and pump in quarry pond. All electrical and mechanical systems should be hidden and not accessible by visitors. These panels are probably not in use and should be removed.

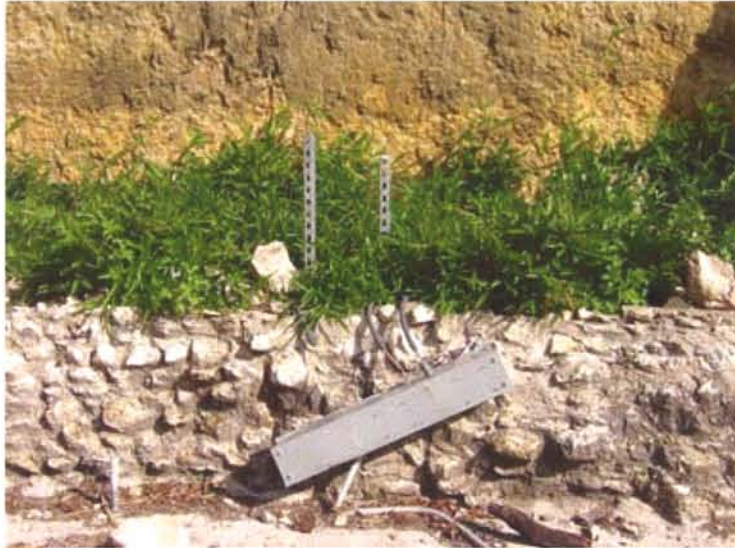
34

- 34. Junction box at Old Quarry wall. Box is not functioning and missing significant pieces. Junction box should be replaced and future junction boxes should be hidden in the planting. Conduit from this junction box runs across the pond floor to the junction box at the Core Island.

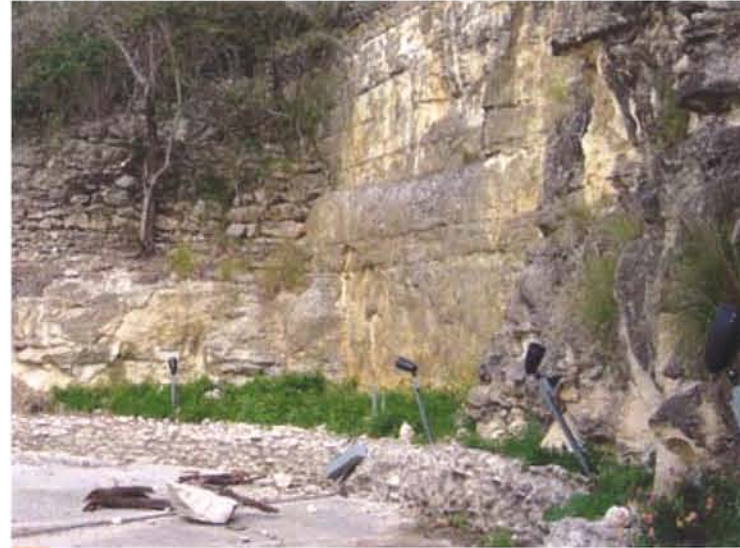
35

- 35. Uplights at Old Quarry wall. Lights do not work and are missing significant parts. Lights should be replaced and future lights should be hidden in planting or buried underground.

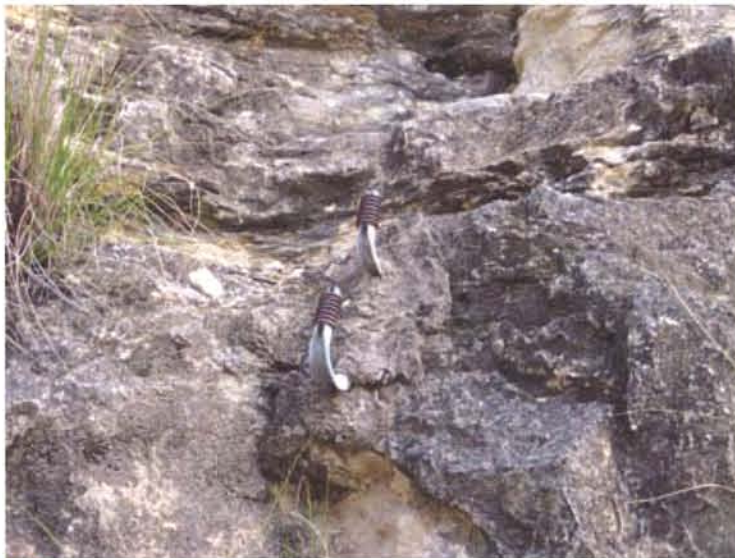
38

- 38. Historic lighting system remnant. Historic lighting should remain and could be explained if necessary.
- 39. Historic lighting system remnant. Historic lighting should remain and could be explained if necessary.

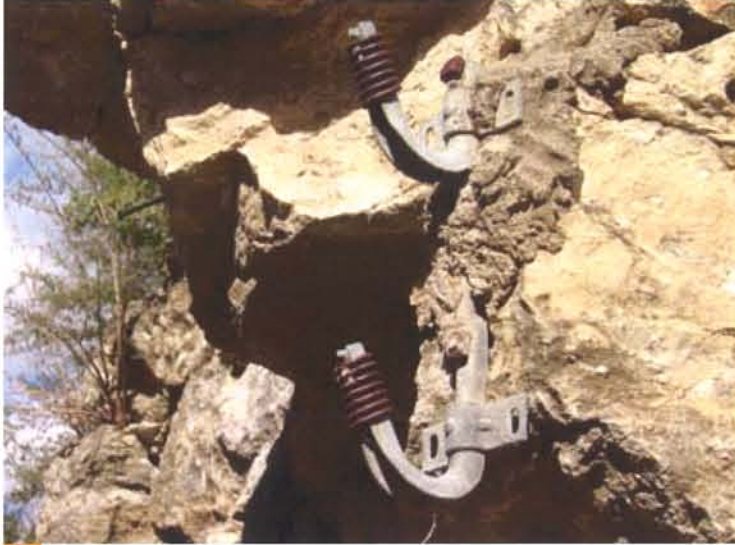
40

40. Historic lighting system remnant. Historic lighting should remain and could be explained if necessary.

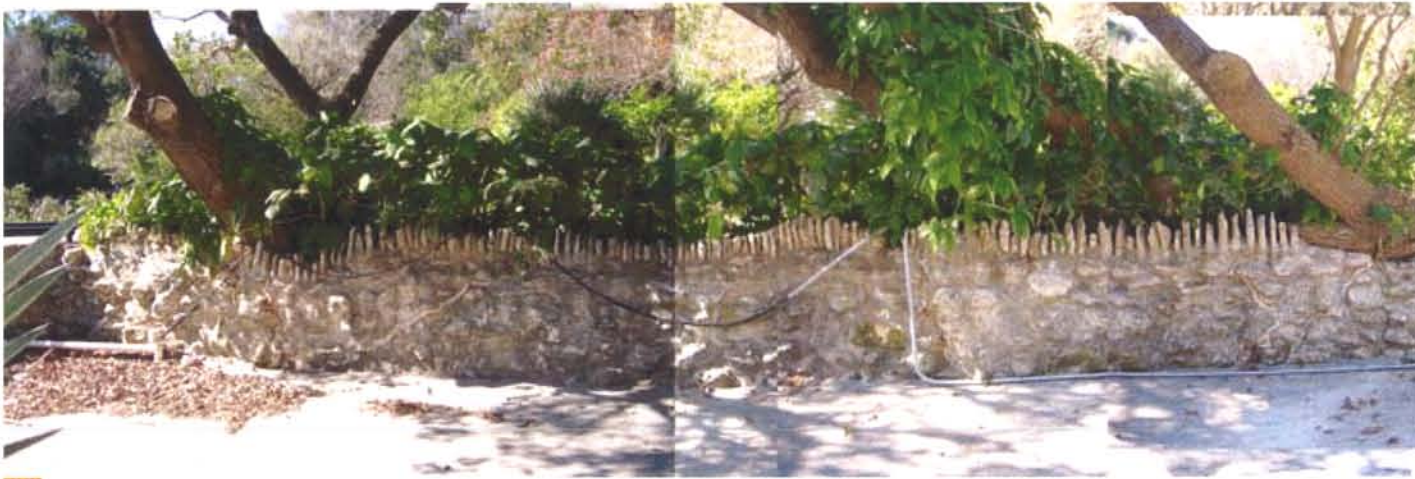
41

41. Conduit at Core Island wall in quarry pond. All conduit should be replaced and removed from visitor view and accessibility.

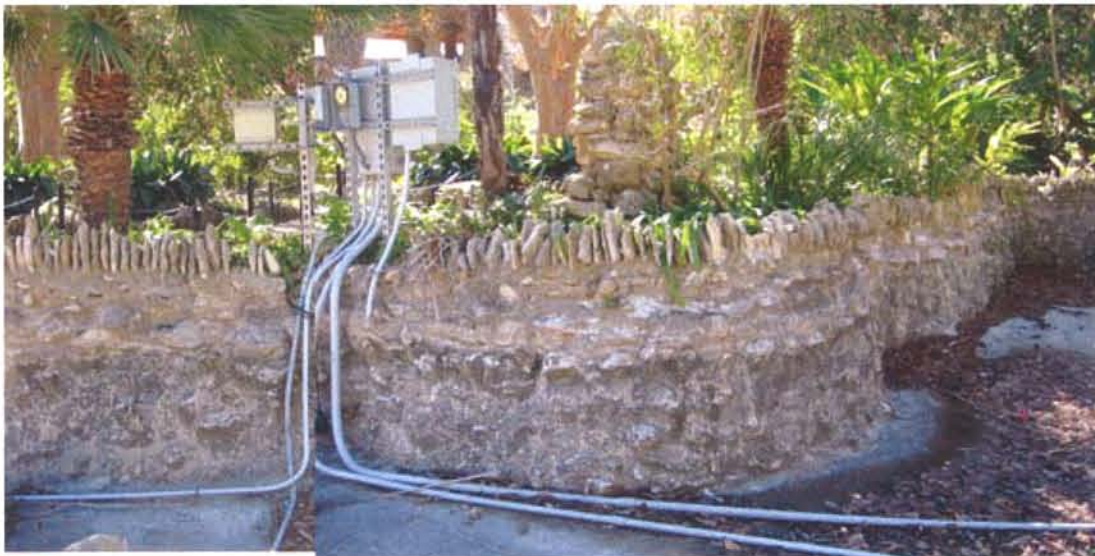
42

42. Electrical panel and conduit at Core Island wall in quarry pond. All electrical systems and conduit should be replaced and removed from visitor view and accessibility.

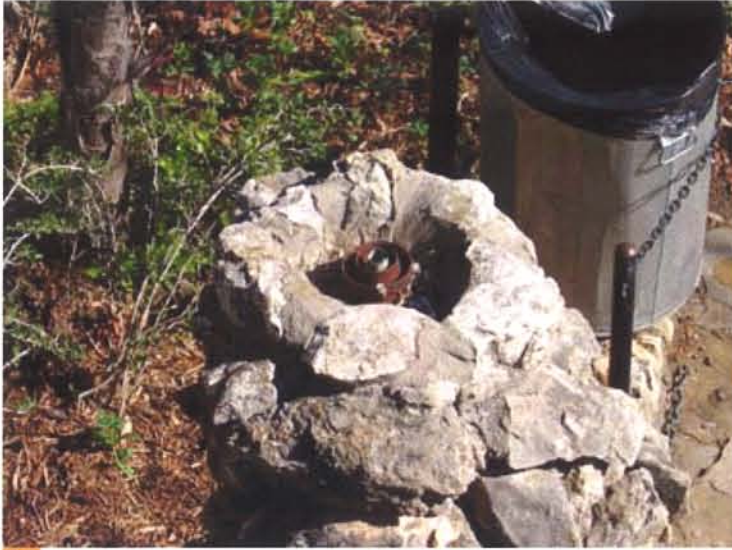
43

43. Top of historic pylon with abandoned light. There are no images of the historic pylon lighting, but it is described by Mabel Jingu in a documentary. Future lighting should recall the historic aesthetic of the gardens.

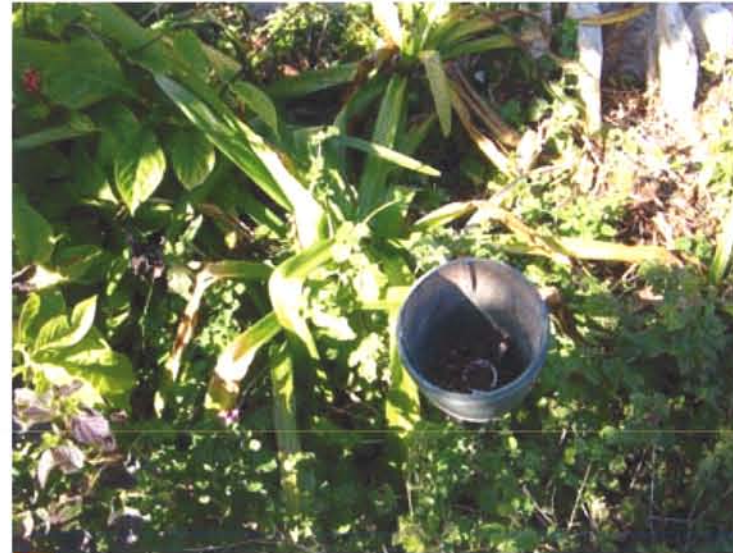
46

46. Abandoned upright in Core Island planting bed. All abandoned lighting should be removed and replaced with lighting that is hidden in ground or in the planting bed as necessary.

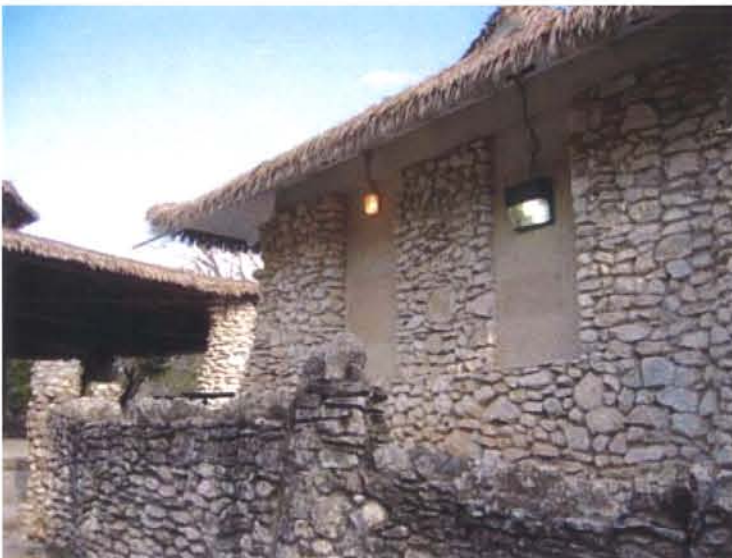
47

47. Non-historic lighting at Jingu house. These lights should be removed and replaced with historically appropriate lighting.

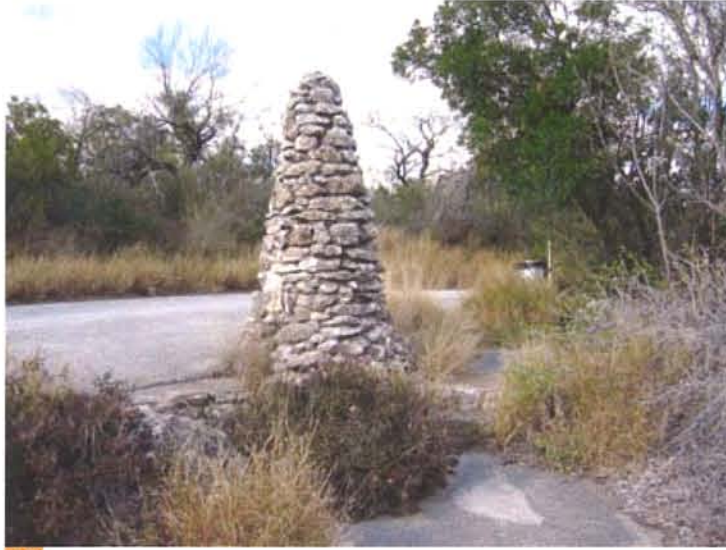
48

48. Historic pylon on Alpine Drive. The light at top is visible, but does not function. It is not clear if this lighting was present at the period of significance, but it was described by Mabel Jingu in a documentary on the gardens. All abandoned lighting should be removed and replaced with lighting that is hidden in ground or in the planting bed as necessary.

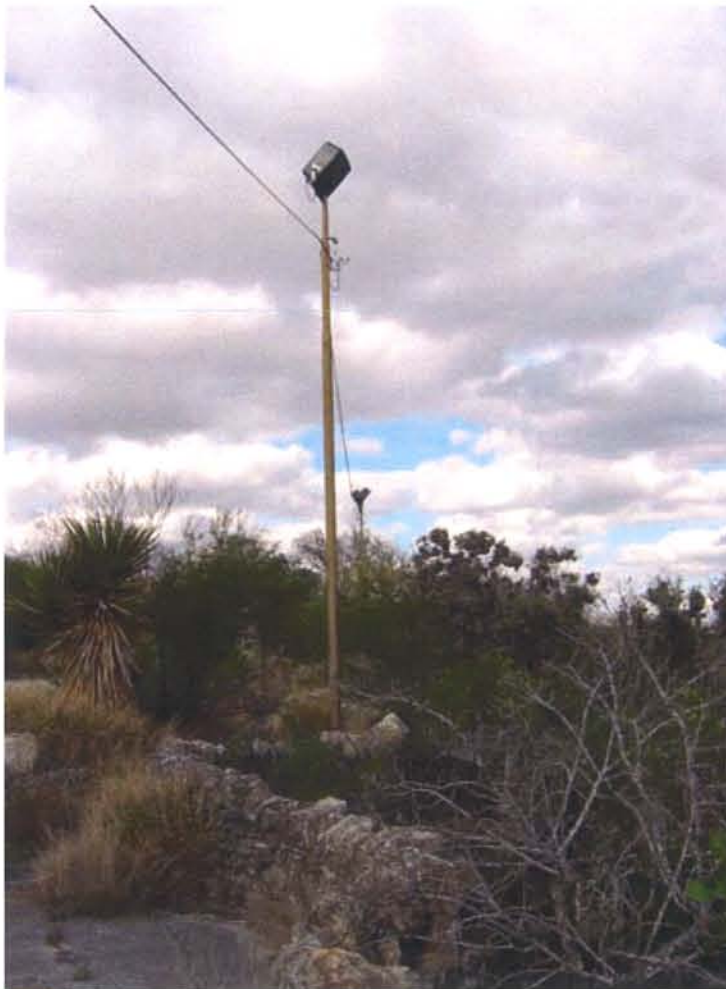
50

50. Uplight along Alpine Drive is visible from the ponds below and outdated. Uplight should be replaced with appropriate light standard and consider views from above and below.

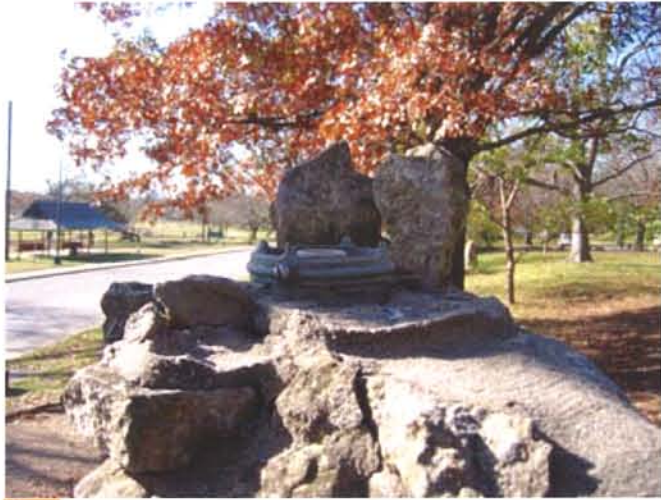
1

1. Typical pylon with missing light fixture. There is no historic images of the light fixture, however, it lighting was described by Mabel Jingu in a documentary on the garden. Lighting should be restored, but it should be sensitive to the historic aesthetics of the gardens.

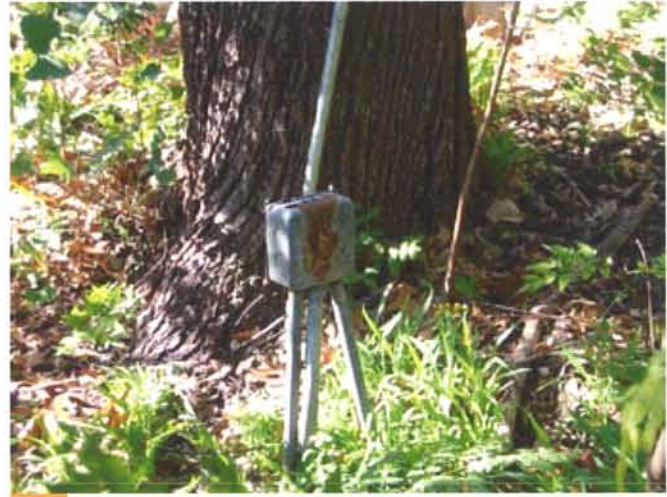
3

3. Typical pylon with missing light fixture. There is no historic images of the light fixture, however, it lighting was described by Mabel Jingu in a documentary on the garden. Lighting should be restored, but it should be sensitive to the historic aesthetics of the gardens.

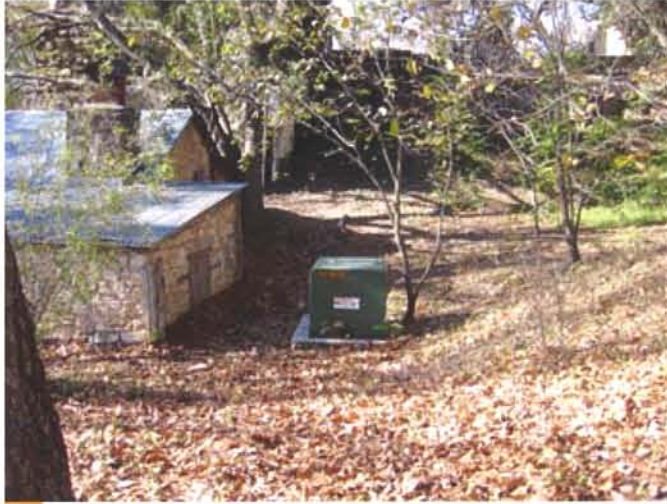
7

- 7. Electrical transformer behind Mexican Village Casistas. Landscape improvements should help to hide the transformer.
- 8. Electrical pole with ? on pole?
- 9. Electrical panel attached to back of the Old Kiln at Mexican Village. This panel should be relocated and removed from public access.
- 10. Electrical power at Mexican Village. This panel should be relocated and removed from public access.
- 11. Green pole near Blue Pavilion entry. New and in good condition.

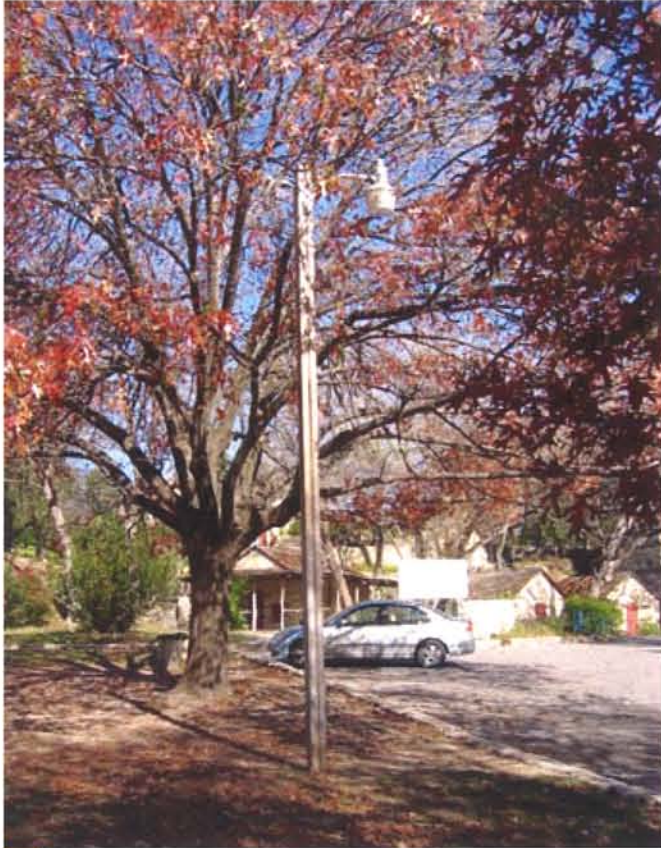
12

- 12. Light pole at Mexican Village Parking lot. Light pole should be replaced with standard site lighting as necessary.
- 13. Conduit and tree light. Tree lights should be placed in the crotch of the tree and all conduit should be painted black.
- 14. Conduit and tree light. Tree lights should be placed in the crotch of the tree and all conduit should be painted black.
- 15. Power box at base of tree in Number 14. All power boxes should either be placed in-grade or elevated above ground level at the crotch of the tree. All conduit should be painted black.

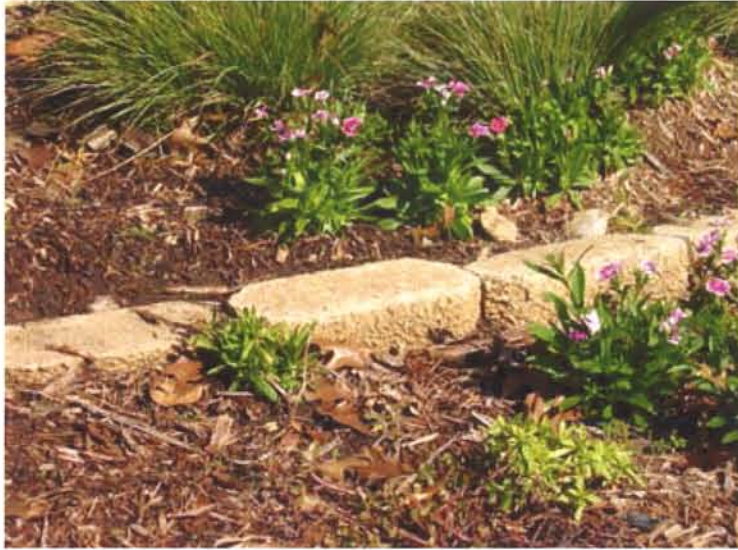
1

1. Concrete edging is not historic and should be removed.
2. Tree has been poorly pruned over the years and should be removed.
3. Planting beds are empty and should be filled with appropriate material.
4. Pylon cap detail. If planting is acceptable historic treatment, all pylons should be planted with appropriate material.
5. Tree not historic (see historic images) and should be removed. The City of San Antonio does not generally support the removal of trees on the property. All trees to be removed should be evaluated for aesthetics, safety, health, etc. by various City staff, the consultants, and contractors involved in Master Plan implementation to determine the best for the facility.
6. Cane should be removed and appropriate material planted in beds at Pavilion.

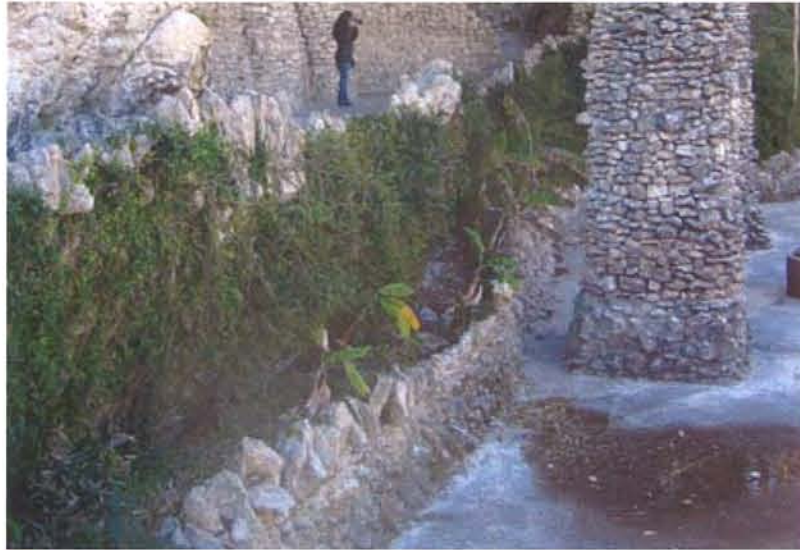
7

7. Planting bed above Pavilion pond. The vine growing on the Pavilion walls is overgrown & should be thinned out. Appropriate planting should be restored. While the banana trees are historic planting material, they are not in good shape.
