Japanese Tea Garden Master Plan

Japanese Tea Garden
Master Plan
San Antonio, Texas

June 2007

SWA Group
Project Landscape Architect
Houston, Texas

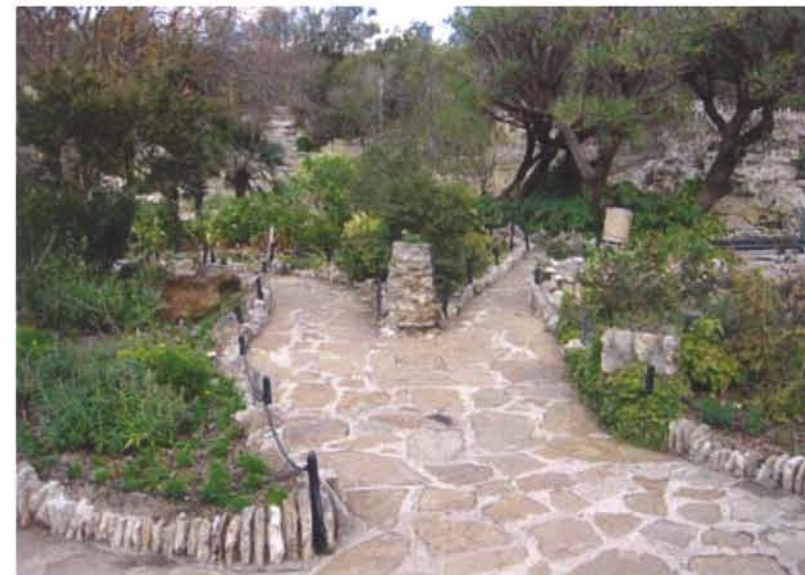
11

11. Typical planting beds on core island. All beds should be lined with upright limestone header. All beds should contain appropriate plant materials and it should remain below hip height in this area.

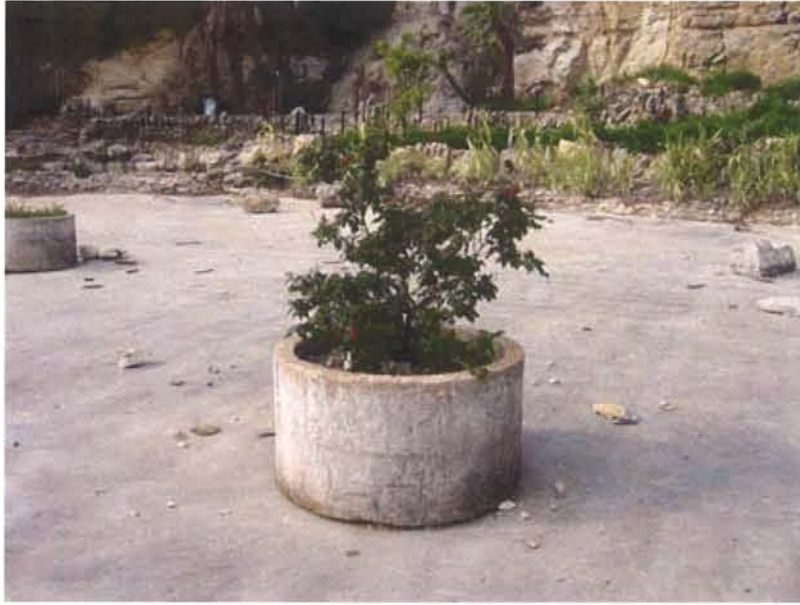
12

- 12. Typical planter in ponds. These planters are not from the period of significance and should be removed.
- 13. Empty planter beds below dragon bridge should be filled with appropriate plant material. No planting should be added to the bridge.
- 14. View to quarry walls & Alpine Drive. The planting should be thinned out to allow views.
- 15. View to garden after exiting dragon bridge. Consideration should be given to thin out the upper pathways and quarry walls.

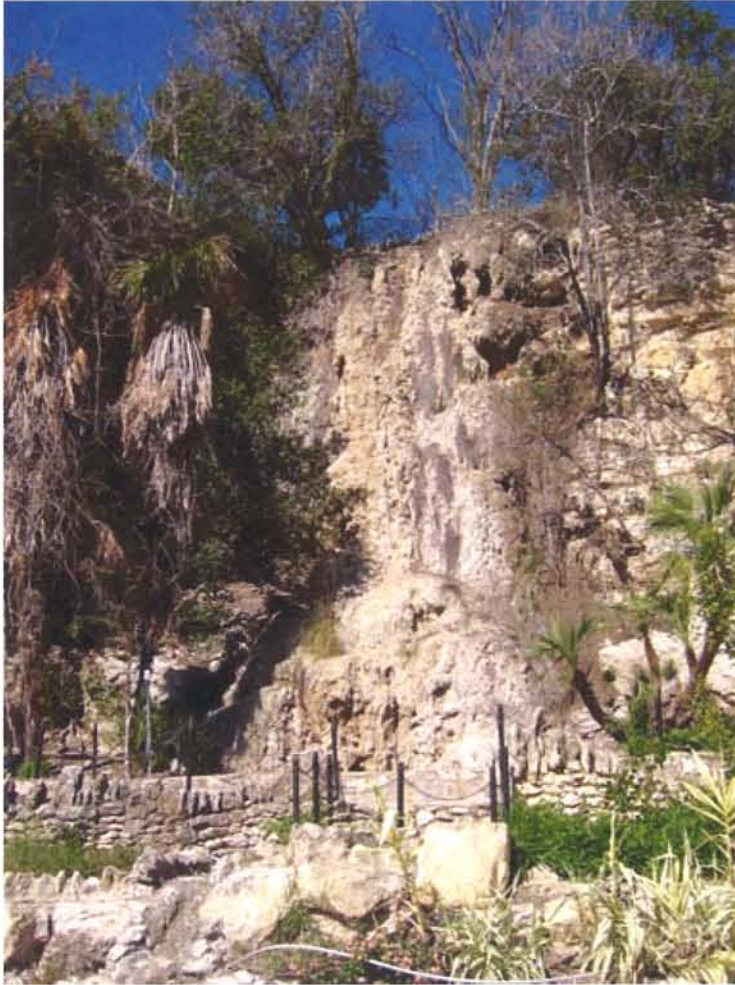
16

16. Historic waterfall covered in dried lichens and moss. It is believed this plant material will return to life once the water is restored. If necessary, file in with similar species to create the appropriate landscape effect.
17. Mid-level pathway through planter beds.
18. Planting at the upper level pathway includes more overhead canopy trees. The trees help create a distinct planting zone and should be protected.

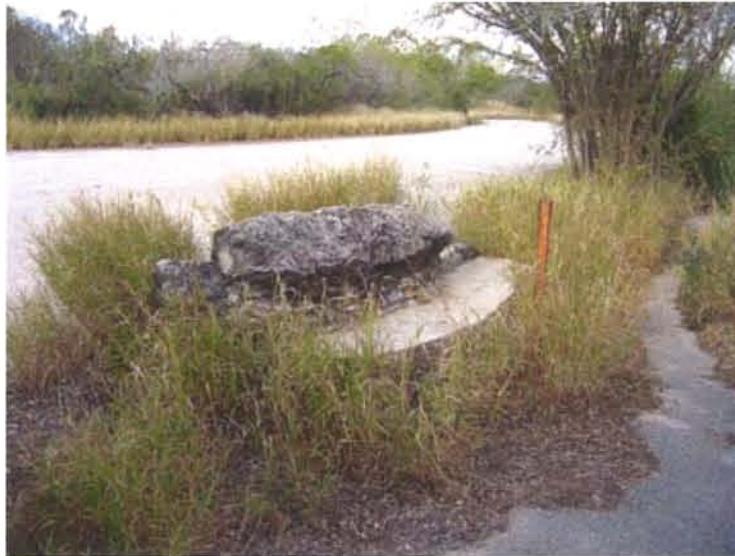
19

- 19. Pathway and overgrown planting along Alpine Drive. The weeds should be removed.
- 20. Scenic overlook along Alpine Drive. The planting has taken over the pathway and should be removed as necessary.
- 21. Planting next to stair at scenic overlook along Alpine Drive. While the planting next to steps are mostly weeds, the effect is desirable. It should be thinned out and contain appropriate plant material.
- 22. View to garden/Pavilion from scenic overlook. Overgrown trees and vegetation should be thinned to restore views from above. (See historical images, appendix).
- 23. View to ponds from Alpine Drive. Large crape myrtle (*lagerstroemia indica*) blocks views to Pavilion. Historically, lower planter material was used on the island.
- 24. Steps up from zoo entry. Understory should be thinned out.

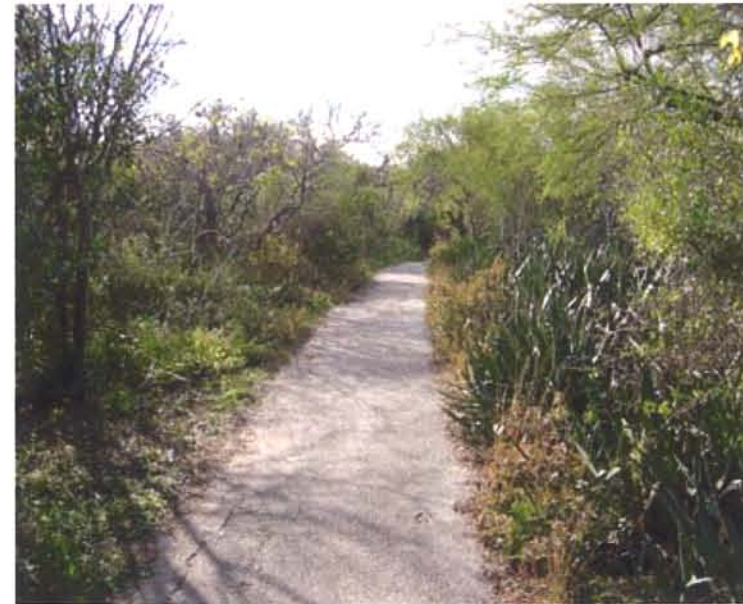
25

- 25. Pathway along Alpine Drive. Pathway provides walks through various plant communities. It is a great opportunity for plant and environmental education. This portion is characterized by lower grasses without much canopy.

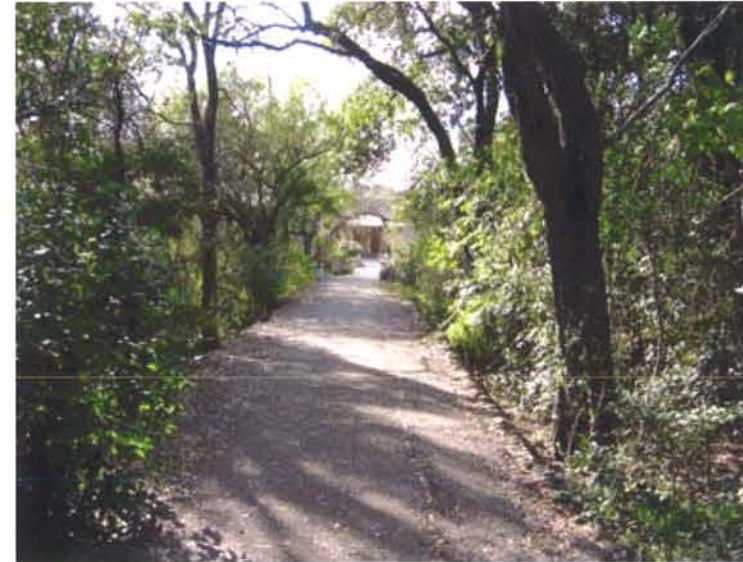
28

- 28. Pathway along Alpine Drive. Pathway provides walks through various plant communities. It is a great opportunity for plant and environmental education. The canopy is fully developed and the understory is very lush. It might be desirable to thin out the understory to take advantage of vistas and increase security.

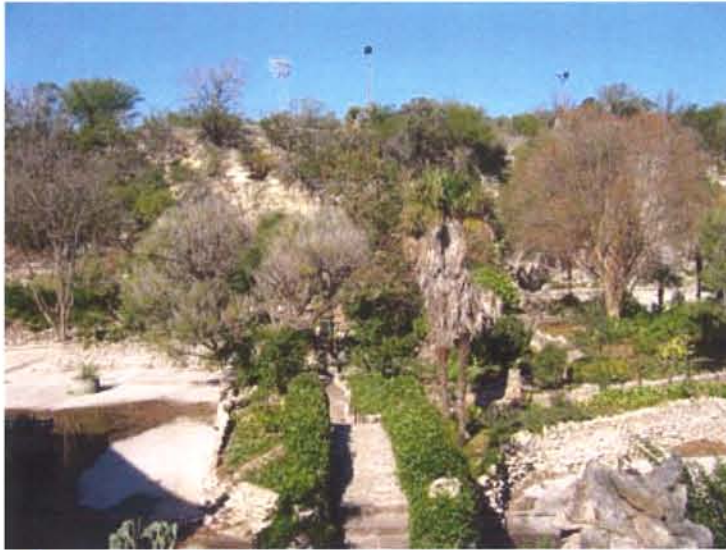
29

- 29. View of overall core island canopy.
- 30. Crape myrtle (*Lagerstroemia indica*)
- 31. Coral tree (*Erythrina caffra*) causing damage to pond wall.
- 32. Coral tree (*Erythrina caffra*) causing damage to pond wall.
- 33. Trees causing damage to pond wall.
- 34. Coral tree (*Erythrina caffra*) causing damage to pond wall.

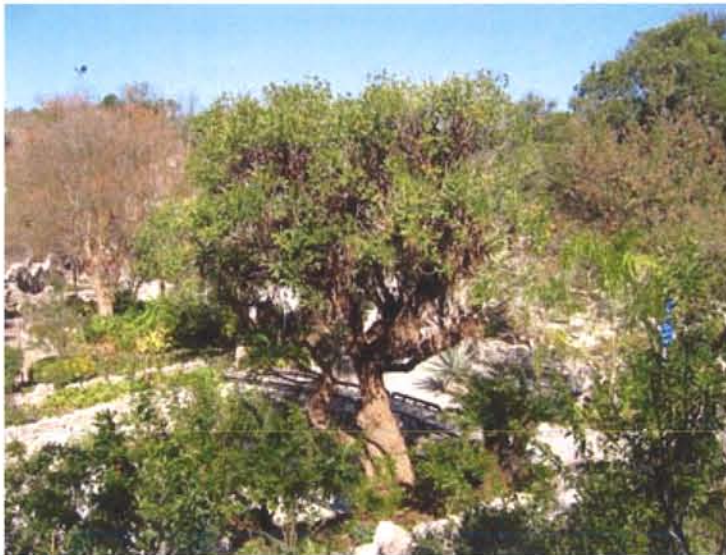
31

Trees on the core island have not been maintained or pruned over the years. They are overgrown and some towards the end of their lifespan. Some of the trees are damaging the pond walls and should be removed prior to pond restoration. However, the City of San Antonio does not generally support the removal of trees on the property. All trees to be removed should be evaluated for aesthetics, safety, health, etc. by various City staff, the consultants, and contractors involved in Master Plan implementation to determine the best for the facility.

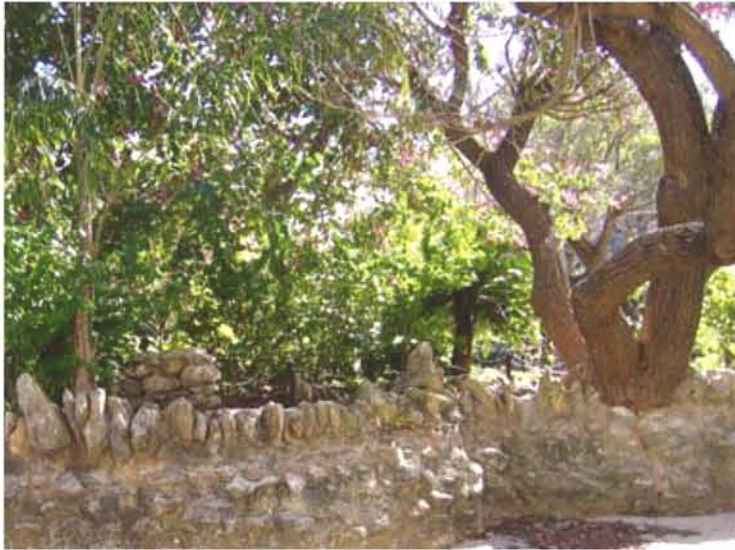
35

- 35. Overgrown tree near weir. The tree is causing damage to pond walls and stone cap. Tree should be removed and pond walls reconstructed with ponds restoration work. The City of San Antonio does not generally support the removal of trees on the property. All trees to be removed should be evaluated for aesthetics, safety, health, etc. by various City staff, the consultants, and contractors involved in Master Plan implementation to determine the best for the facility.

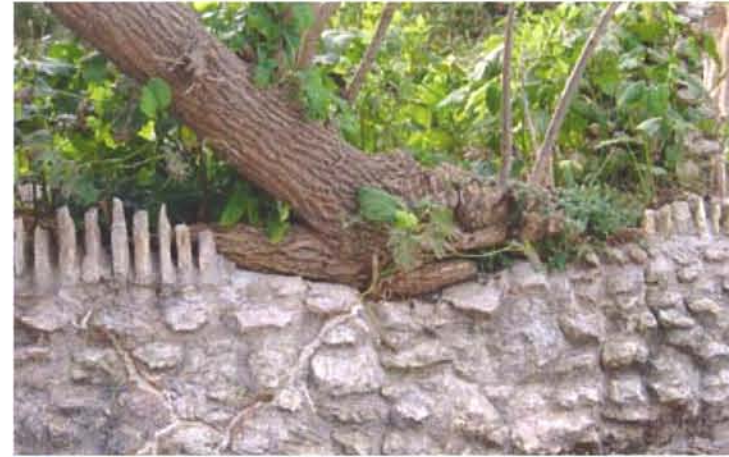
36

- 36. Coral tree (*Erythrina caffra*) overgrown and causing damage to pond walls and stone cap. Tree should be removed and ponds walls reconstructed with ponds restoration work. The City of San Antonio does not generally support the removal of trees on the property. All trees to be removed should be evaluated for aesthetics, safety, health, etc. by various City staff, the consultants, and contractors involved in Master Plan implementation to determine the best for the facility.

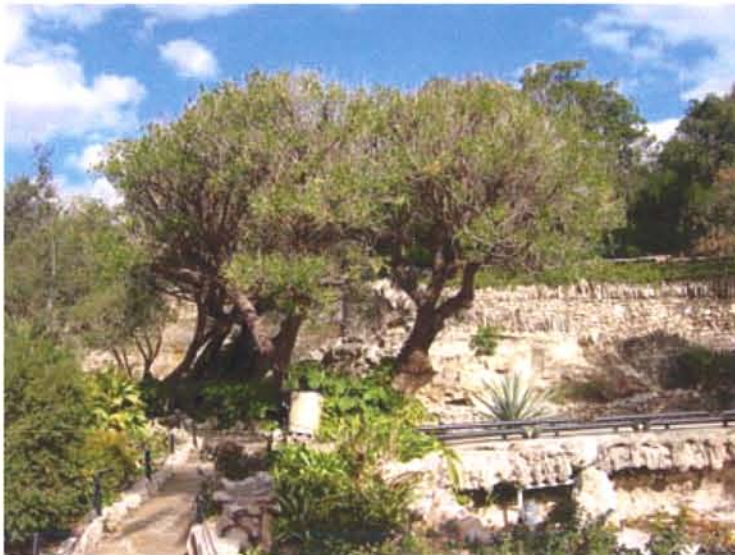
37

- 37. Orchid tree on central island. Tree is large and overgrown. While it doesn't cause a threat to pond walls, it should be considered for removal. The City of San Antonio does not generally support the removal of trees on the property. All trees to be removed should be evaluated for aesthetics, safety, health, etc. by various City staff, the consultants, and contractors involved in Master Plan implementation to determine the best for the facility.

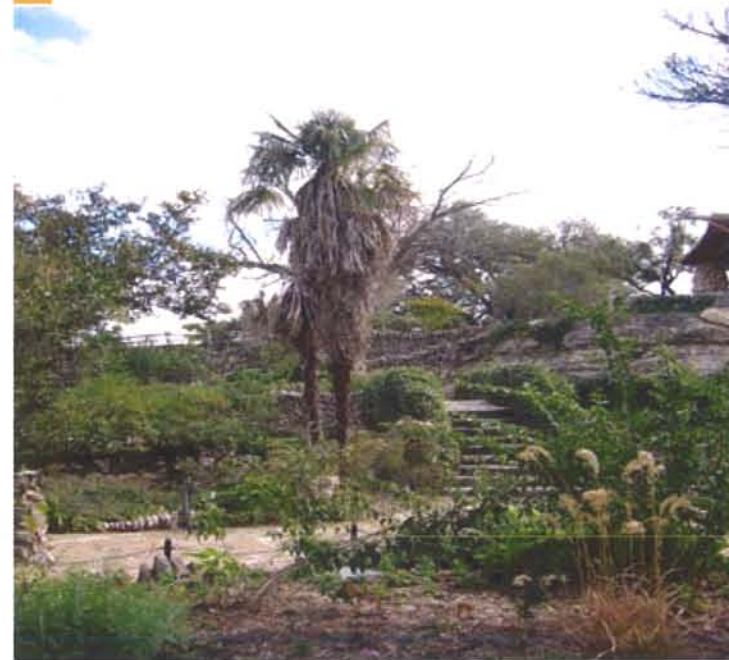
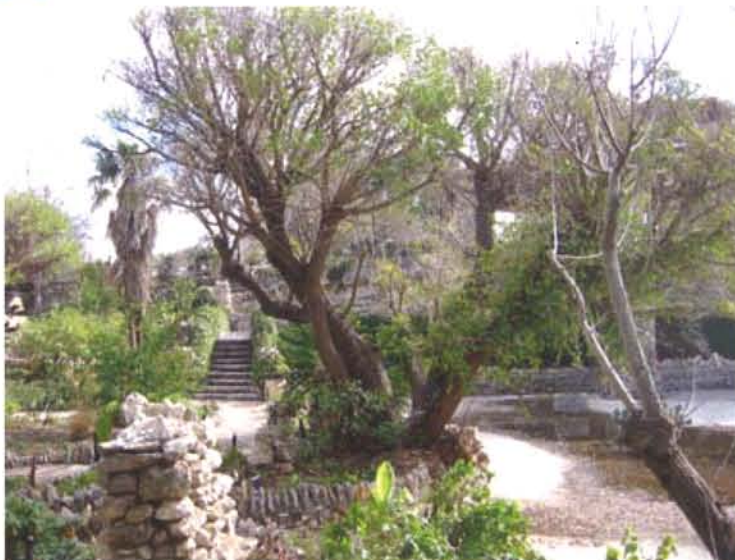
- 38. *Rhapis humilus* palm. Remove dead fronds.
- 39. Coral tree (*Erythrina caffra*) overgrown and causing damage to pond walls and stone cap. Tree should be removed and ponds walls reconstructed with ponds restoration work. The City of San Antonio does not generally support the removal of trees on the property. All trees to be removed should be evaluated for aesthetics, safety, health, etc. by various City staff, the consultants, and contractors involved in Master Plan implementation to determine the best for the facility.

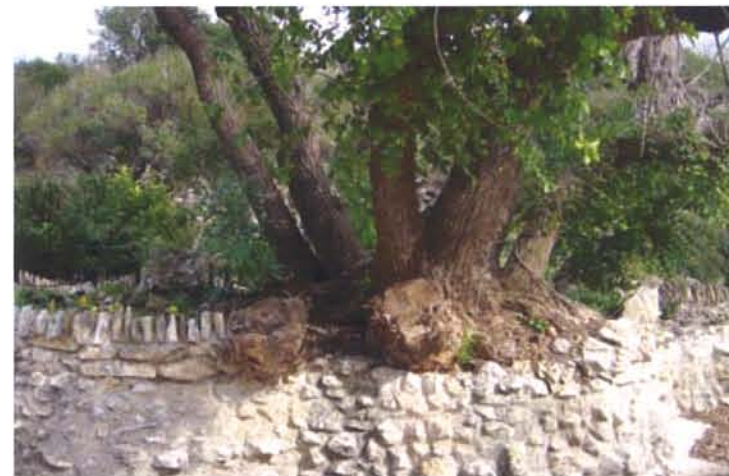
40

- 40. Coral tree (*Erythrina caffra*) overgrown and causing damage to pond walls and stone cap. Tree should be removed and ponds walls reconstructed with ponds restoration work. The City of San Antonio does not generally support the removal of trees on the property. All trees to be removed should be evaluated for aesthetics, safety, health, etc. by various City staff, the consultants, and contractors involved in Master Plan implementation to determine the best for the facility.

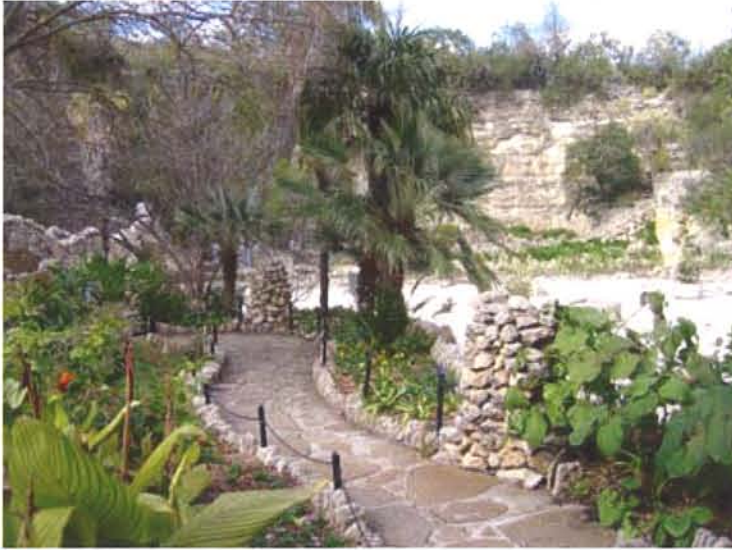
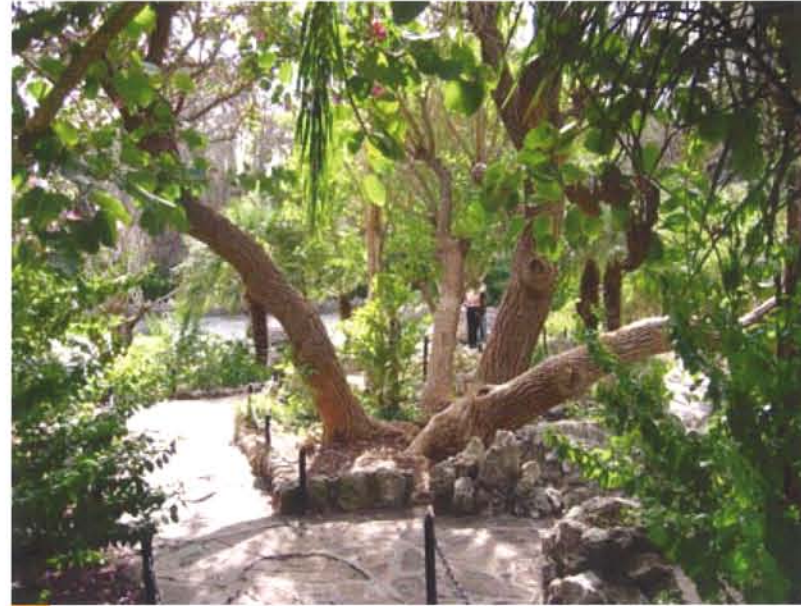
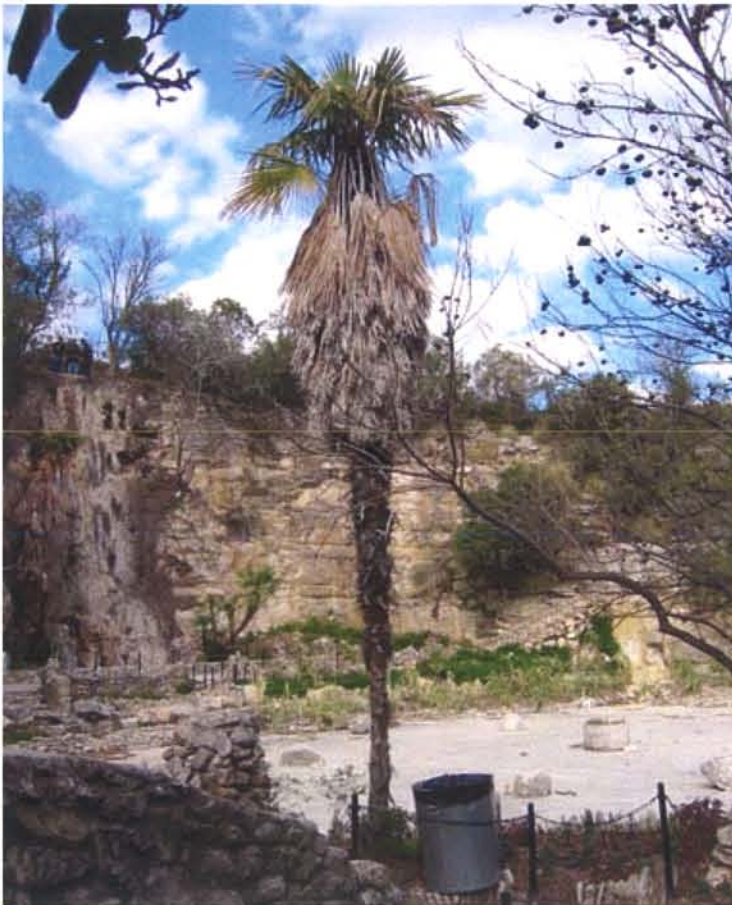
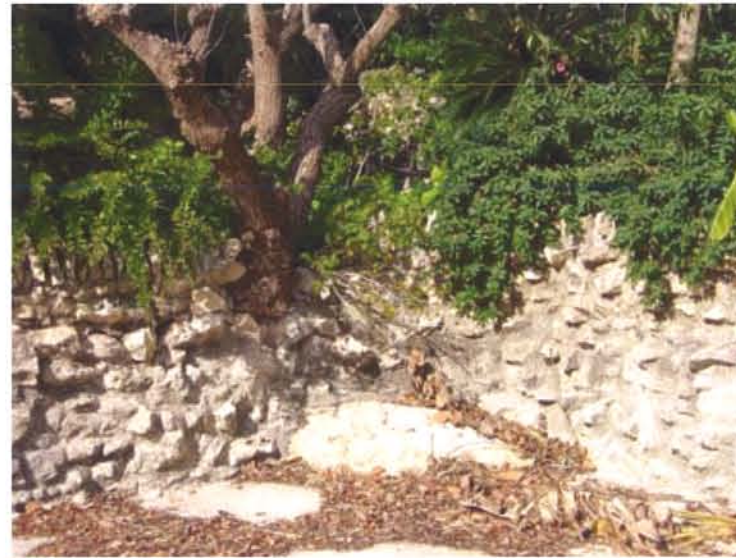
- 41. *Tracheocypres fortuniei* group near electrical junction box.
- 42. Orchid tree overgrown on central island.
- 43. *Rhapis humilus*. Remove dead palm fronds.
- 44. Coral tree (*Erythrina caffra*) compromising walls at Core Garden island. In order to successfully restore the ponds, the tree should be removed. The City of San Antonio does not generally support the removal of trees on the property. All trees to be removed should be evaluated for aesthetics, safety, health, etc. by various City staff, the consultants, and contractors involved in Master Plan implementation to determine the best for the facility.

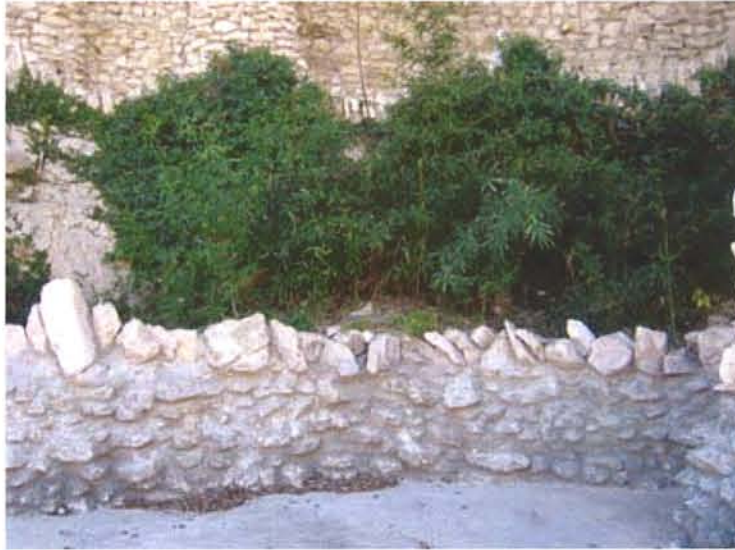
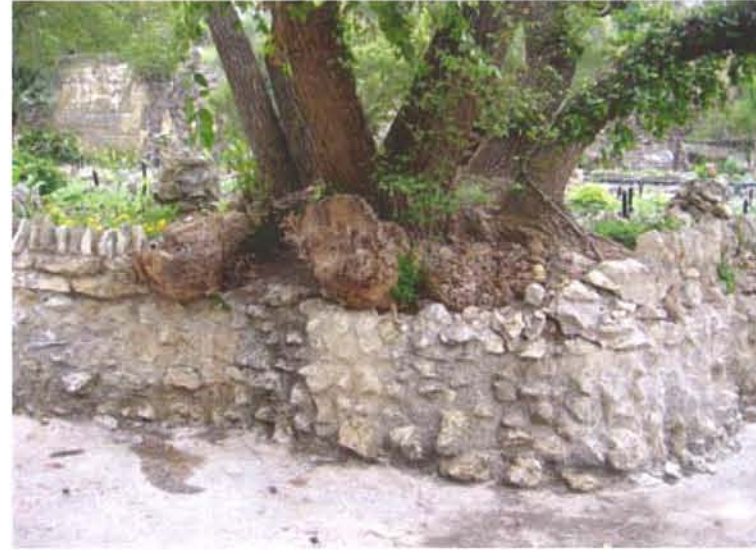
- 45. Invasive bamboo typical at Pavilion pond. It should be removed.
- 46. Overgrown Coral tree (*Erythrina caffra*) tree is compromising walls at Core Garden island. In order to restore the ponds, the tree should be removed. The City of San Antonio does not generally support the removal of trees on the property. All trees to be removed should be evaluated for aesthetics, safety, health, etc. by various City staff, the consultants, and contractors involved in Master Plan implementation to determine the best for the facility.

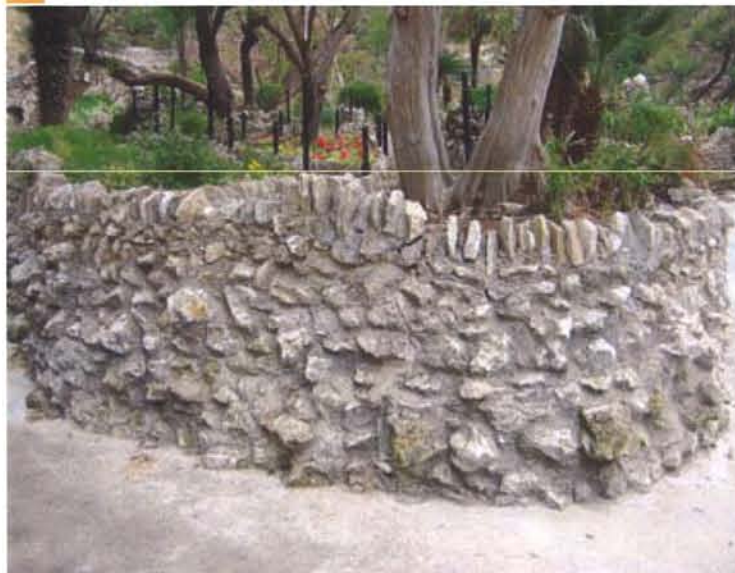
50

- 50. Overgrown Coral tree (*Erythrina caffra*) tree is compromising walls at Core Garden island. In order to restore the ponds, the tree should be removed. The City of San Antonio does not generally support the removal of trees on the property. All trees to be removed should be evaluated for aesthetics, safety, health, etc. by various City staff, the consultants, and contractors involved in Master Plan implementation to determine the best for the facility.

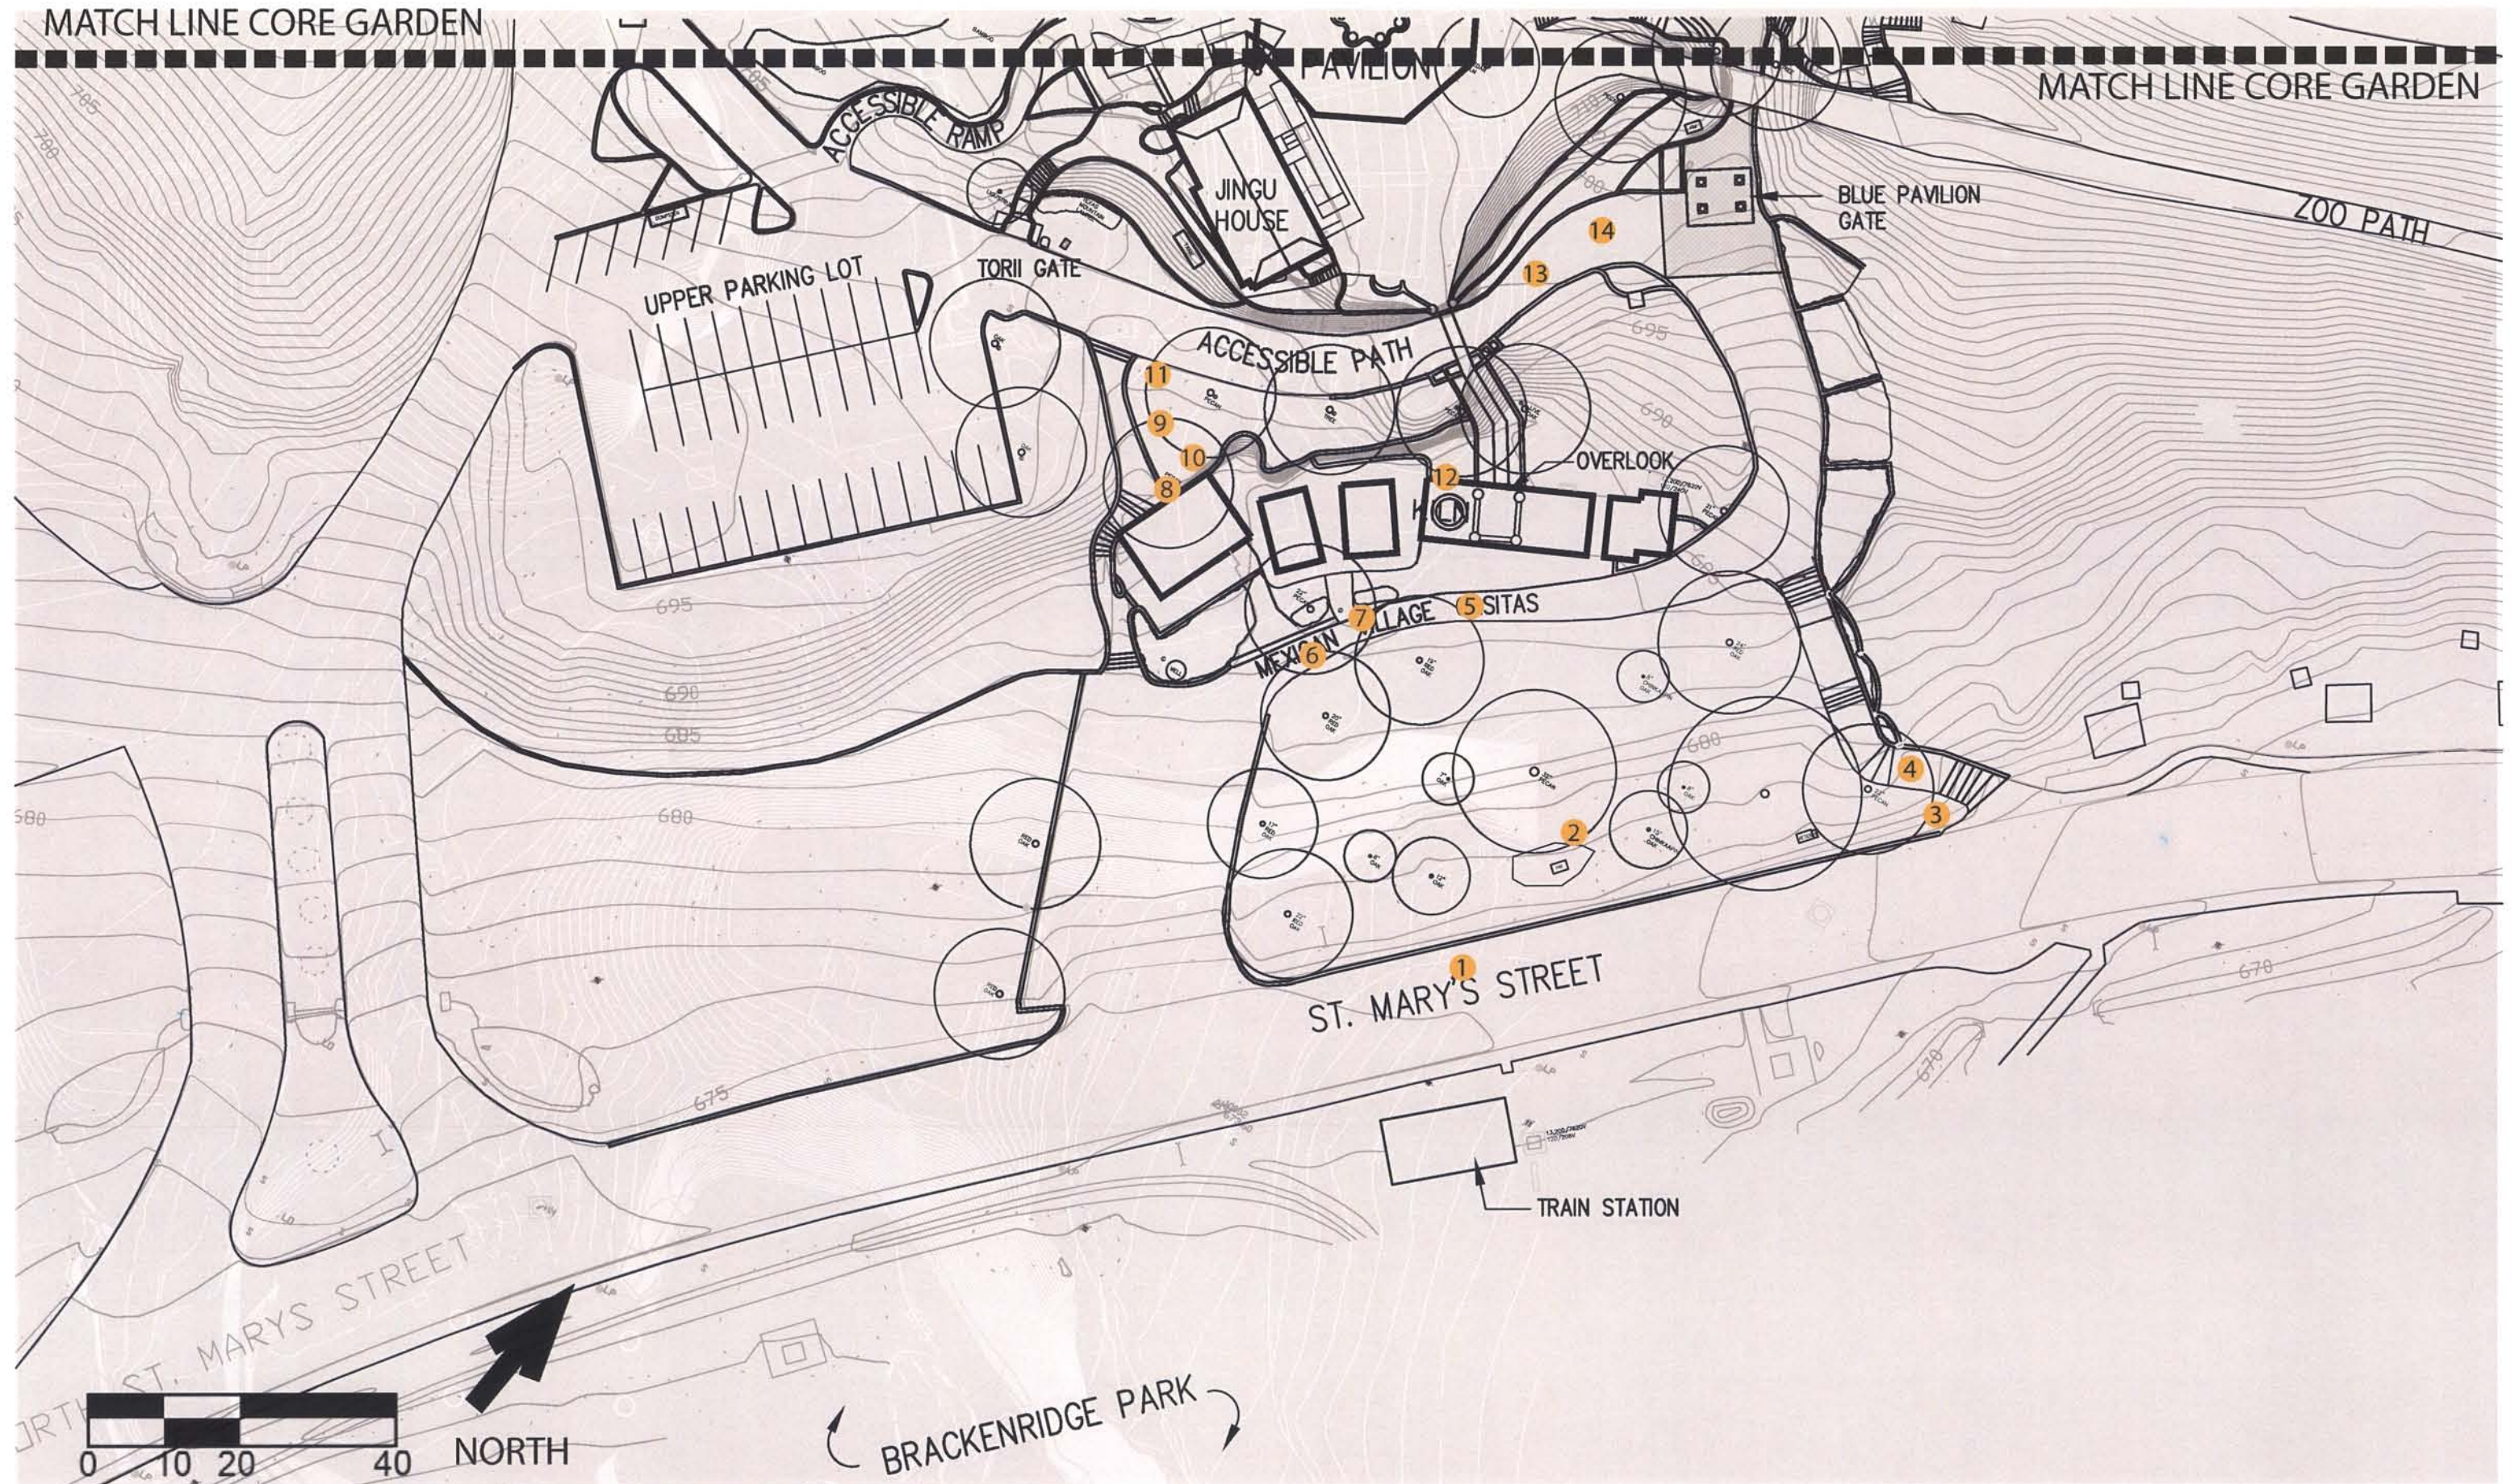
1. Canopy trees at Mexican Village.

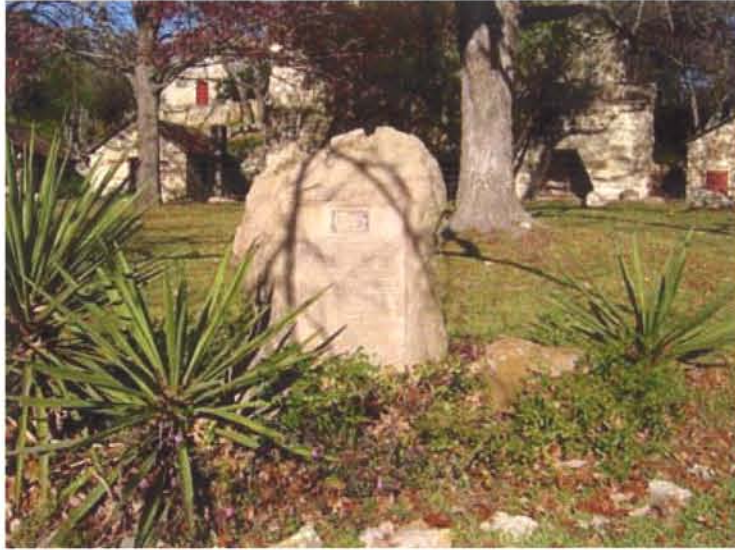
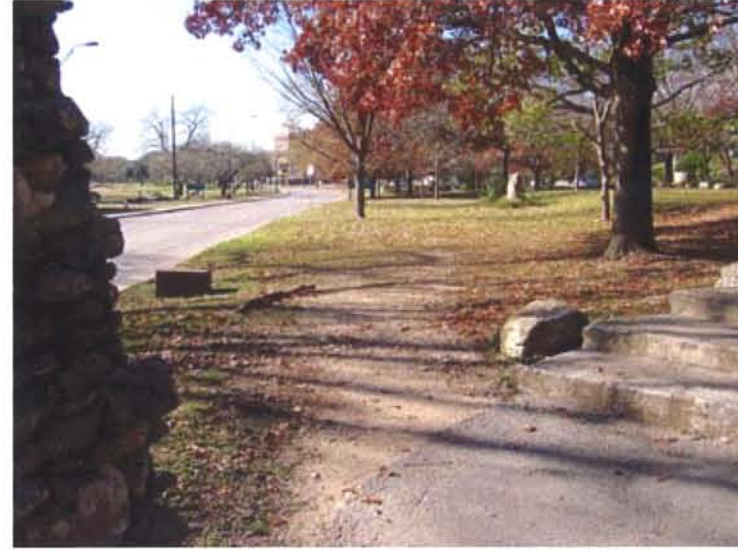
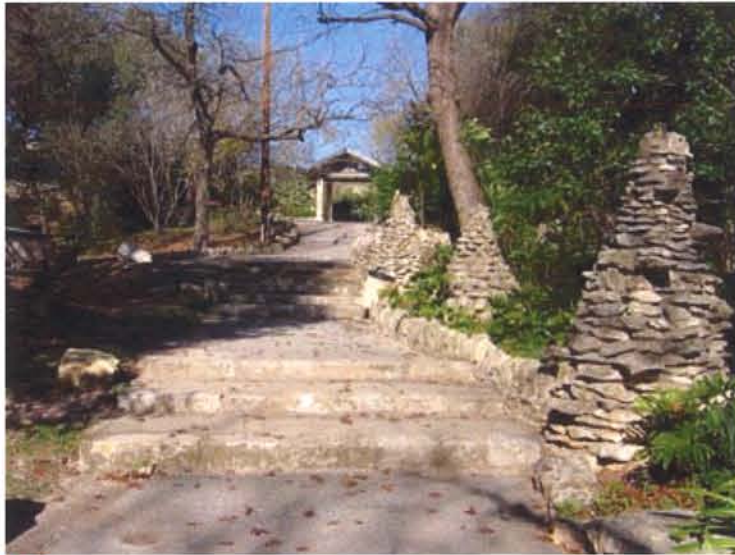
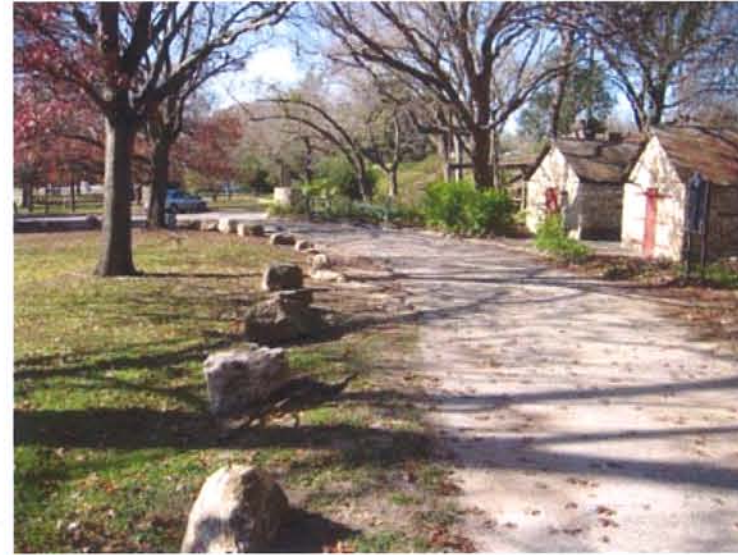
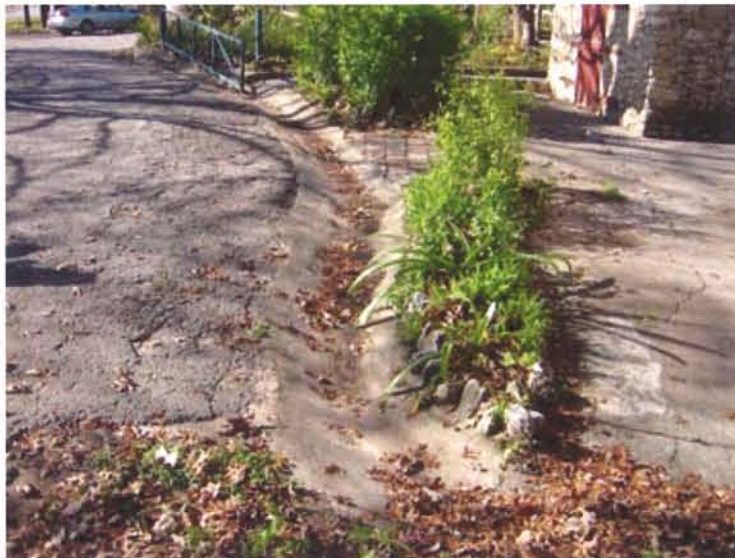
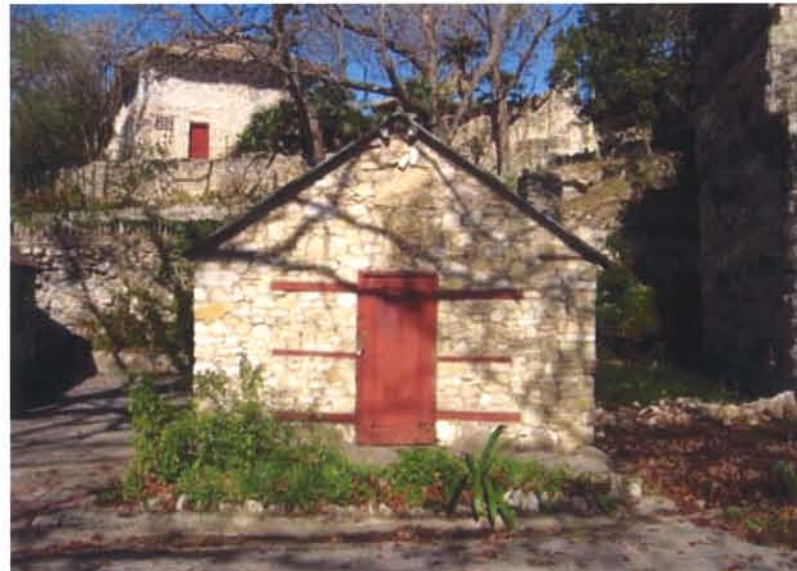
2. Yucca planting by quarry monument
3. The pedestrian path along St. Mary's St. ends at the stair. Path users have forged an unofficial path in front of Mexican Village. A permanent path should be considered for this location.
4. Planting beds along North side of pathway
5. Stones used as edging.
6. Planting bed next to swale. Swale is present in historic photos, but was not always concrete.
7. Planting bed at Mexican Village casitas. Planting bed is not historical.

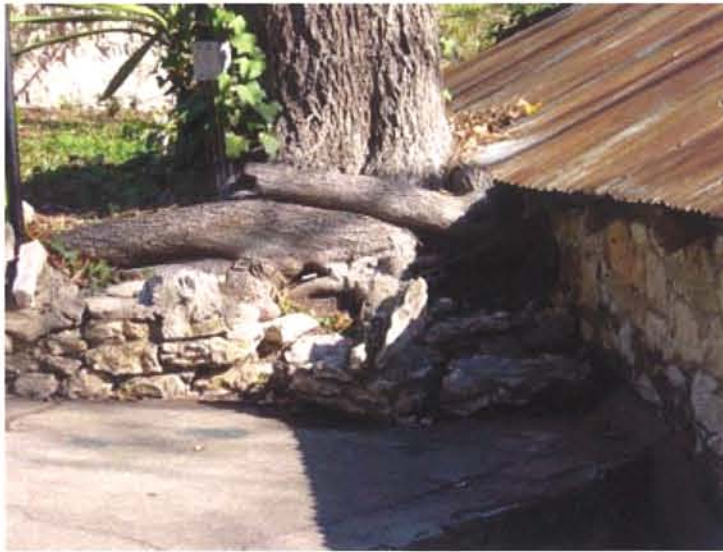
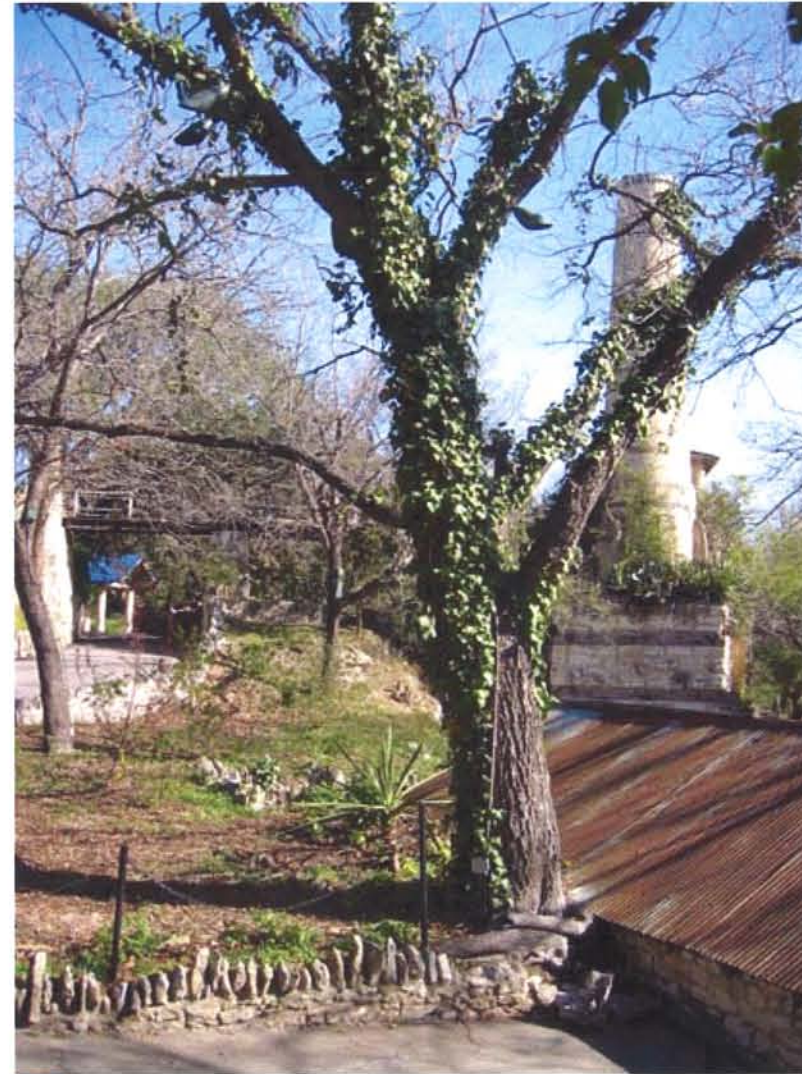
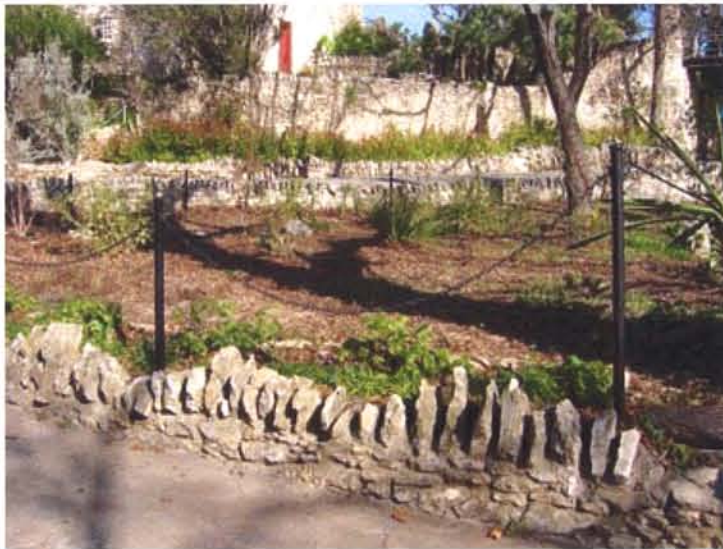
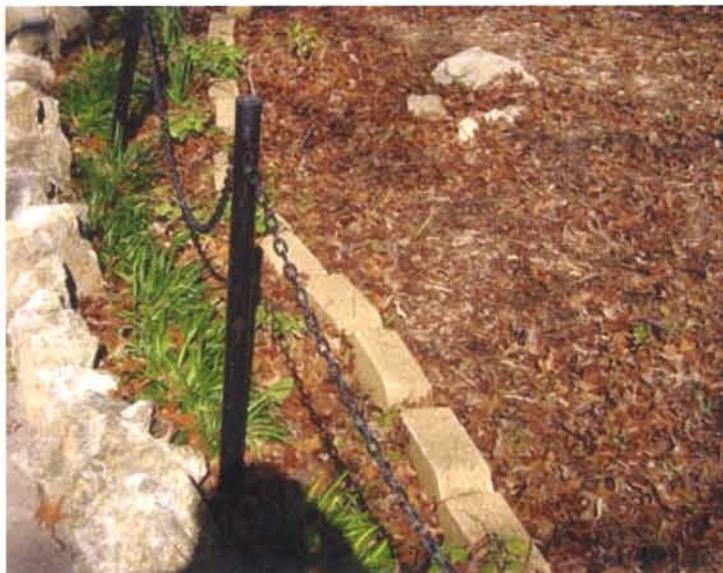
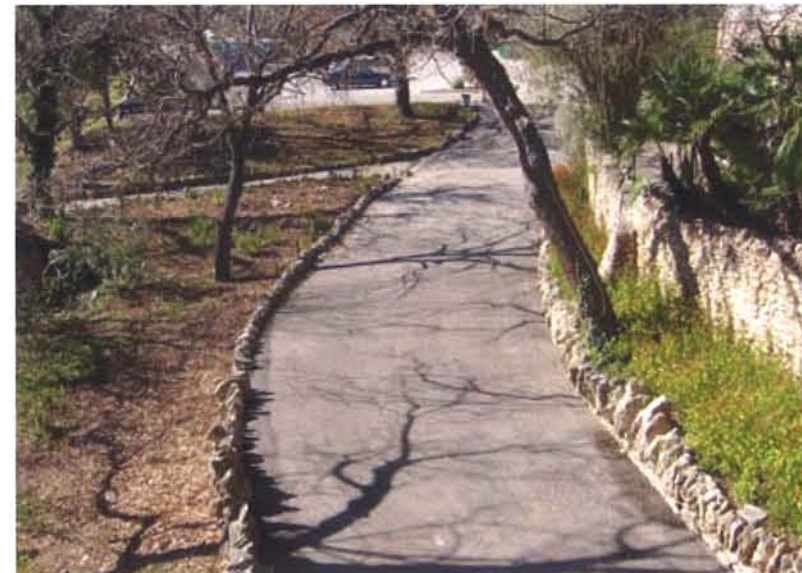
8. Overgrown tree at Mexican Village casitas. Remove tree.
9. Planting bed. Fill in with groundcover.
10. Vine overtaking tree. Tree to be removed. Tree should be removed and ponds walls reconstructed with ponds restoration work. The City of San Antonio does not generally support the removal of trees on the property. All trees to be removed should be evaluated for aesthetics, safety, health, etc. by various City staff, the consultants, and contractors involved in Master Plan implementation to determine the best for the facility.
11. Remove concrete edging.
12. Remove weeds from bed to North of accessible path and replace with appropriate planting material.

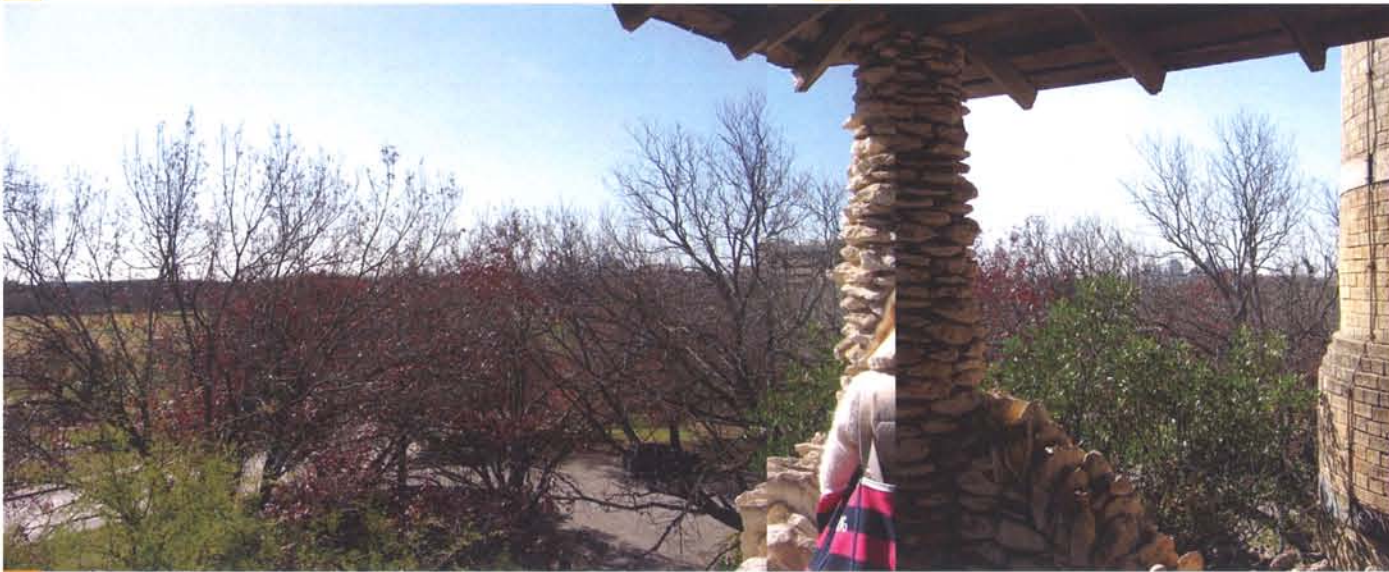
14

13. Shaded planting bed near Blue Pavilion entry.
14. Planting beds stepping up to Kiln Overlook bridge.
15. If city views are desirable, the pecan and red oak in front of the casitas needs to be removed. The City of San Antonio does not generally support the removal of trees on the property. All trees to be removed should be evaluated for aesthetics, safety, health, etc. by various City staff, the consultants, and contractors involved in Master Plan implementation to determine the best for the facility.

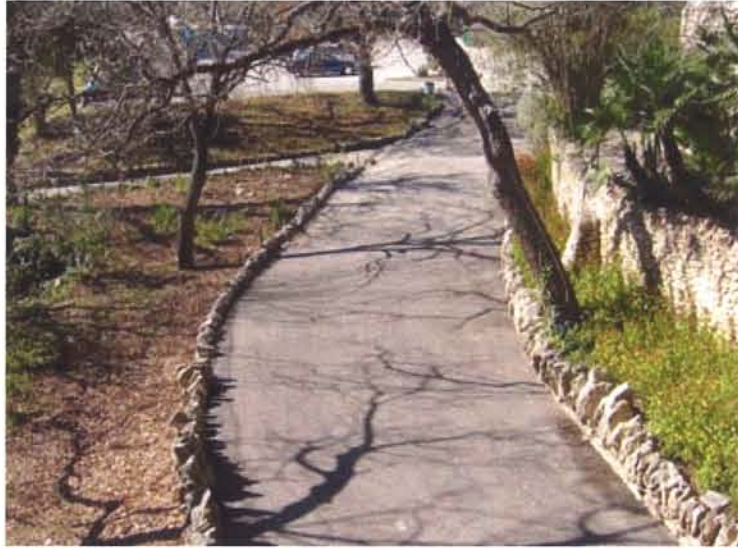
1

1. Accessible entry path between Mexican Village and Core Gardens. The accessible path is to one side of the large asphalt drive. Because the asphalt path is not entirely accessible, it is recommended that this path be modified in both material and design to create a central accessible path.

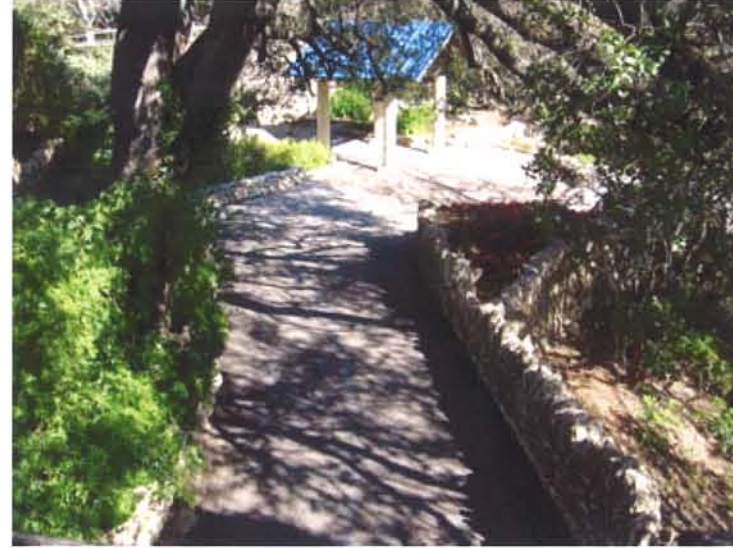
2

2. Accessible entry path between Mexican Village and Core Gardens. The accessible path is to one side of the large asphalt drive. Because the asphalt is not accessible, it is recommended that this path be modified in both material and design to create a central accessible path.

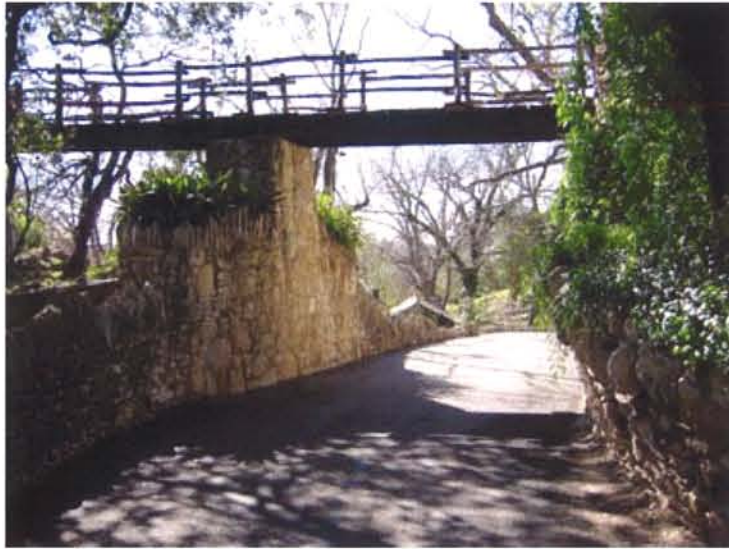
3

3. Accessible entry path between Mexican Village and Core Gardens. The accessible path is to one side of the large asphalt drive. Because the asphalt is not accessible, it is recommended that this path be modified in both material and design to create a central accessible path.
