Japanese Tea Garden Master Plan

Japanese Tea Garden
Master Plan
San Antonio, Texas

June 2007

SWA Group
Project Landscape Architect
Houston, Texas

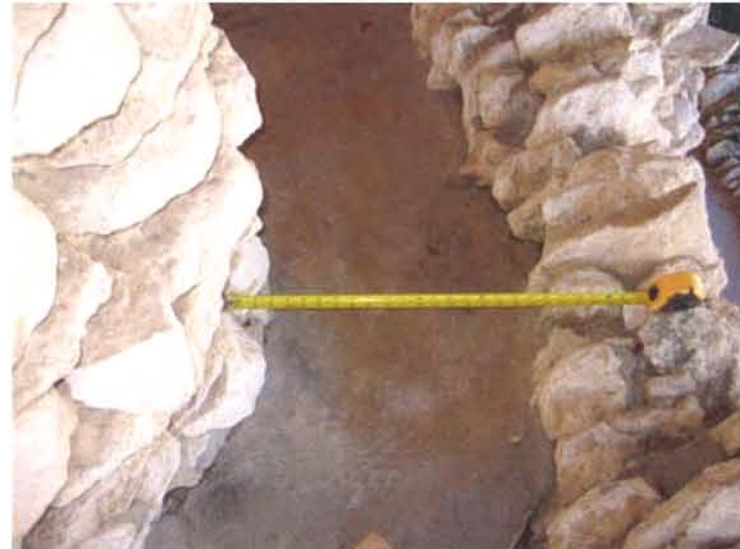
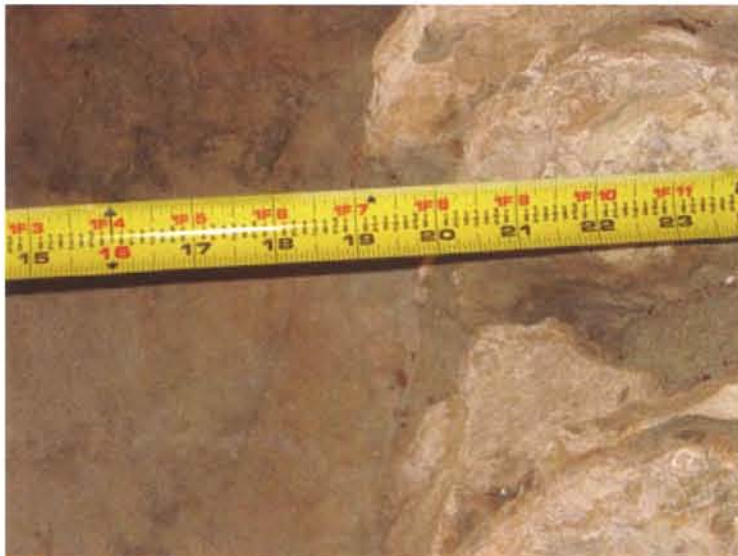
- 4 + 4a. Path at Pavilion is only 1'-9".
- 5 + 5a. Stone wall at Pavilion is only 1'-3" tall. The path drops off to the Pavilion pond below.

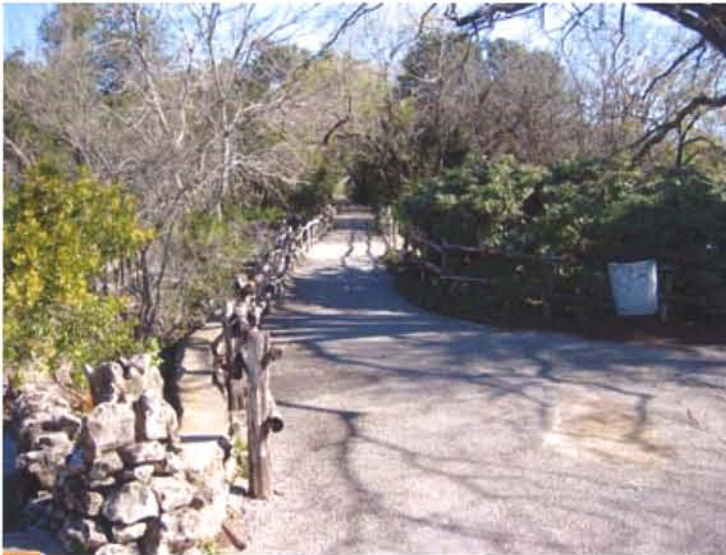
8

- 6. Chinese Tea Garden Gate
- 7. Accessible entry at Core Gardens.
- 8. Zoo entry path at Pavilion level. Security gate needed to keep people from entering the gardens from this path.
- 9. Blue Pavilion Entry. Blue Pavilion to be removed.
- 10. Vandalism on limestone.
- 11. Vandalism on kiln overlook.
- 12. Visitors entering the park through unofficial paths along the quarry walls.

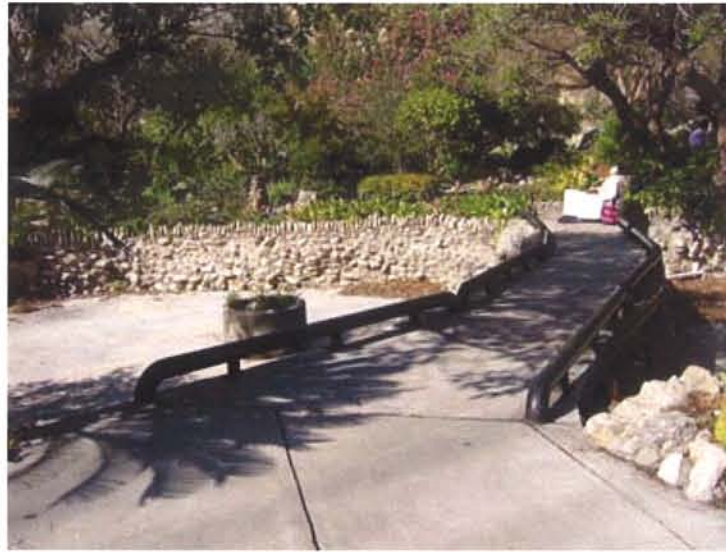
13

- 13. Accessible ramp at Core Garden Island level. The ramp is on top of the historic weir. While the weir is historic, this is the only accessible entry to the island and should be maintained.
- 14. Visitors climbing over Pavilion walls.
- 15. Unsafe drop along Alpine Drive.
- 16. Unsafe drop along Alpine Drive.
- 17. Rock slides from Alpine Drive present a problem to the pathways around the quarry pond.

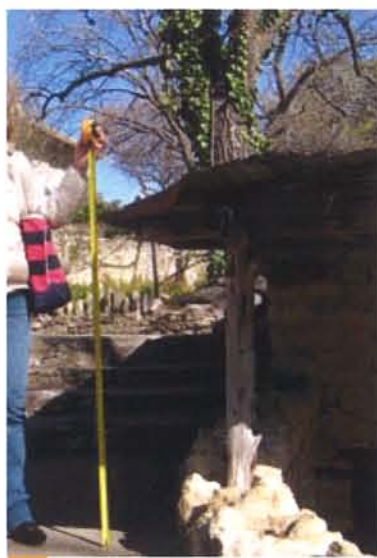
6

1. Entry at Mexican Village Casitas and parking lot.
2. Pedestrian entry at St. Mary's entry.
3. Vehicular entry at Sunken Garden Theater. This is also the entry to Alpine Drive and upper level parking lot.
4. Pedestrian entry at Mexican Village casitas to Core Gardens.
5. Security gate at Mexican Village casitas.
6. Sharp edge at Mexican Village casita and pathway.

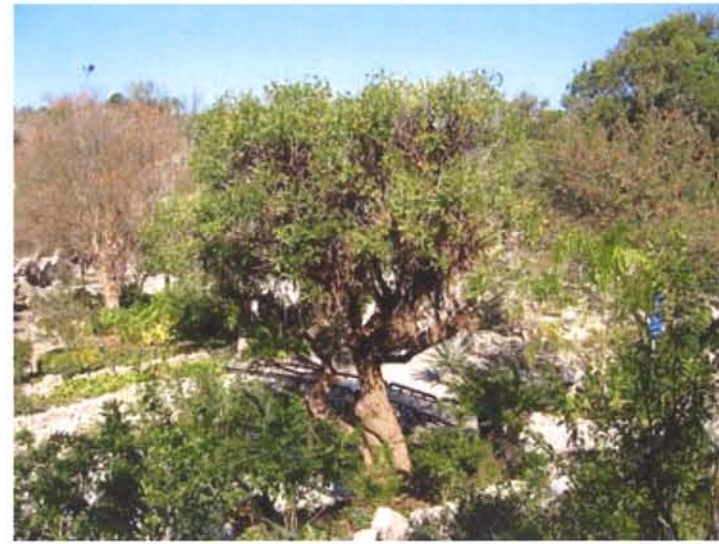
2

2. View from Pavilion to Core Island is blocked by trees. Consider removing trees that block views, such as the coral tree (*Erythrina indica*). If the crape myrtle (*lagerstroemia indica*) were removed, views to Alpine Drive would be re-established.

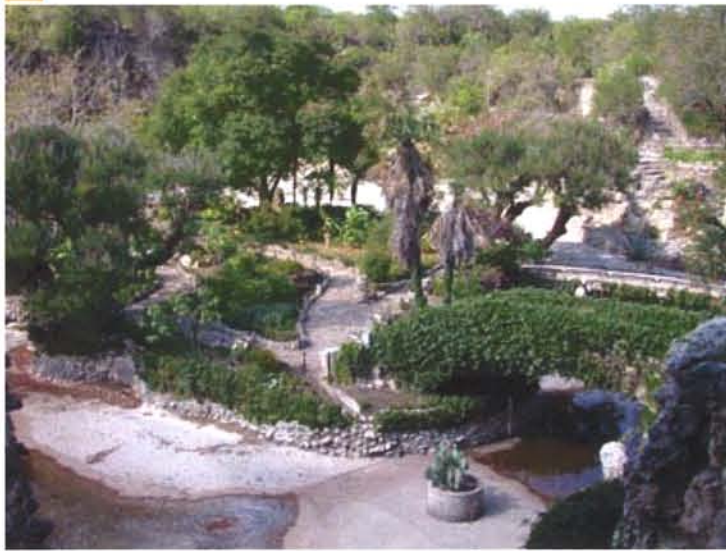
3

3. View from Pavilion to Core Island is blocked by trees. Consider removing trees that block views, such as the coral trees (*Erythrina indica*).
4. View from Pavilion to Core Island and Alpine Drive is blocked by canopy trees. Consider removing trees that block views, including the crape myrtle (*lagerstroemia indica*) and coral trees (*Erythrina indica*). The palms in the planting beds also block views at the pedestrian level. Clearing should also occur along Alpine Drive in order to make this historic route visible.

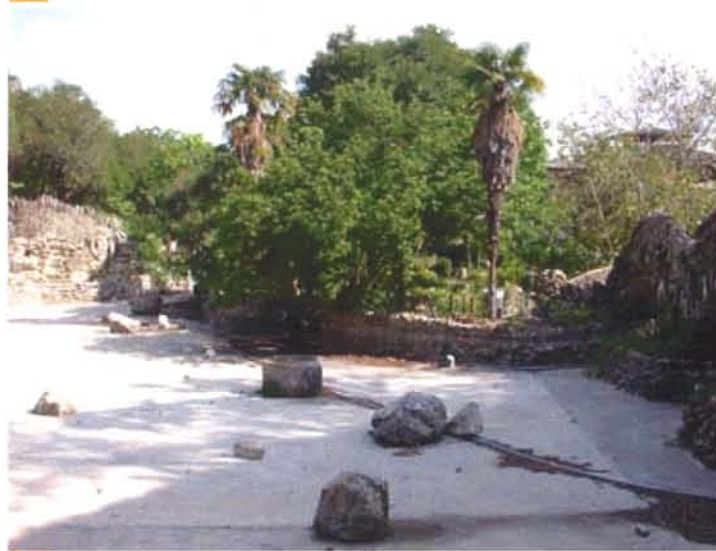
8

8. View from waterfall to Core Island. Consider removing trees that block views, including the crape myrtle (*lagerstroemia indica*) and coral trees (*Erythrina indica*). The shrubs and palms in the planting beds also block views at the pedestrian level. The City of San Antonio does not generally support the removal of trees on the property. All trees to be removed should be evaluated for aesthetics, safety, health, etc. by various City staff, the consultants, and contractors involved in Master Plan implementation to determine the best for the facility.

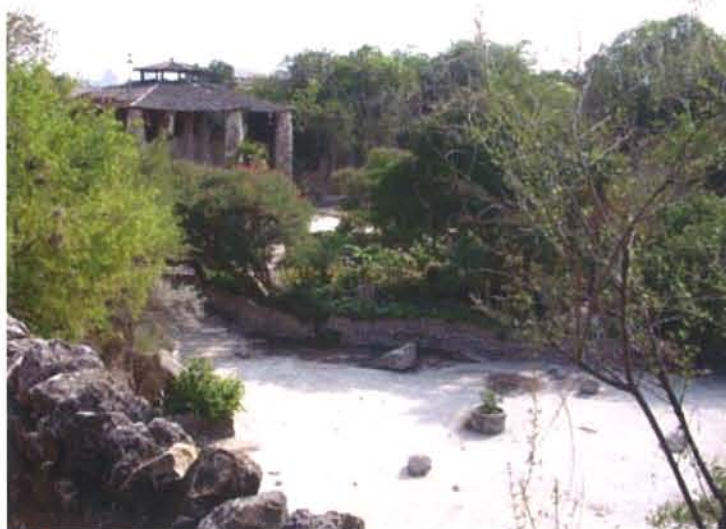
13

- 13. View from mid-path to Pavilion. Consider removing trees that block views, including the crape myrtle (*lagerstroemia indica*) and coral trees (*Erythrina indica*). The shrubs and palms in the planting beds also block views at the pedestrian level. The City of San Antonio does not generally support the removal of trees on the property. All trees to be removed should be evaluated for aesthetics, safety, health, etc. by various City staff, the consultants, and contractors involved in Master Plan implementation to determine the best for the facility.

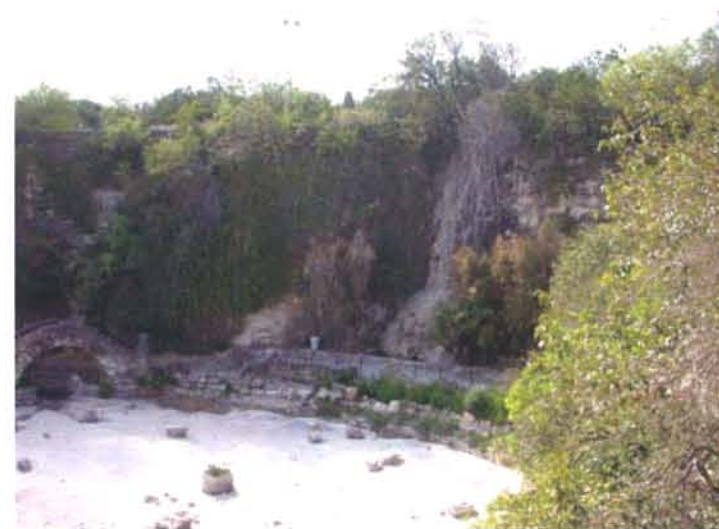
14

- 14. View from mid-path to waterfall and Alpine Drive.

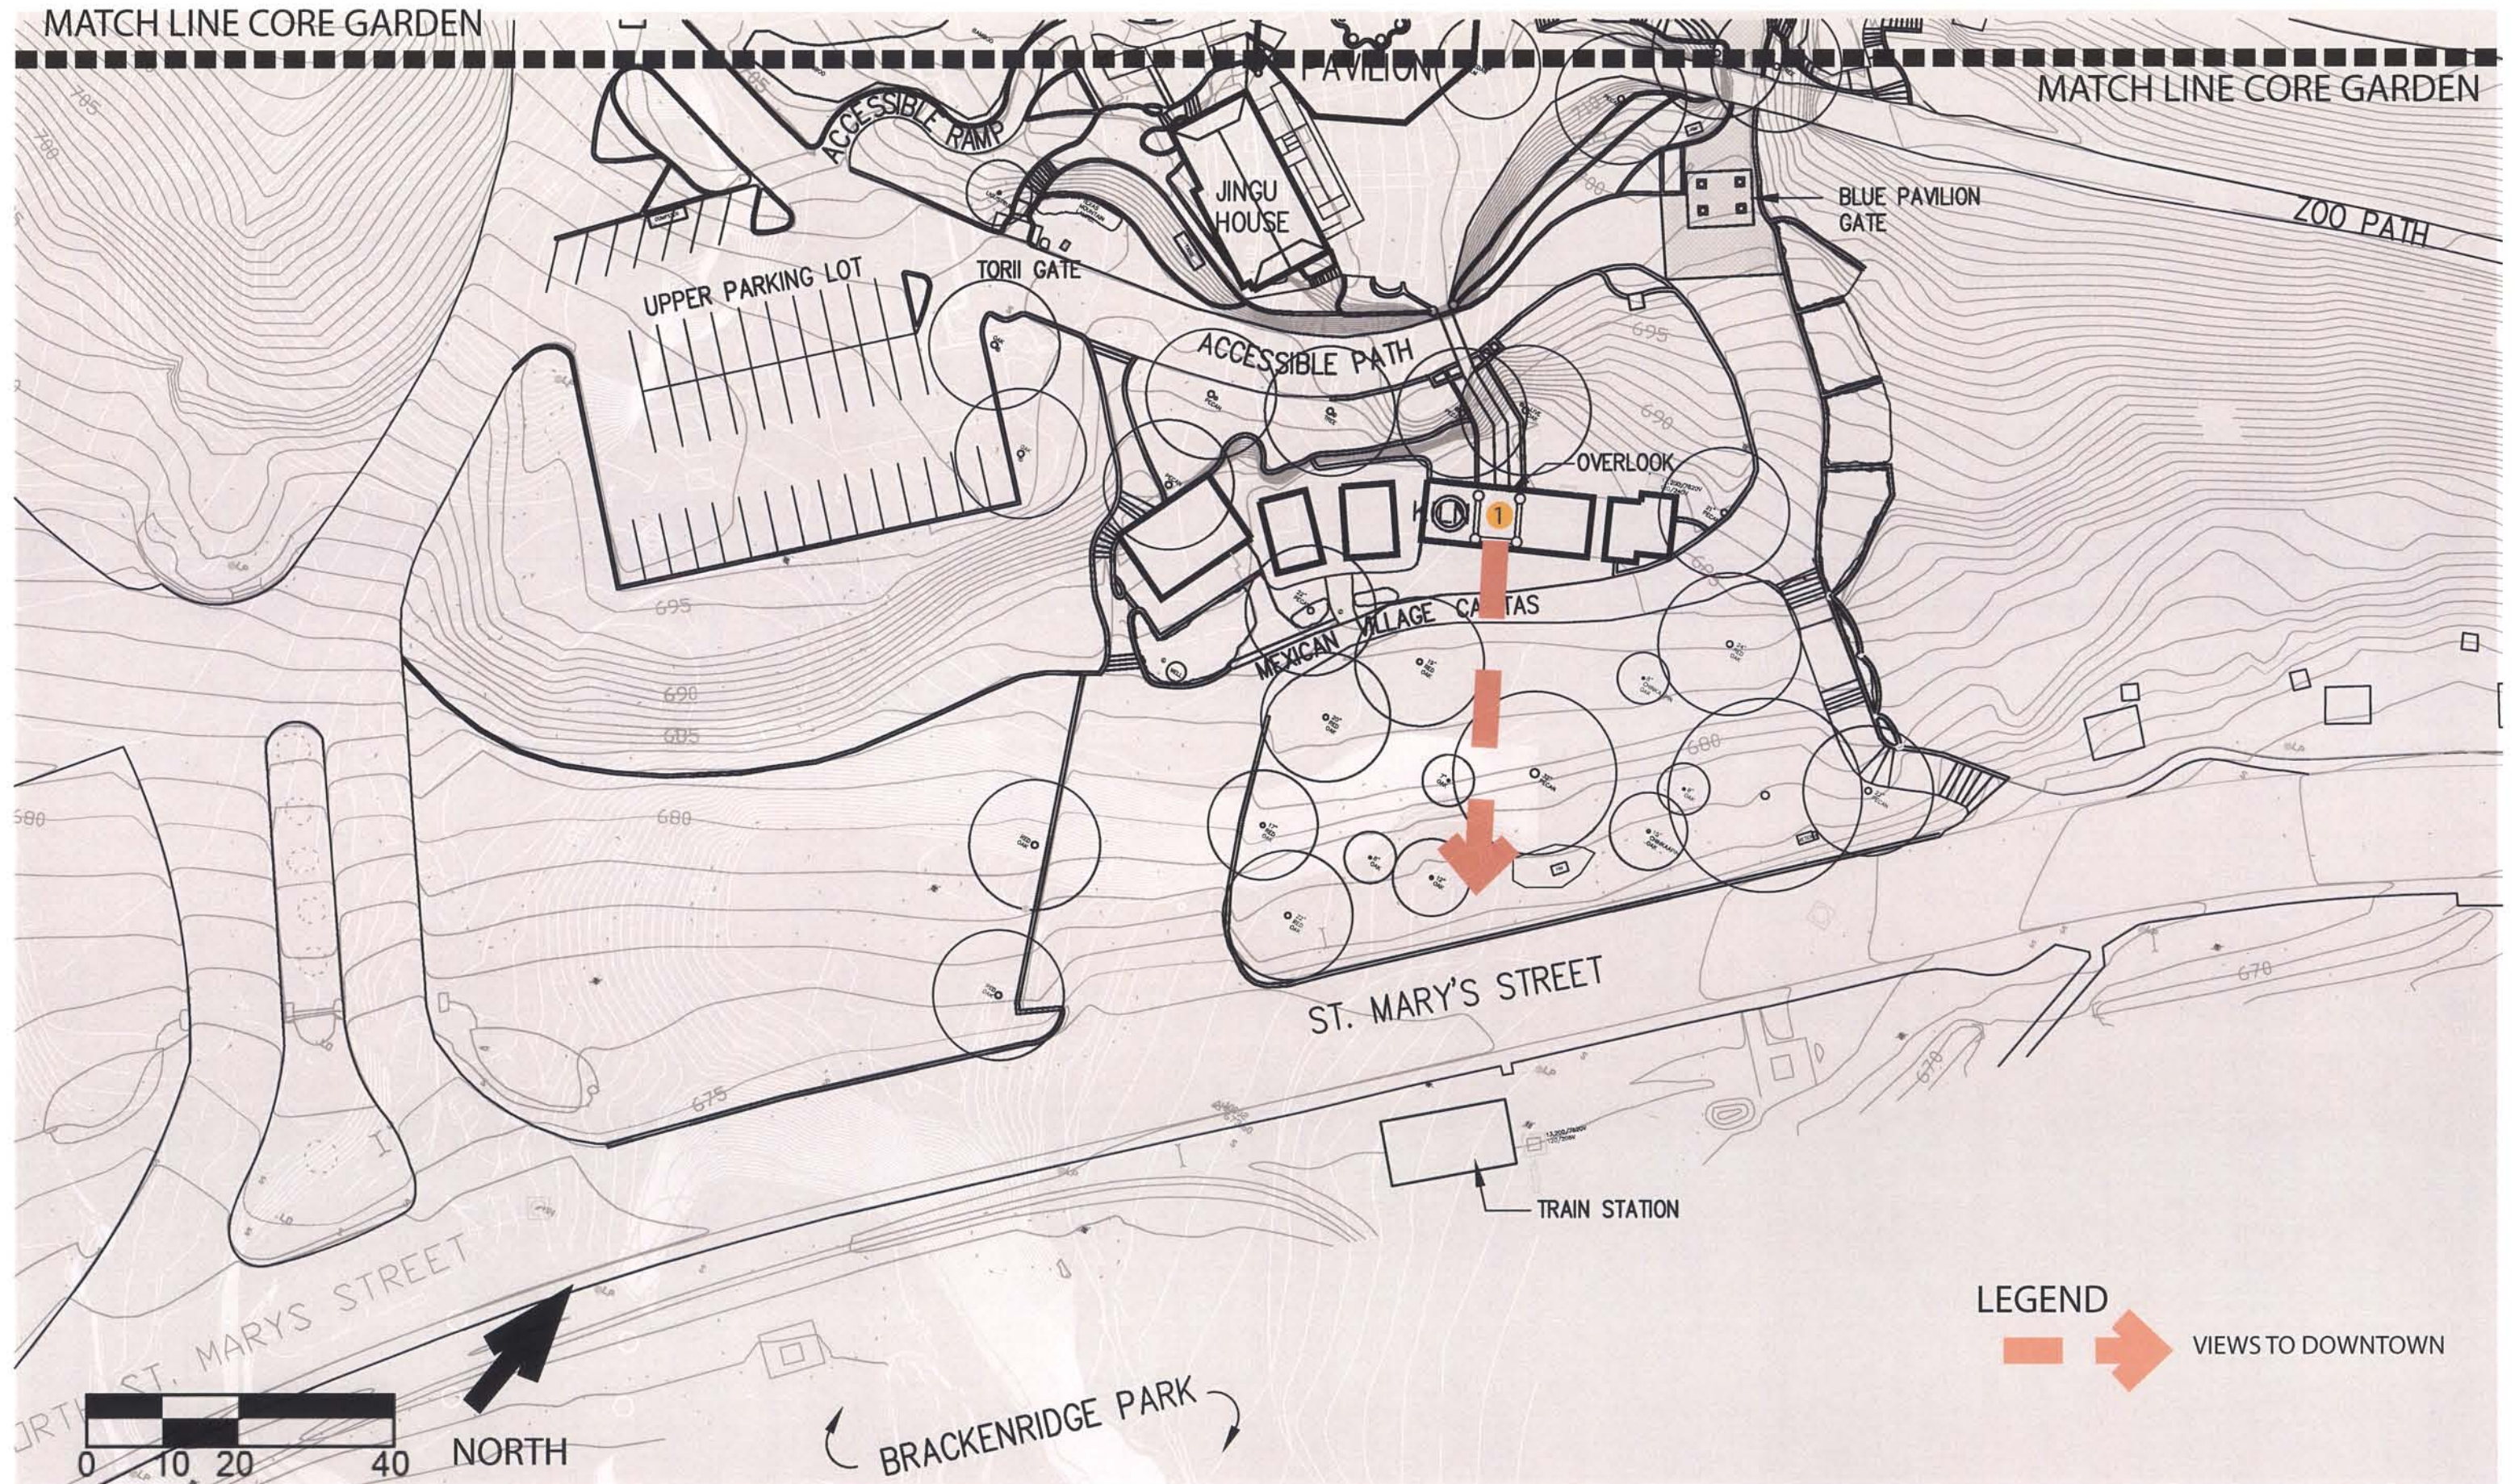
View from kiln overlook is blocked by canopy trees. If city views are desirable, the pecan and red oak in front of the casitas should be removed. The City of San Antonio does not generally support the removal of trees on the property. All trees to be removed should be evaluated for aesthetics, safety, health, etc. by various City staff, the consultants, and contractors involved in Master Plan implementation to determine the best for the facility. The consultants, and contractors involved in Master Plan implementation to determine the best for the facility.

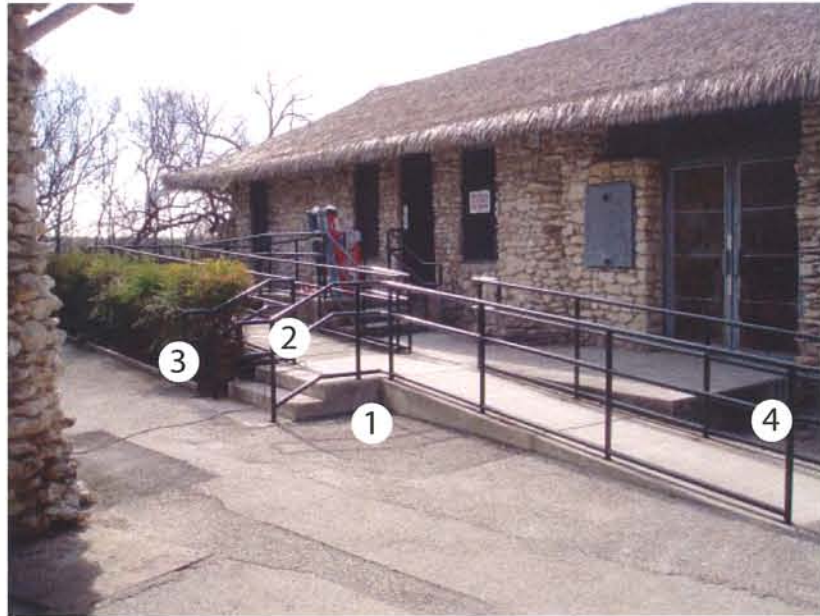
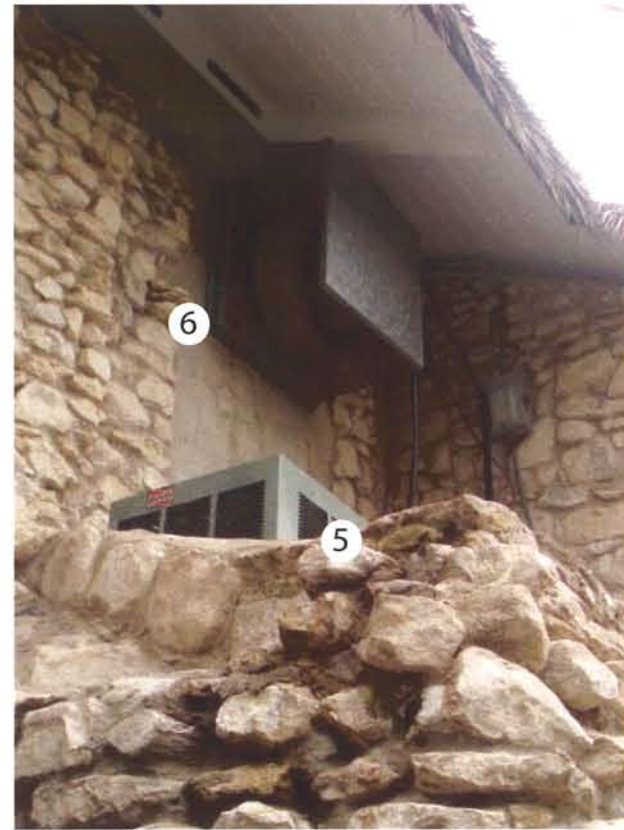
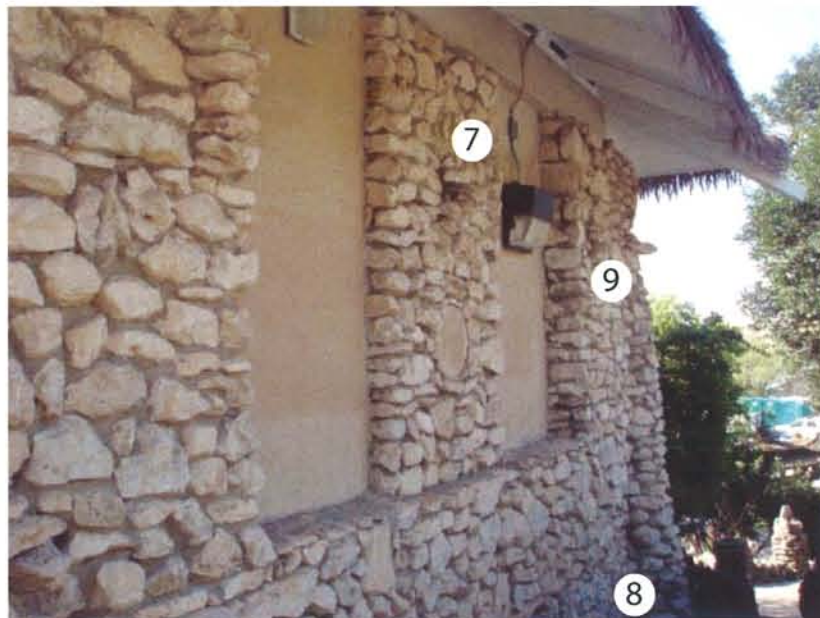
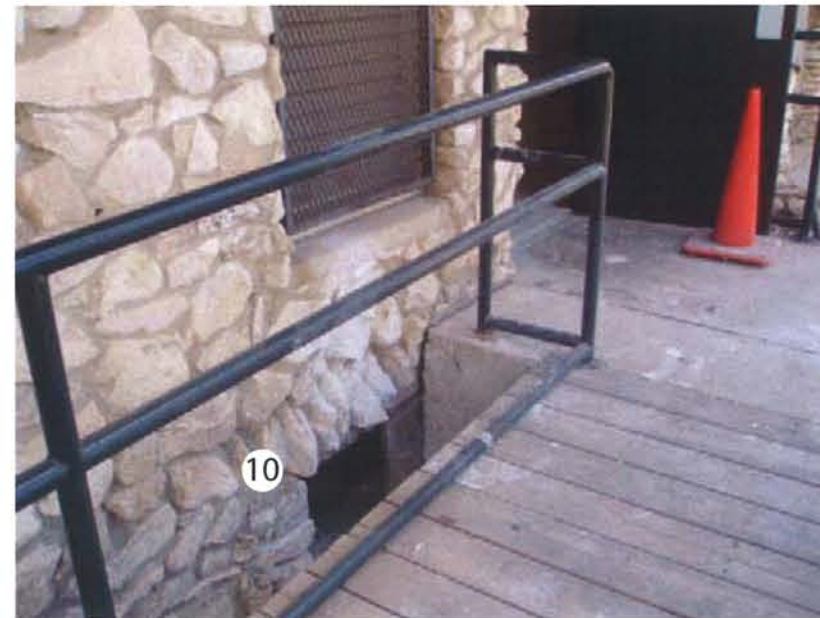
1. Accessible ramp detracts from original facade; does not meet current ADA standards. Remove and relocate ADA access.
2. Wood deck is deteriorating; nails are exposed, creeping up, typ. Remove deck and/or rebuild for necessary ADA access.
3. Open area beneath deck
4. Dropoff at landing = 10"-12"
5. New HVAC condensing unit; relocate or screen as appropriate.
6. Exposed HVAC lines; relocate or screen as appropriate.
7. Unsympathetic lighting, typ. Replace all fixtures with period appropriate placement and selections.
8. Stone masonry spalling off at corner; remove and replace deteriorating stone.
9. Infill/patched area
10. Lower transom windows are covered by concrete/landing.

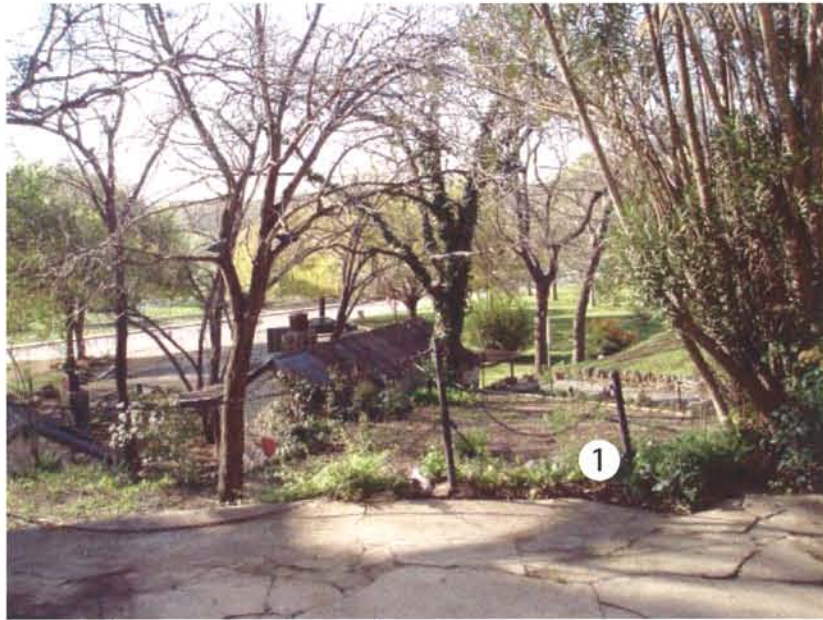
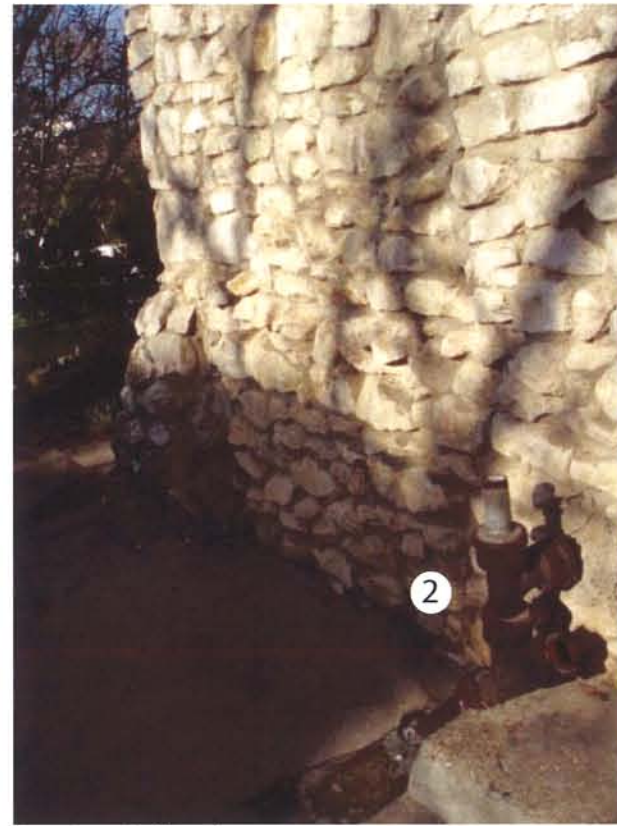
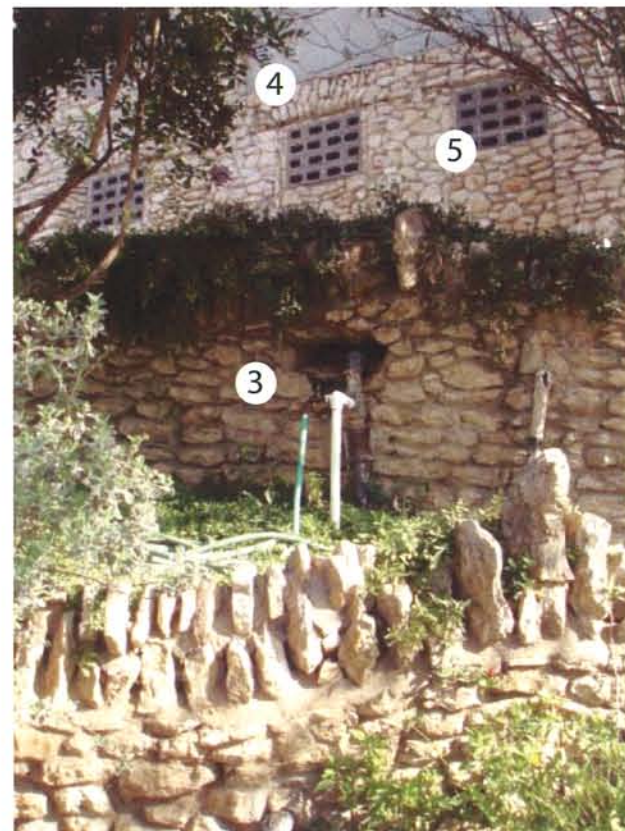
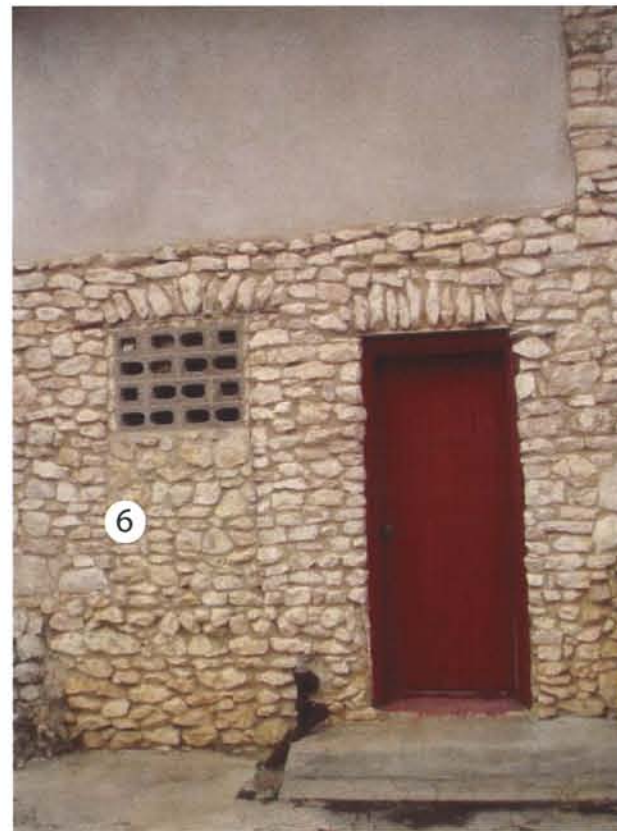
1. Railing at Southern walkway is in disrepair, presents unsafe condition. Replace railing or restrict public access to the area.
2. Exposed cleanout at rear door, walkway
3. Hose bibs/plumbing have damaged retaining walls. Repair landscape walls as necessary for stabilization and screen hose bibs.
4. Exposed wood at stucco sill; remove exposed wood at all locations and replace with stone cap or other period sensitive treatment.
5. CMU infill vents; remove (typical at all locations) and replace with period sensitive window treatment.
6. Stone infill below CMU vents, typ. Remove and replace with period sensitive window treatment.

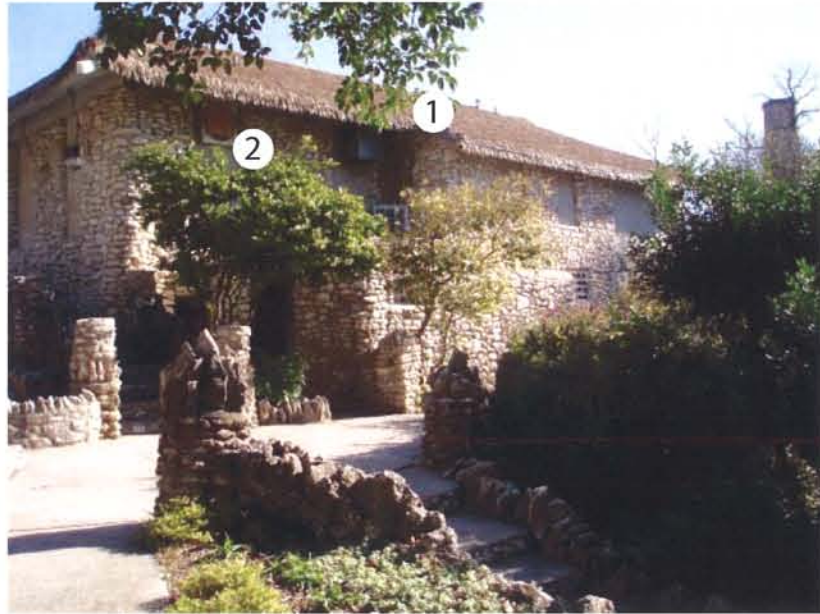
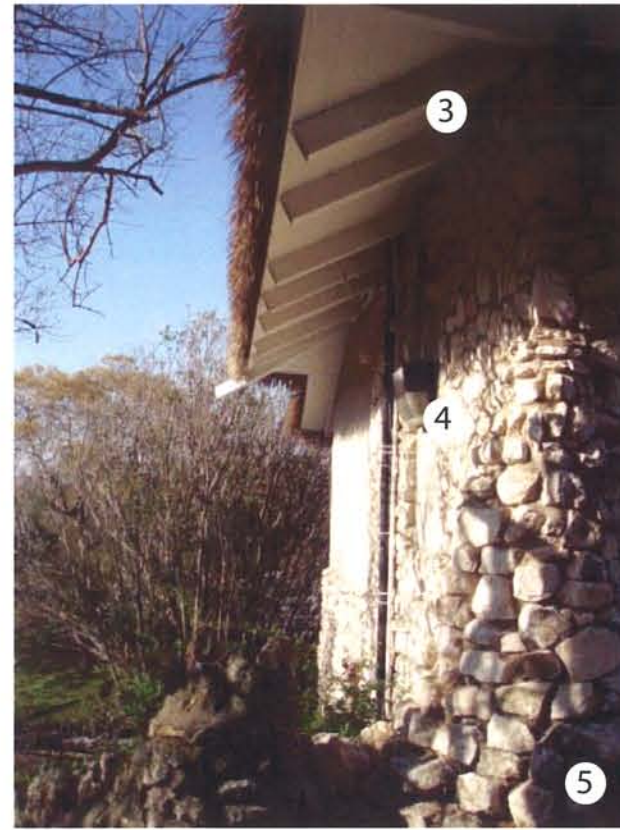
1. New (synthetic) thatched roof
2. Kitchen exhaust fans; remove or screen as appropriate for future use.
3. Roof structure and decking repaired/repainted
4. Unsympathetic lighting, typ. Replace all fixtures with period appropriate placement and selections.
5. Continuous 1/4" crack from infill wall to grade. Repoint mortar as necessary for stabilization.

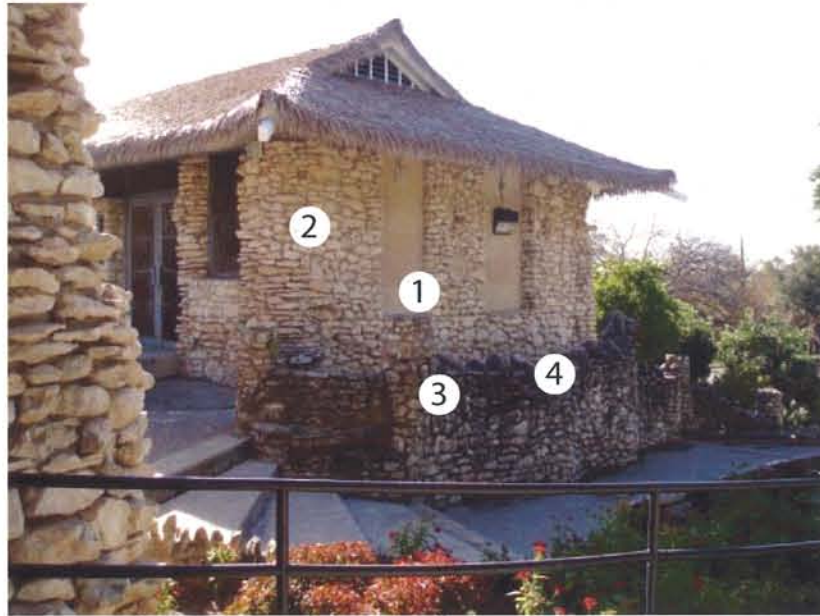
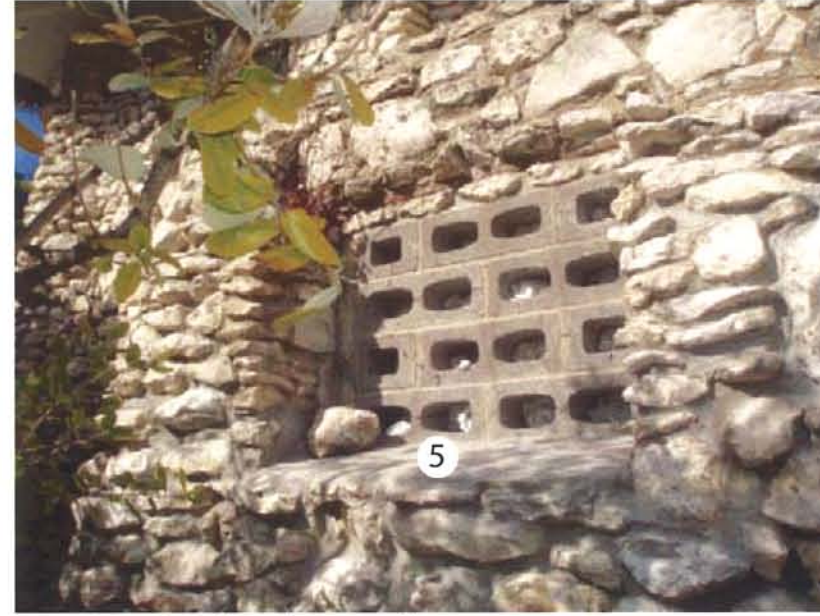
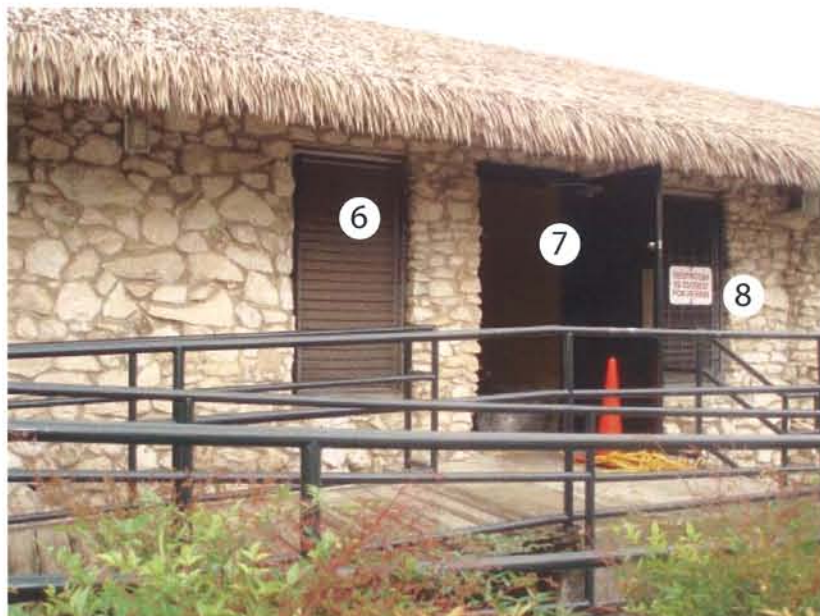
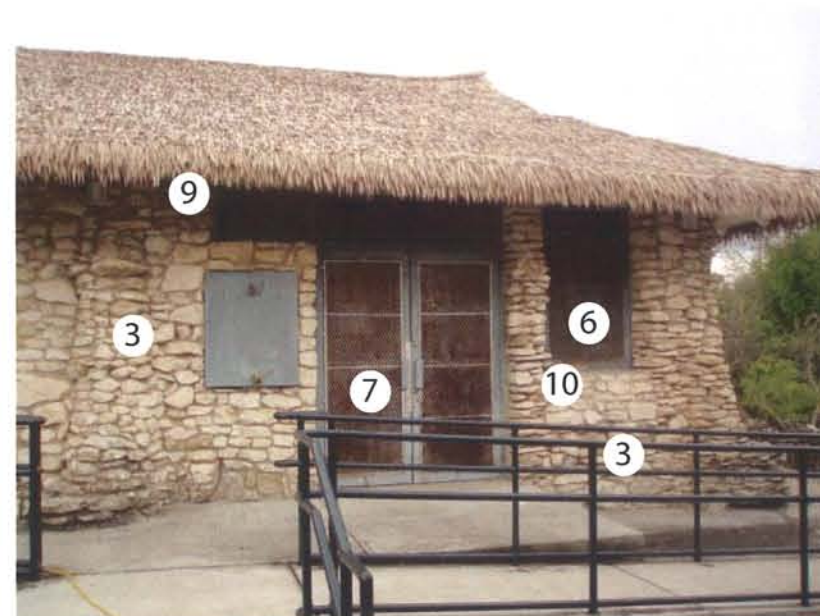
1. Stucco infill at windows; remove and replace with period sensitive window treatment.
2. Stone masonry repair area
3. Continuous vertical crack; repoint mortar as necessary.
4. Continuous horizontal crack at 2nd floor line; 3" gap at steps; assess for structural stability and repair as necessary.
5. CMU infill, typ. Remove and replace with period sensitive window treatment.
6. Security screens at windows, & transoms unsympathetic, typ. Remove and replace with period sensitive window treatment.
7. Doors and screens unsympathetic, typ. Remove and replace.
8. Stone infill does not match style of original masonry. Remove unsympathetic stone and rebuild in original style.
9. Top of stone wall deteriorated along eave line. Remove unsympathetic stone and rebuild in original style.
10. Unsympathetic stone infill below window; Remove unsympathetic stone and rebuild in original style.

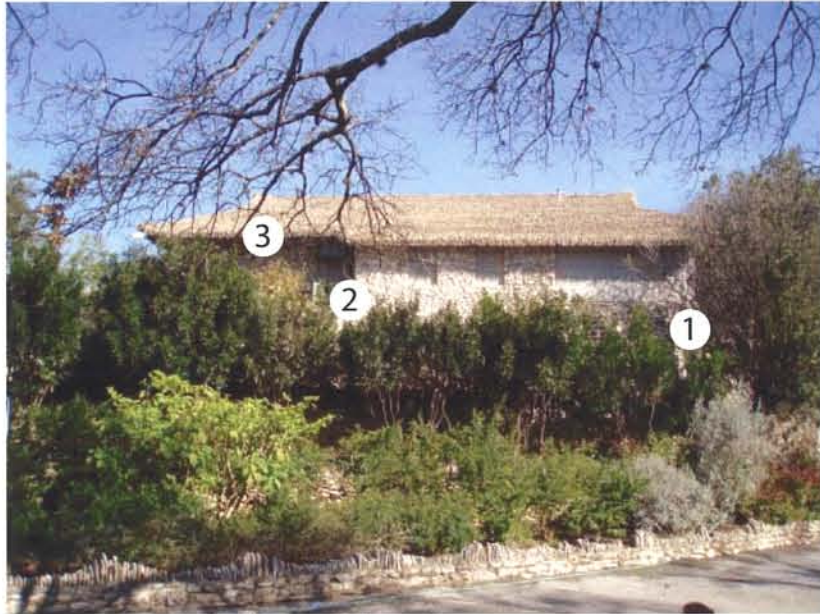
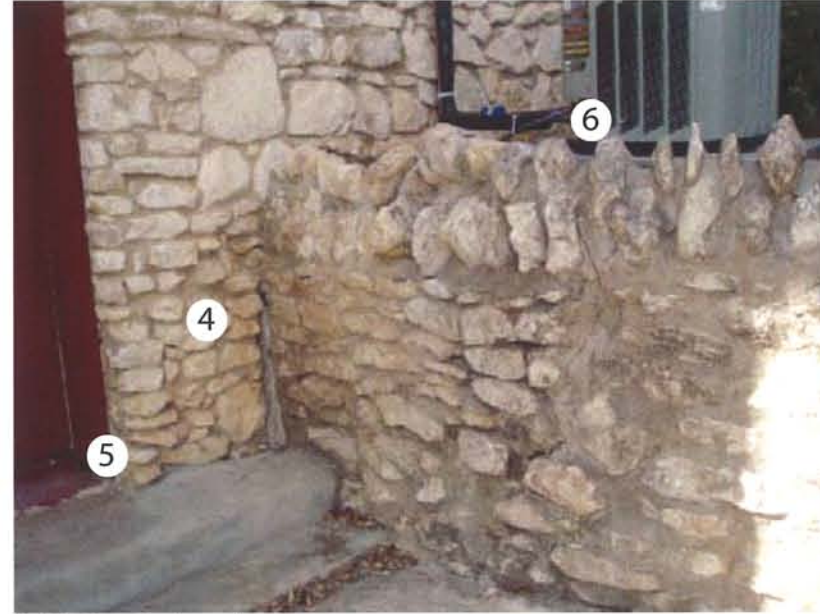
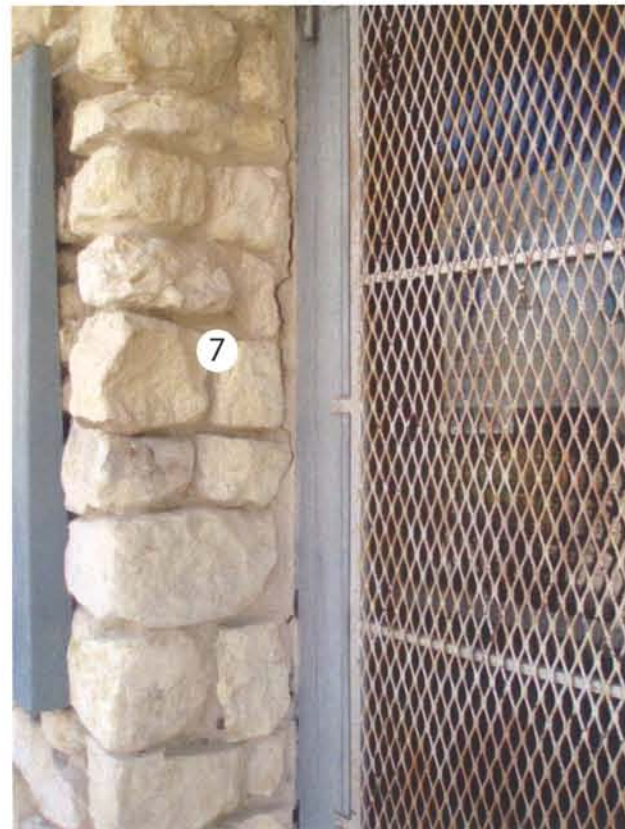
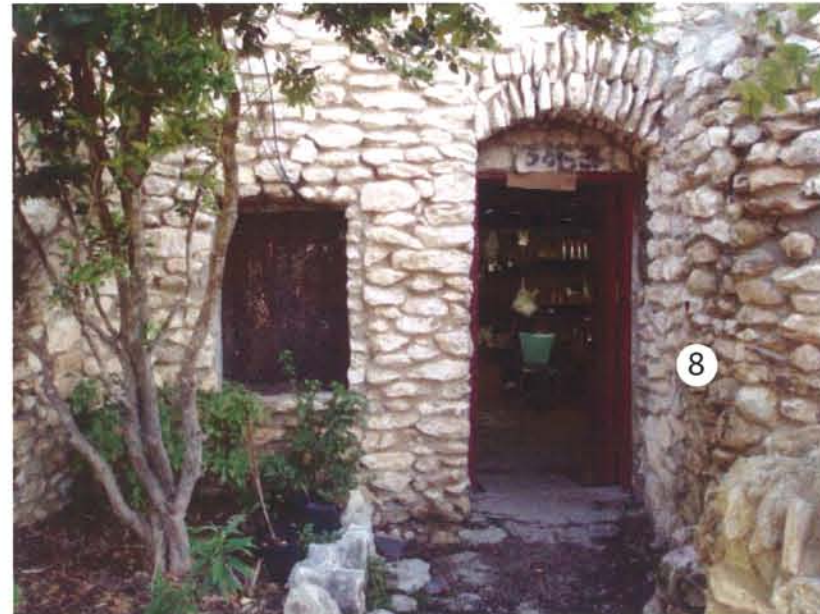
A15- West facade from road

A16- South facade at rear entrance

A17- East facade at concession stand

A18- West facade at main entrance

1. Stucco panel infill at screen porch and window locations; remove and replace with period sensitive window treatment.
2. Remove, relocate, or screen exposed HVAC equipment.
3. Relocate overhead telephone lines (to underground.)
4. Stone masonry in disrepair; repair/repoint as necessary, typ. Exposed wood several locations, typ.
5. Wood door deteriorated, screen door missing. Remove and replace with period door.
6. Restroom HVAC equipment; relocate or screen as necessary.
7. Mortar cracked at screen door frames, typ. repoint mortar as necessary for stabilization.
8. Water damage, vertical crack at low stone masonry wall. Clean stone wall and repoint mortar.

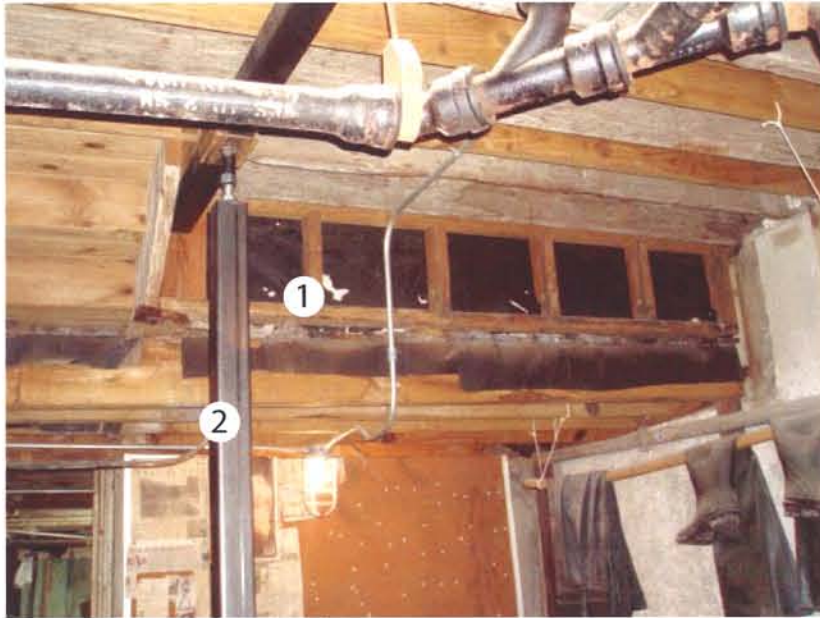
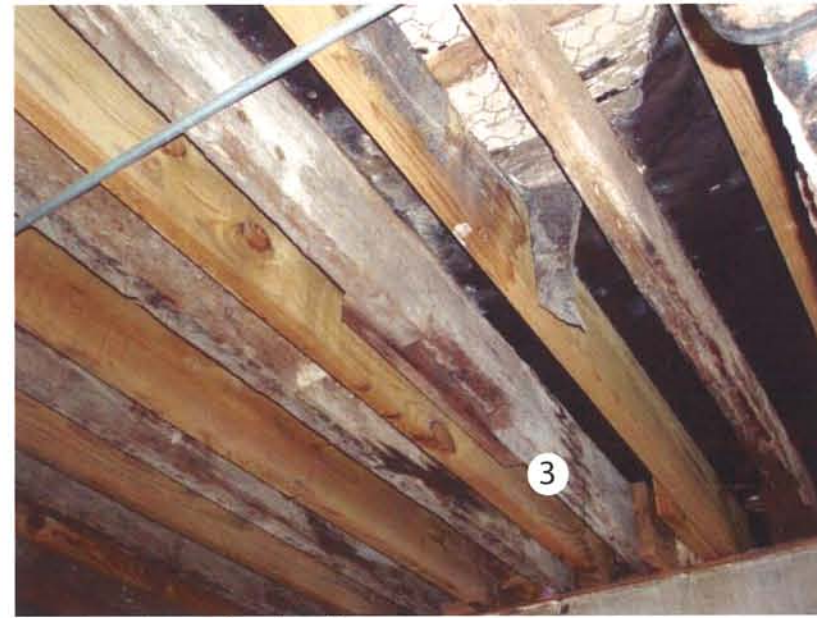
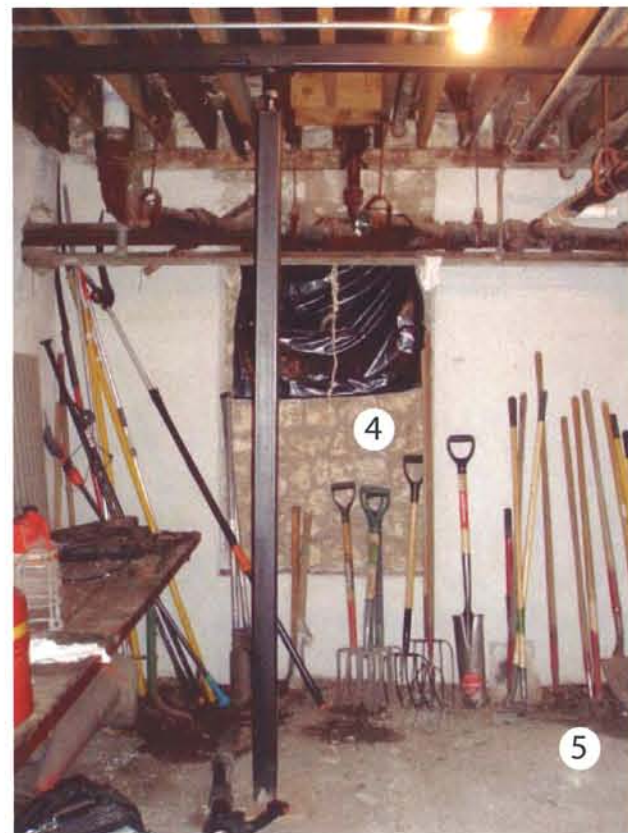
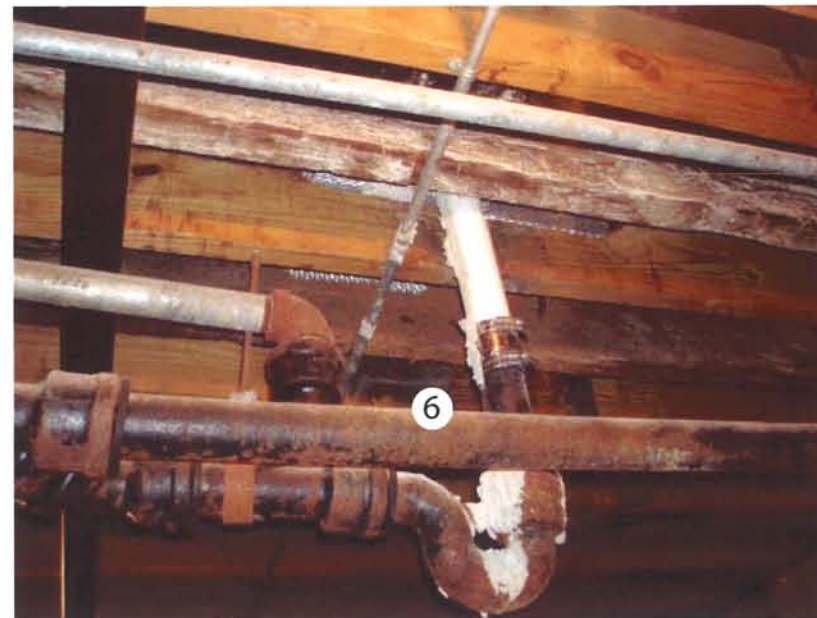
A19- Interior at first level

A20- Interior at first level

A21- Interior at first level

A22 Interior at first level

1. High-low ceiling condition at grade transition above (stairs from upper level are visible.)
2. New steel shoring supporting 2nd floor, typ. (Installed during restroom renovation; supported on concrete floor with wood blocking.) Future use to determine more appropriate structural reinforcement
3. Major water damage to 2nd floor structure throughout; remove and replace damaged structure
4. Window infill panels do not appear to be damproofed/waterproofed; remove infill and replace with period sensitive treatment
5. Concrete floor uneven and not level; appears to be infill without water barrier (sweating.) Relevel/rebuild floor as appropriate for future use
6. Exposed piping in poor condition, typ; clearance under pipes less than 7'-0" clear in some areas. Piping needs to be determined for future use and replaced/repared as necessary.
