Japanese Tea Garden Master Plan

Japanese Tea Garden
Master Plan
San Antonio, Texas

June 2007

SWA Group
Project Landscape Architect
Houston, Texas

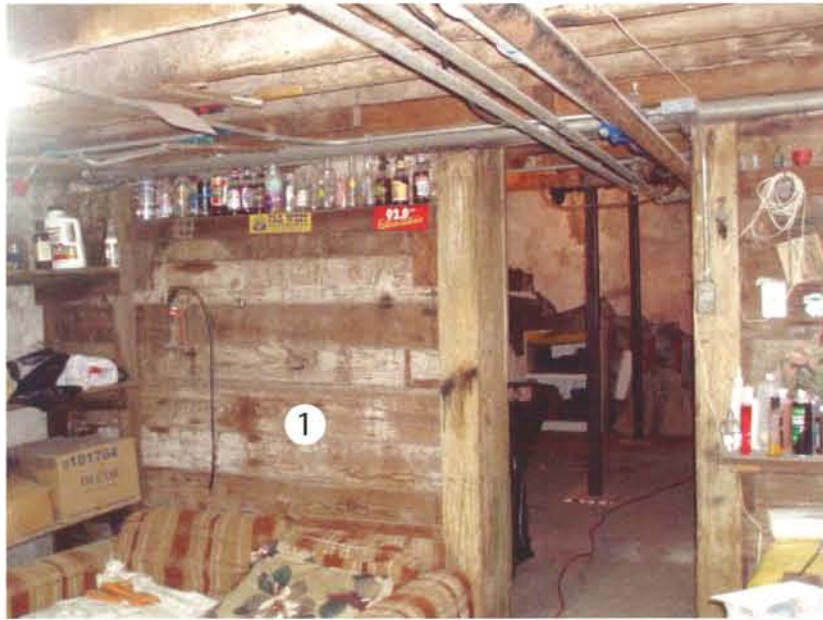
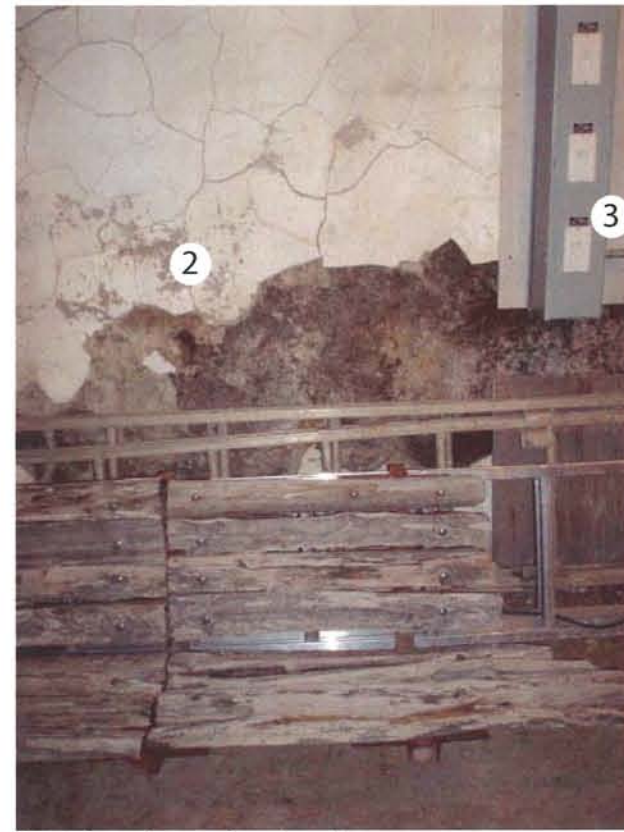
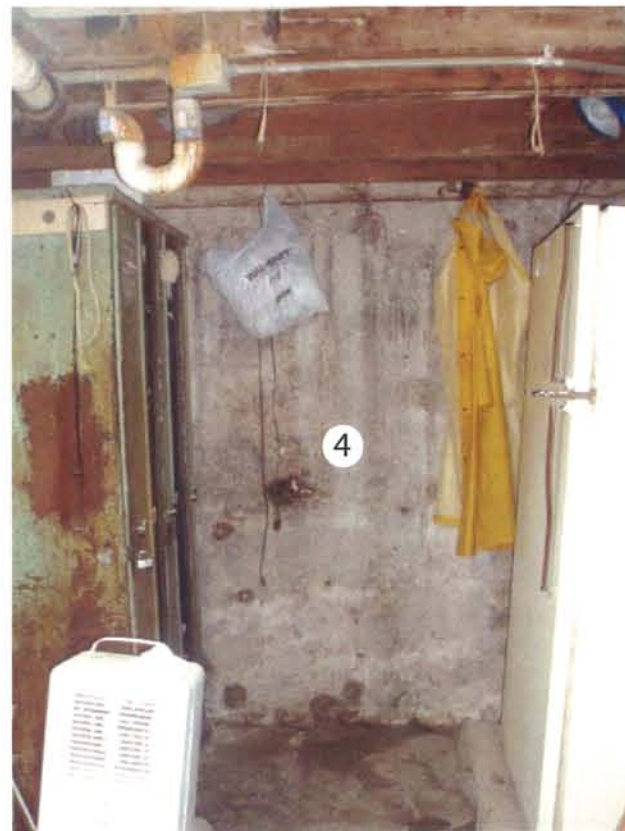
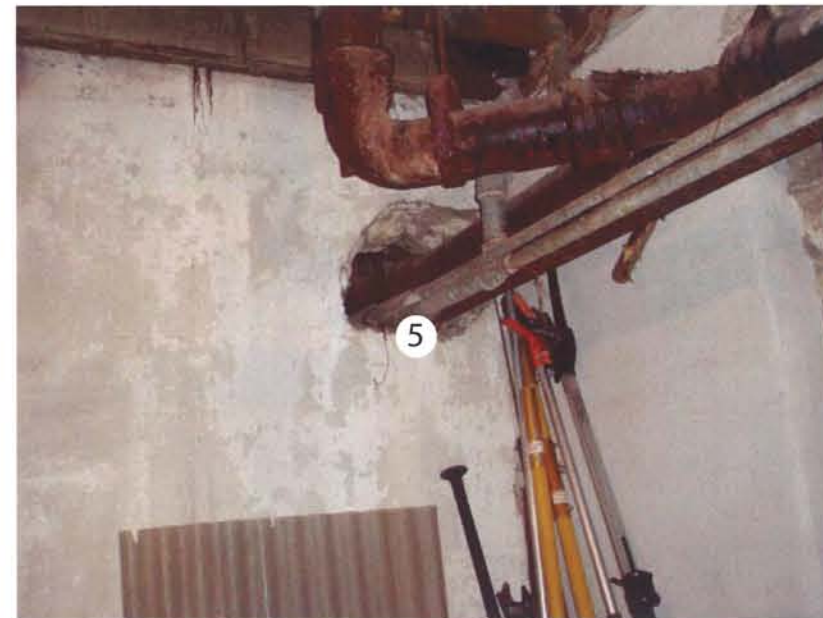
A23- Interior at first level

A24- Interior at first level

A25- Interior at first level

A26- Interior at first level

1. Wood batten walls deteriorated due to water damage. Future use of this level to determine level of preservation or non-historical repair (typ.)
2. Plaster walls are cracked, deteriorated, typ. Mold and water stains are present; does not appear to be waterproofed. Repair plaster, rebuild walls with adequate moisture barrier.
3. All electrical devices are exposed; some appear abandoned. Determine functional electrical service and remove nonfunctional equipment.
4. Mold/ mildew growth present at multiple locations; clean and remove mold and repair/rebuild walls as necessary.
5. Piping penetrations damaging walls. Determine needs for piping and remove or replace.

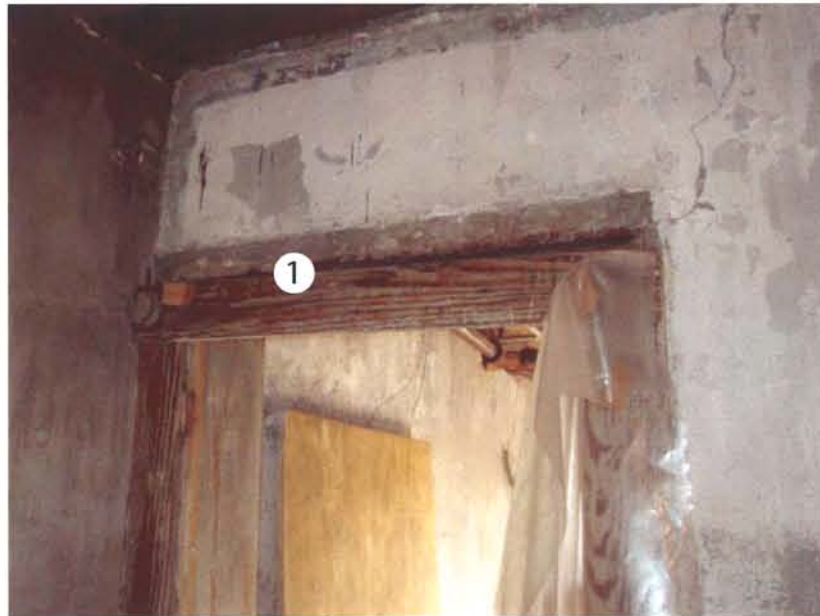
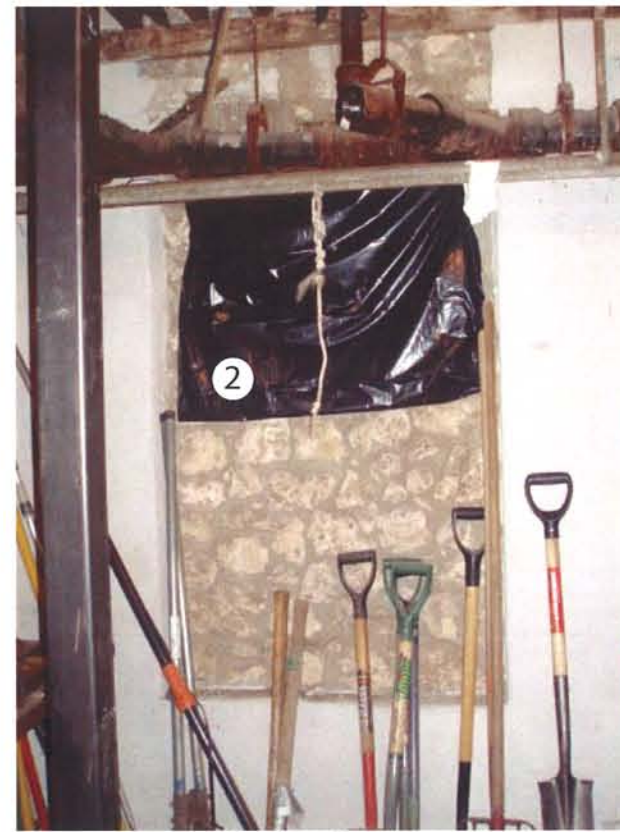
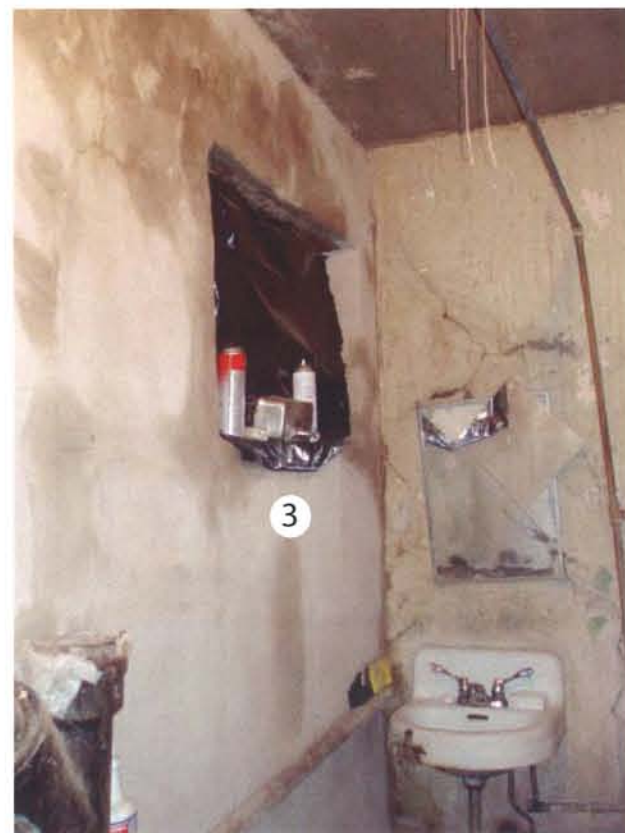
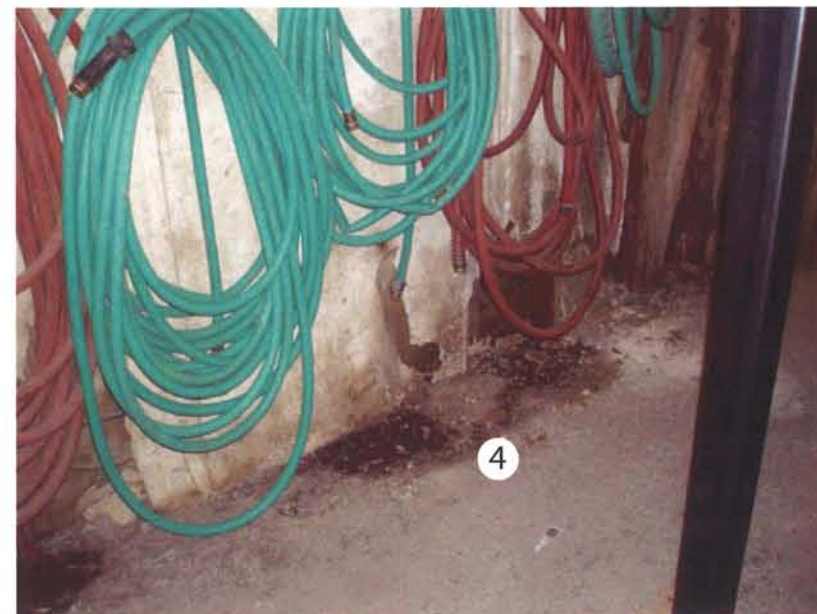
A27- Interior at first level

A28- Interior at first level

A29- Interior at first level

A30- Interior at first level

1. Door frames are deteriorated, wood rotted, typ. Remove and replace with period door.
2. Infill at window locations, typ; do not appear to be damproofed/ waterproofed; remove and replace with period sensitive window treatment.
3. New patch work at West exterior wall; future use to determine level of interior wall restoration necessary.
4. Water damage at floor, typ; floor uneven. Relevel/rebuild floor as appropriate for future use.

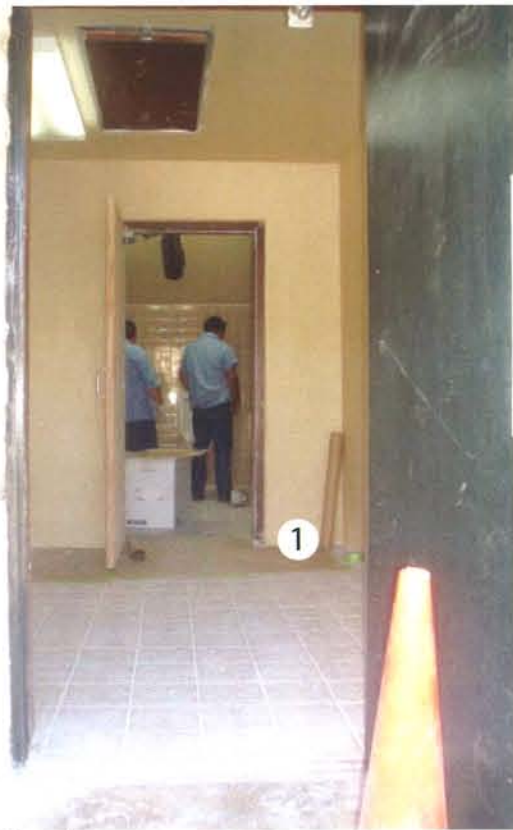
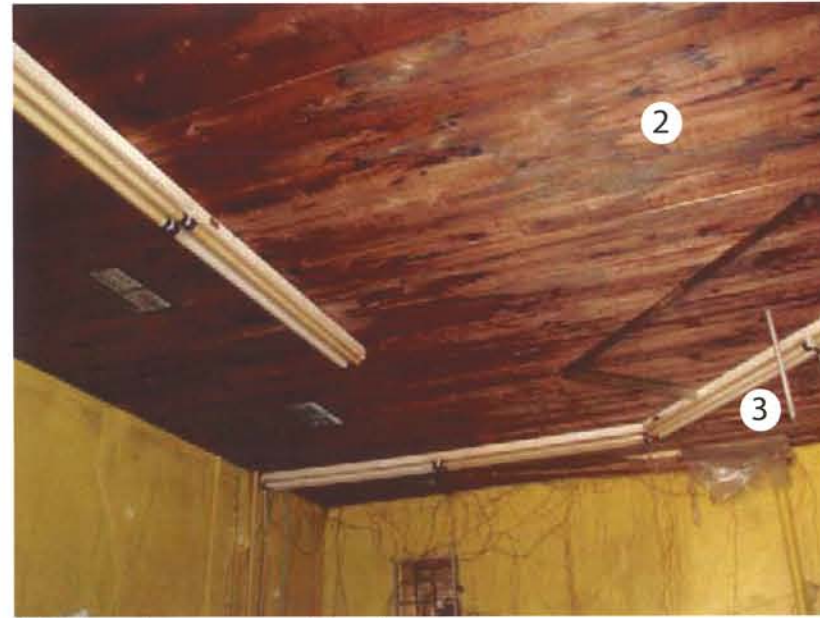
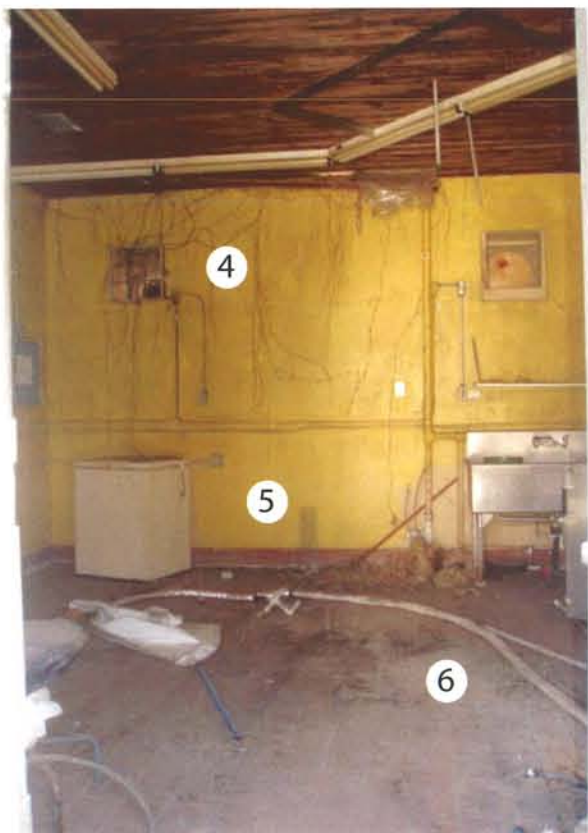
A31- Interior at second level

A32- Interior at second level

A33- Interior at second level

1. Current restroom renovations prohibit preservation of structure to original house plan. Future use will determine needs of this area.
2. Water damage evident at concession stand ceiling, typ. Remove and replace ceiling deck; further damage assesment will be necessary.
3. Light fixtures require bulb guards; electrical work not installed to workman-like standard. Remove and replace with fixtures suited to future use.
4. Vine growth spread to interior, damaging walls. Remove source of vine growth and repair walls as necessary.
5. Plumbing and electrical services exposed; some appear abandoned. Unable to determine if functional; determine future needs and repair or replace as necessary.
6. Water damage at quarry tile floor. Remove and replace with sympathetic flooring.

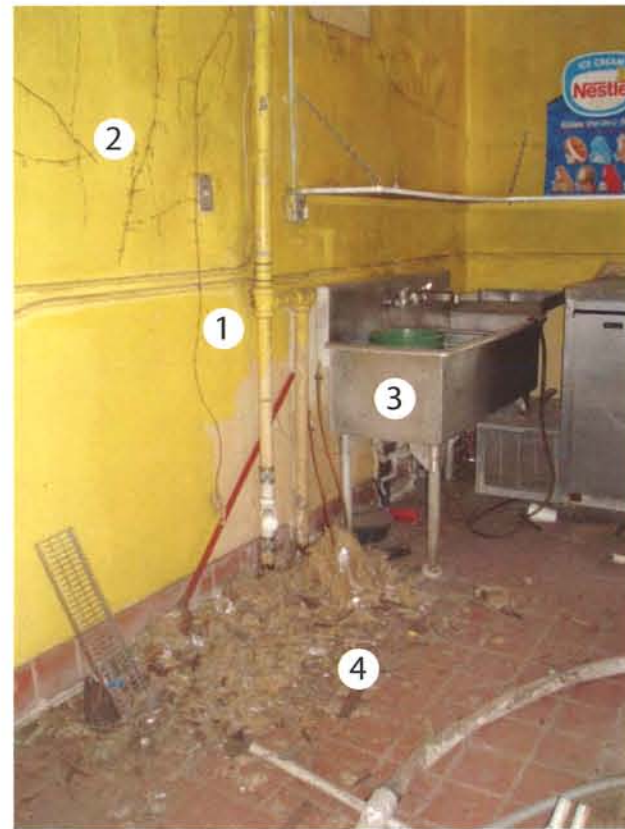
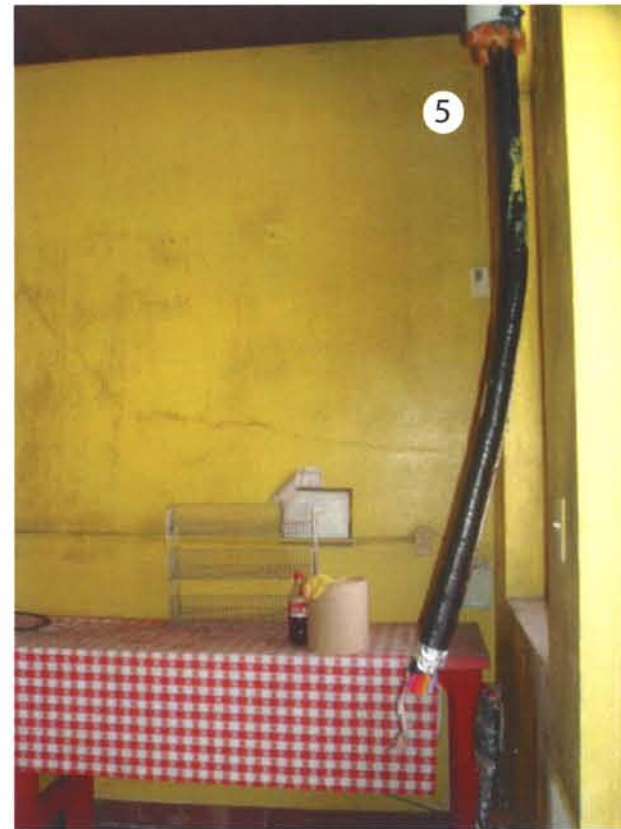
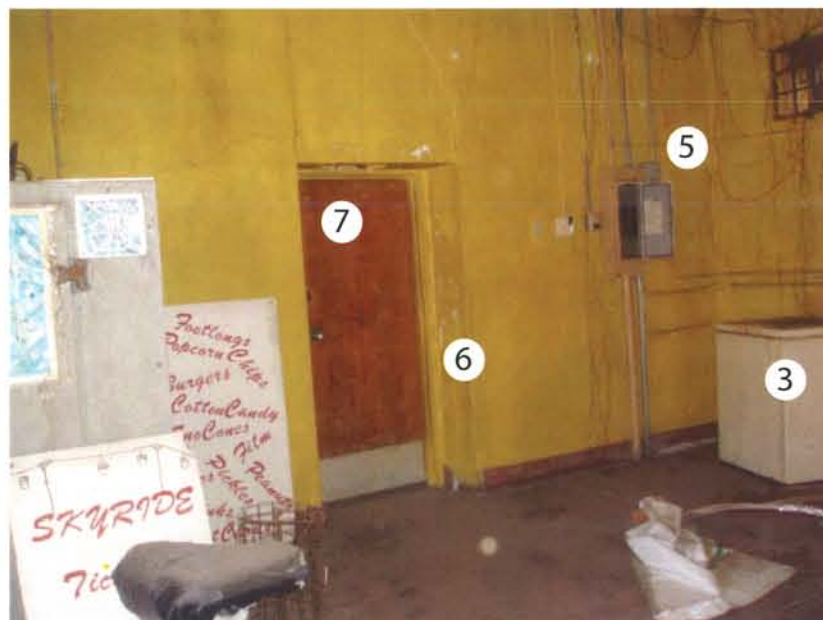
A34- Interior at second level

A35- Interior at second level

A36- Interior at second level

1. Exposed pipe, conduit at interior, typ; insulation in poor or nonexistent condition. Determine needs for future use and repair or replace as necessary.
2. Vine growth on walls; remove source of vine growth and repair walls as necessary.
3. Miscellaneous abandoned kitchen equipment; remove
4. Concession stand in disrepair. Determine needs for future use; remove and discard materials and clean area.
5. Exposed electrical & HVAC lines appear to be disconnected; HVAC condensing unit located on West side of building. Determine needs for future use and remove or replace equipment, conduit, etc.
6. Original walls are in need of repair and restoration.
7. Door does not appear to be original, although location likely is. Remove and replace with period door.

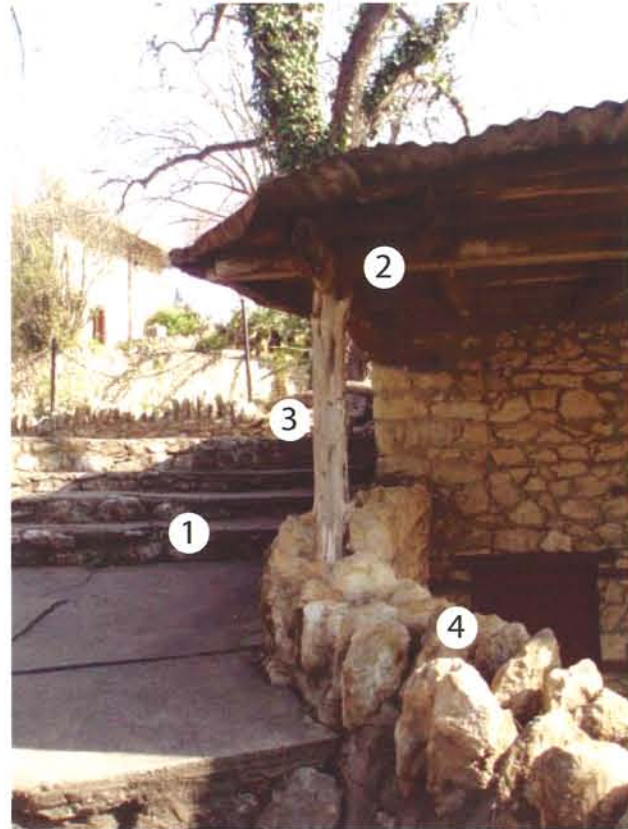
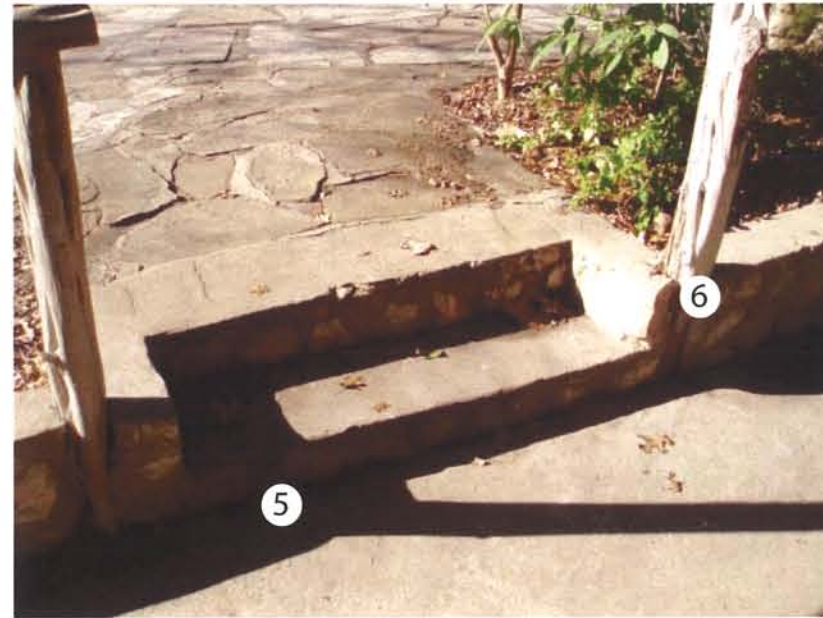
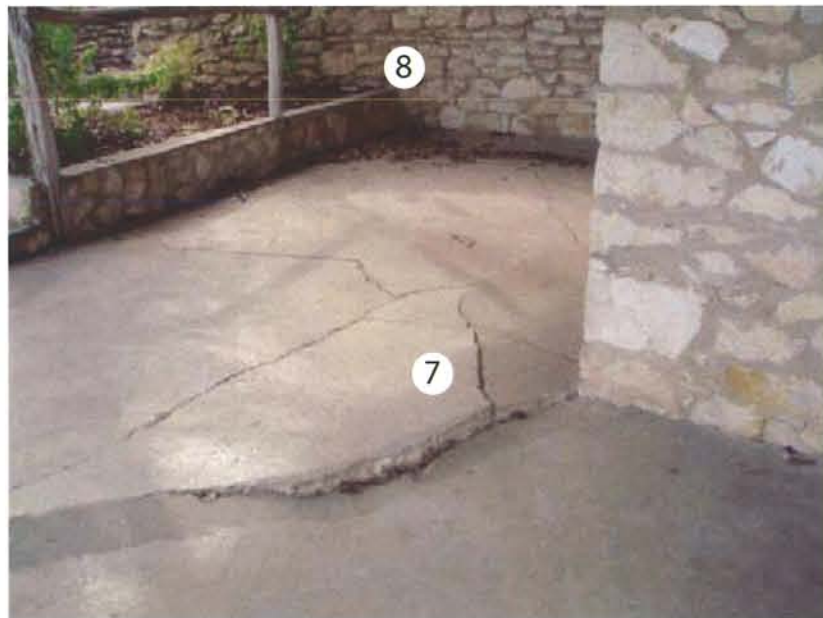
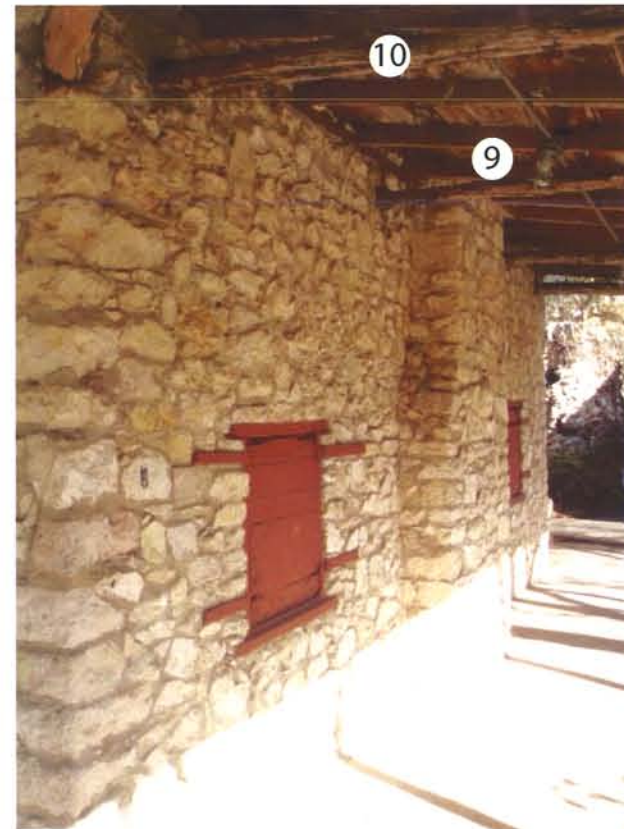
B1- Stairs at Northwest corner

B2- Stairs onto porch at West side

B3- Porch floor at Southwest corner

B4- South facade

1. Edge of steps from Jingu House in disrepair, present unsafe condition
2. Porch roof plane overhangs stairs; does not meet ADA clearance requirements.
3. No handrail at stairs; Install/repair period sensitive railing where needed.
4. Retaining wall showing cracks, instability. Repair and repoint mortar as necessary.
5. Entry from main path is inaccessible. Incorporate overall accessible path to Historic Mexican Village.
6. Wood railing showing water rot; replace damaged railing and repair.
7. Concrete porch floor sheared, presents unsafe condition. Relevel floor for safety and watershed.
8. Vertical crack at retaining wall; repair and repoint mortar as necessary.
9. Exposed conduit, light fixture; remove and replace with sympathetic fixture or install concealed security lighting only.
10. Insect damage at porch roof; repair or replace damaged boards.

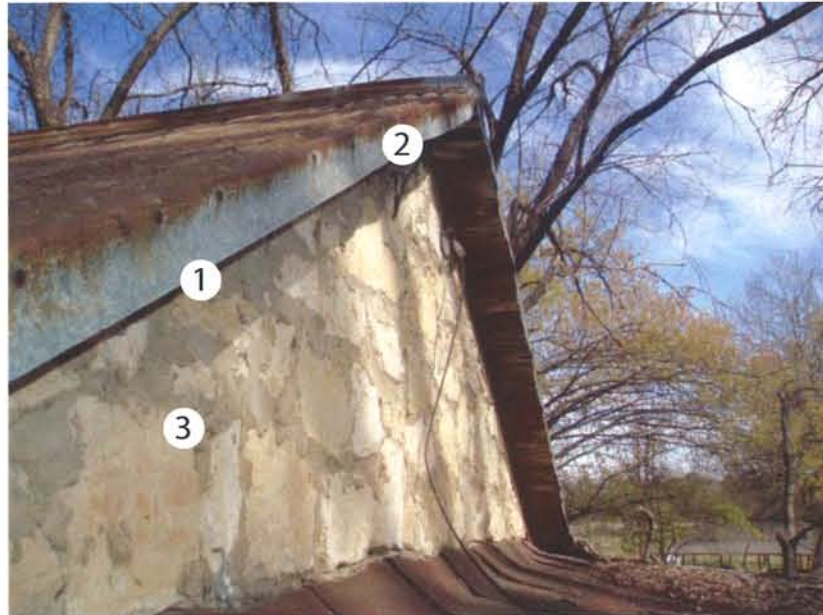
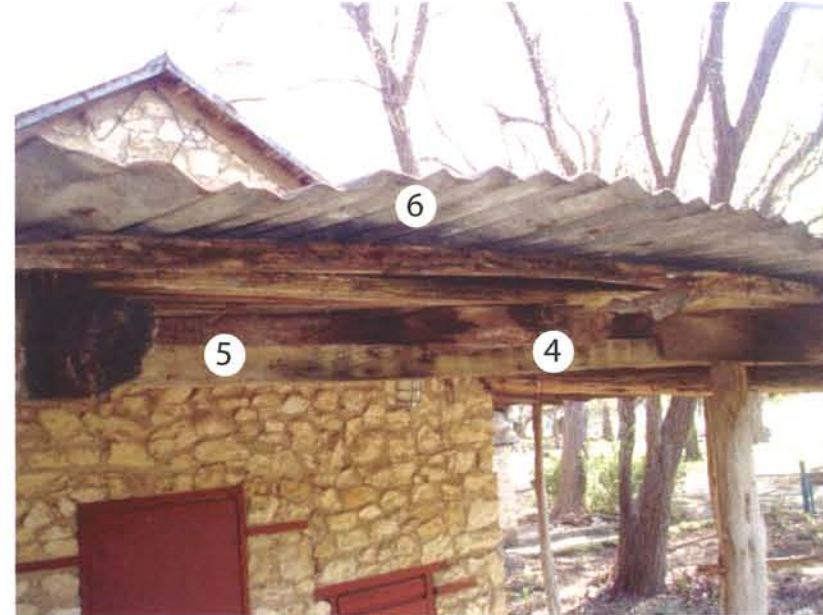
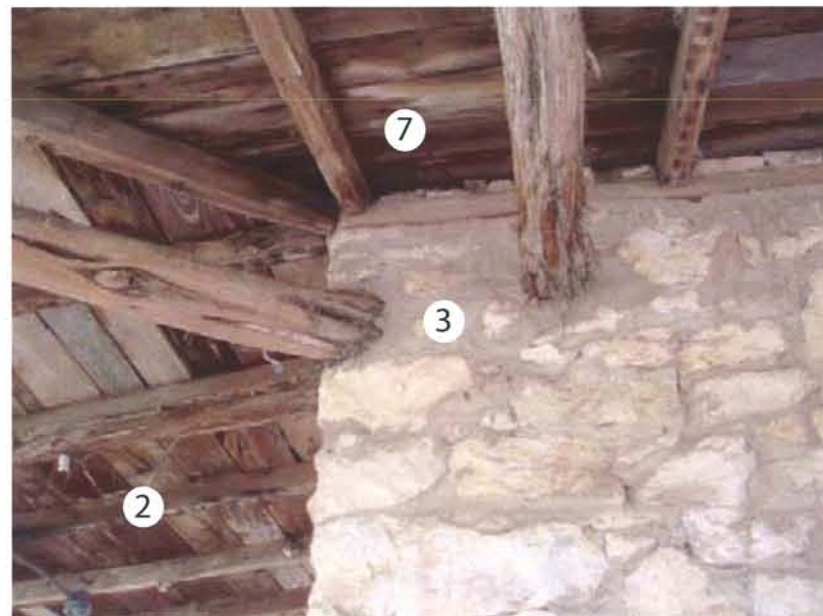
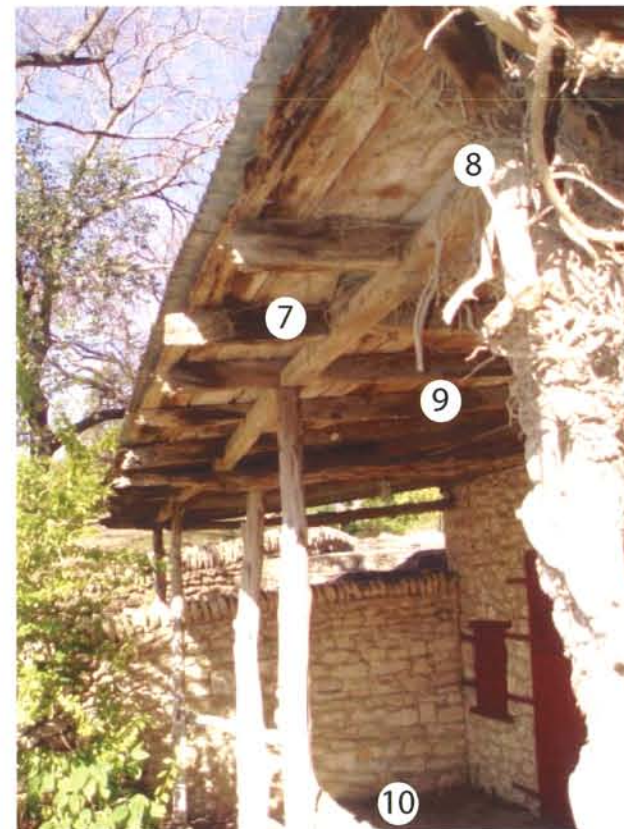
B5- Roof at West facade

B6- Roof at West facade

B7- Porch roof at Southwest corner

B8- Porch roof at Southwest corner

1. Corrugated roof deteriorated, typ. Remove, repair structure, and replace with period sensitive roof.
2. Exposed wiring; remove all nonfunctional wiring and devices.

3. Area of apparant mortar repair/patching. Remove and replace with period sensitive mortar repair.
4. Wood trellis structure deteriorated & showing water damage, typ. Remove and repair structure, and decking.

5. Nails exposed where rot has ocured; repair or replace structure.
6. Corrugated roof buckling; remove, repair structure, and replace with period sensitive roof.

7. Wood decking deteriorated & showing water damage, typ. Repair or replace damaged boards.
8. Trellis structure overrun with dead plant growth, typ. Remove source of growth and repair or replace damaged structure.

9. Insect damage at porch roof; repair or replace damaged boards.
10. Wood railing in disrepair, missing some locations. Install/repair period sensitive railing where needed.

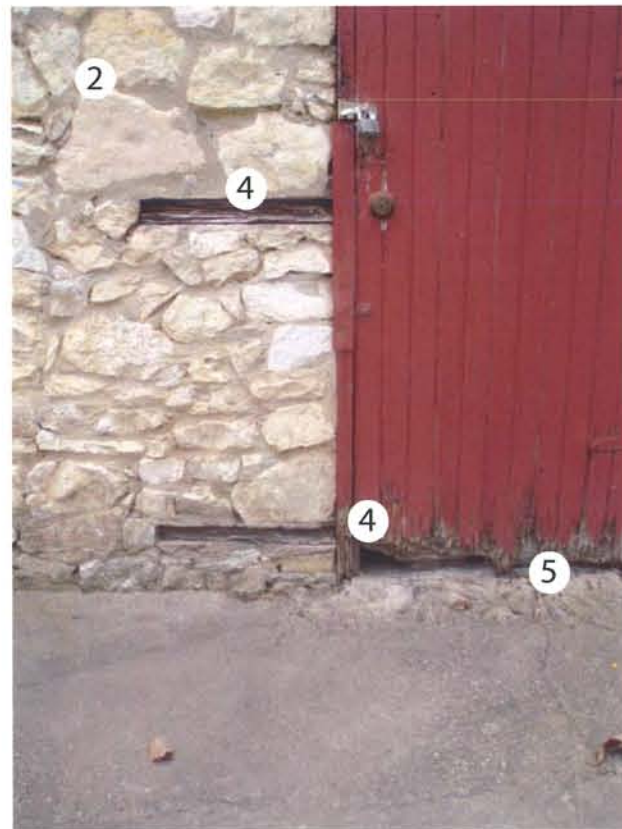
B11- Rear door at East facade

1. Stone masonry spalling off at building base; remove and replace deteriorating stone.
2. Area of apparant mortar repair/patching; remove and replace with period sensitive mortar repair.
3. Continuous vertical crack around opening; assess structural stability and repair/repoint mortar as necessary.
4. Exposed wood deteriorating; replace where necessary; determine suitability for future use.
5. Major water damage at door threshold; remove deteriorated wood and replace with period door.
6. Water damage to chimney where exposed. Chimney cap deteriorated; repair and clean stone; repair and repoint mortar where necessary. Determine suitability for fireplace use for future needs.
7. Corrugated roof deteriorated, buckling. Remove, repair structure, and replace with period sensitive roof.

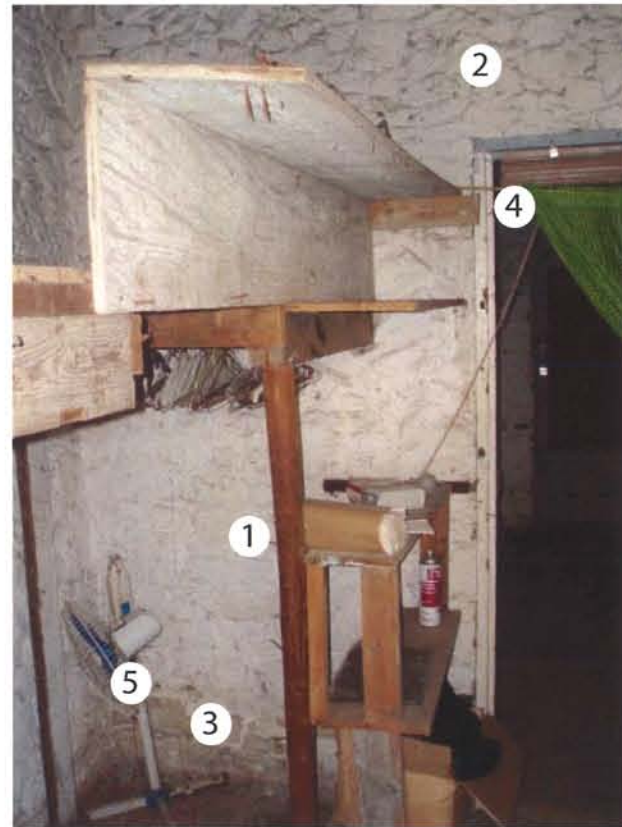
B13- Interior

1. Remove all built-ins
2. Stone masonry painted, typ.
3. Water damage to walls; deteriorating stone, typ. Determine future use and repair damage as necessary.
4. Wood door frames deteriorated; remove and replace with period door
5. Remove abandoned personal effects
6. Window infill unsympathetic; remove and replace with period sensitive window treatment.
7. Exposed fiberglass batt insulation; remove and install insulation as appropriate for future use.
8. Exposed electrical conduit, fixtures; remove and replace with period sensitive fixtures and concealed conduit.

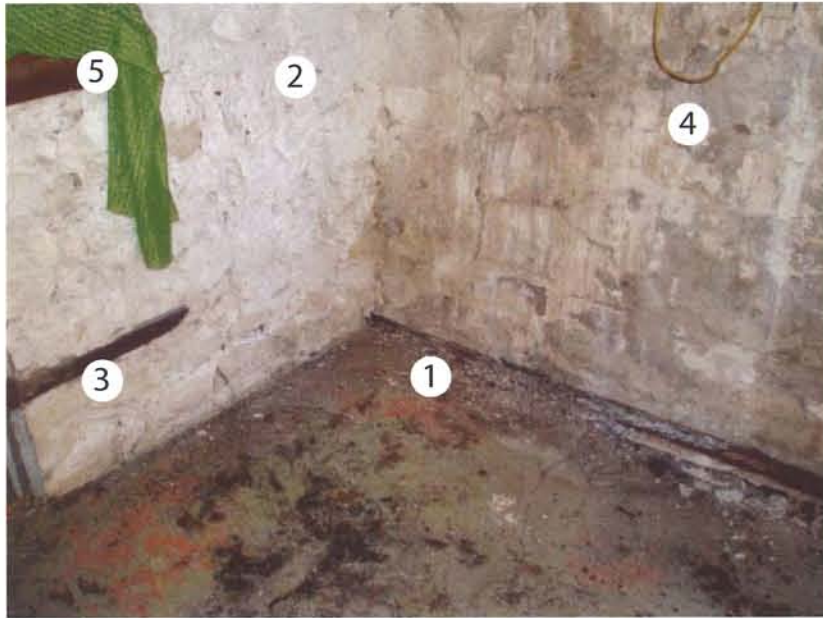
B17- Interior

1. Concrete floor in disrepair, typ. Repair, re-level, and clean as necessary for future use.
2. Stone masonry painted, typ.
3. Exposed wood deteriorating; remove and replace as necessary.
4. Water damage to walls, deteriorating stone, typ. Determine future use and repair damage as necessary.
5. Remove abandoned personal effects
6. Exposed electrical fixture; remove and replace with period sensitive fixtures and concealed conduit.
7. Mold growth on walls; Determine future use and repair damage as necessary.
8. Vertical crack from base of wall to corner; repair and repoint mortar as necessary.

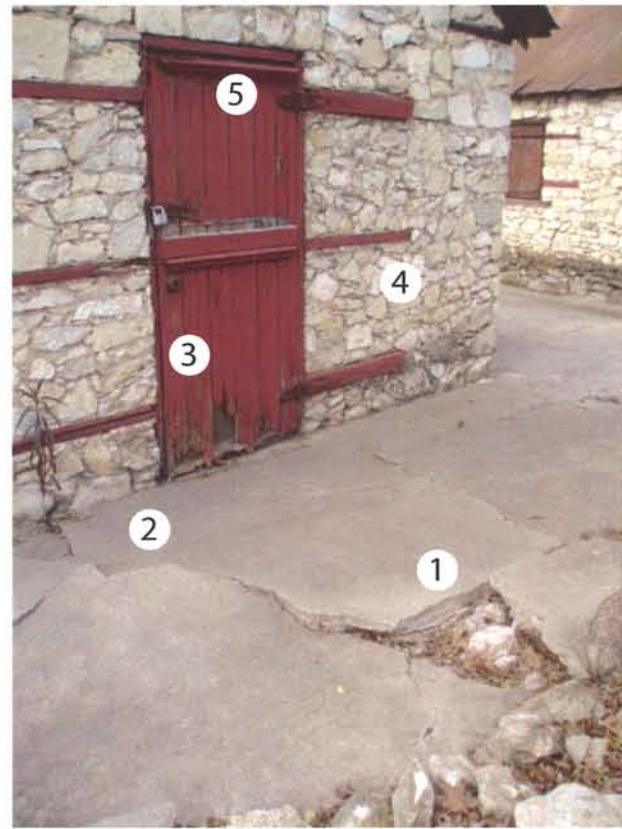
C1- Front entry at South facade

1. Concrete slab sheared, broken; path is inaccessible. Relevel floor and incorporate overall accessible path to Mexican Village.
2. Grade slopes in towards building, apparrant water damage. Regrade or repave concrete slab for watershed; clean and repair damaged stone.
3. Exposed wood deteriorating, typ. Replace where necessary.
4. Area of apparrant mortar repair/ patching; remove and replace with period sensitive mortar repair.
5. Door does not meet ADA clearance requirements.
6. Exposed /overhead electrical and telephone service; remove all nonfunctional wiring and devices.
7. Remove and replace deteriorated wood blocking.
8. Unsympathetic repair at window shutters; replace.
9. Curb presents unsafe or inaccessible condition.
10. Remove light fixture; replace with sympathetic fixture or install concealed security lighting only.
11. Brick pavers in disrepair; remove and repave area.

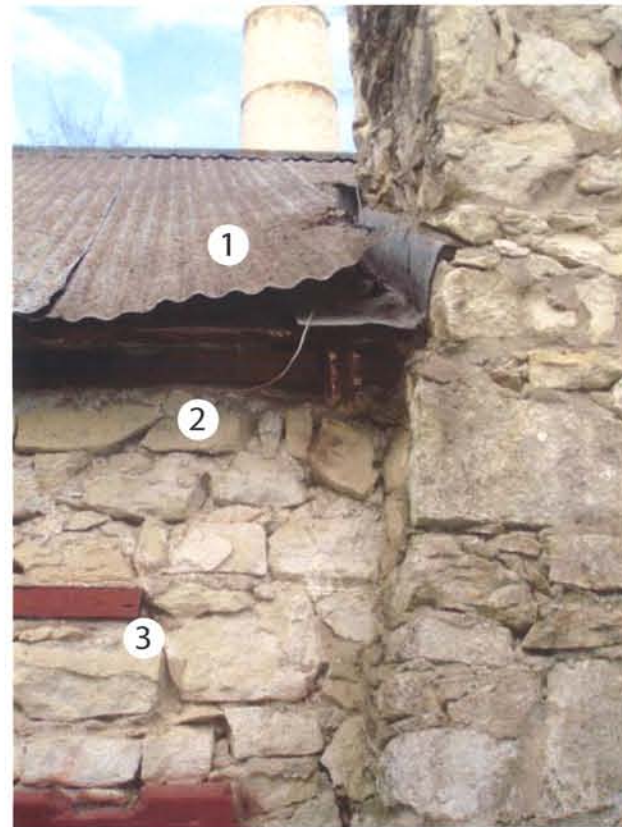
C5- West facade at chimney

1. Corrugated roof deteriorated, buckling, typ. Remove, repair structure, and replace with period sensitive roof.
2. Area of apparant mortar repair/patching; remove, repair structure, and replace with period sensitive roof.
3. Vertical crack; repair and repoint mortar as necessary.
4. Wood decking & roof structure deteriorated. Repair or replace structure.
5. Insulation penetrating building envelope; remove and seal building envelope.
6. Remove light fixture; replace with sympathetc fixture or install concealed security lighting only.
7. Grade slopes in towards building; apparant water damage. Regrade or repave concrete slab for watershed; clean and repair damaged stone.
8. Original porch and roof structure has been removed; determine feasability of restoration.
9. Original breezeway structure removed; determine feasability of restoration.
10. Tree roots destablizing concrete slab

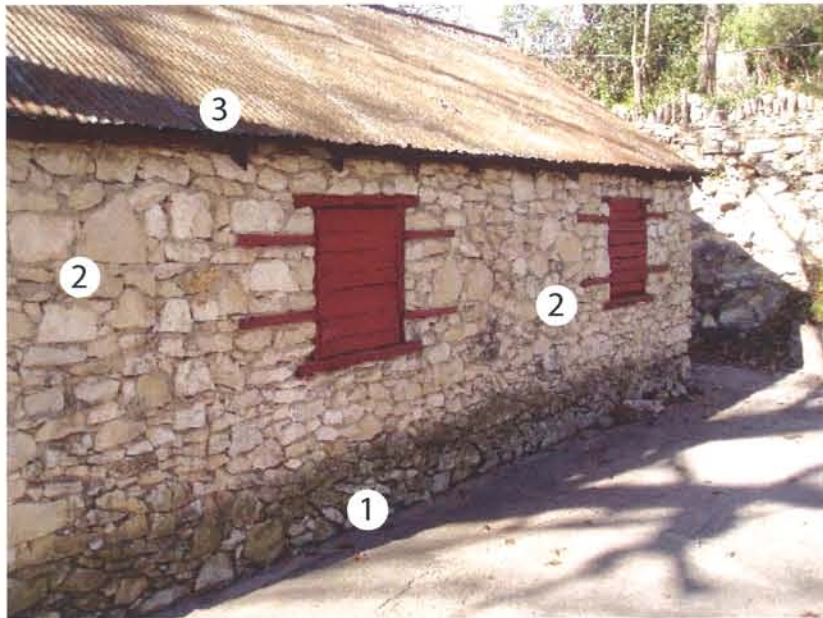
C8- East facade

1. Grade slopes in towards building; apparant water damage. Regrade or repave concrete slab for watershed; clean and repair damaged stone.
2. Area of apparant mortar repair/patching; remove and replace with period sensitive mortar repair.
3. Corrugated roof deteriorating; remove, repair structure, and replace with period sensitive roof.
4. Nails exposed where rot has occured; repair or replace structure.
5. Exposed wood deteriorated; repair or replace as necessary.
6. Door does not meet ADA clearance requirements
7. Water damage to stone masonry at chimney; repair at damaged areas.
8. Chimney cap deteriorated; repair and clean stone, repair and repoint mortar where necessary. Determine suitability for fireplace use for future needs.

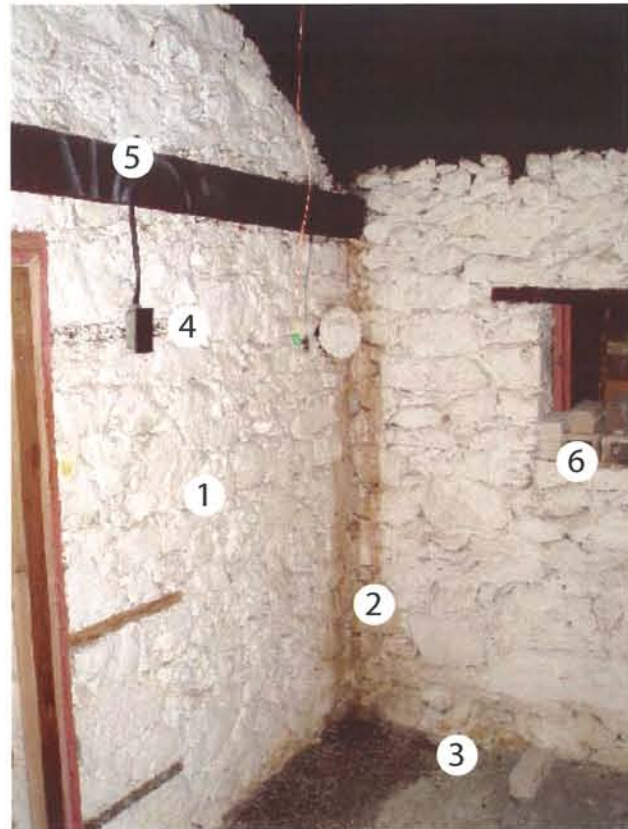
C12- Interior

1. Stone masonry painted, typ.
2. Water damage to walls, deteriorating stone, typ. Determine future use and repair damage as necessary.
3. Concrete floor in disrepair. Repair, re-level, and clean as necessary for future use.
4. Exposed electrical switch/fixture, conduit; remove and replace with period sensitive fixtures and concealed conduit.
5. Wood structure requires restoration
6. Loose infill at window locations; remove and replace with period sensitive window treatment.
7. Continuous vertical crack above window; repair and repoint mortar as necessary for stability.
8. Windows/shutters in disrepair; remove and replace with period sensitive window treatment.
9. Remove insulation at ceiling; check for additional water damage at decking and repair as necessary.

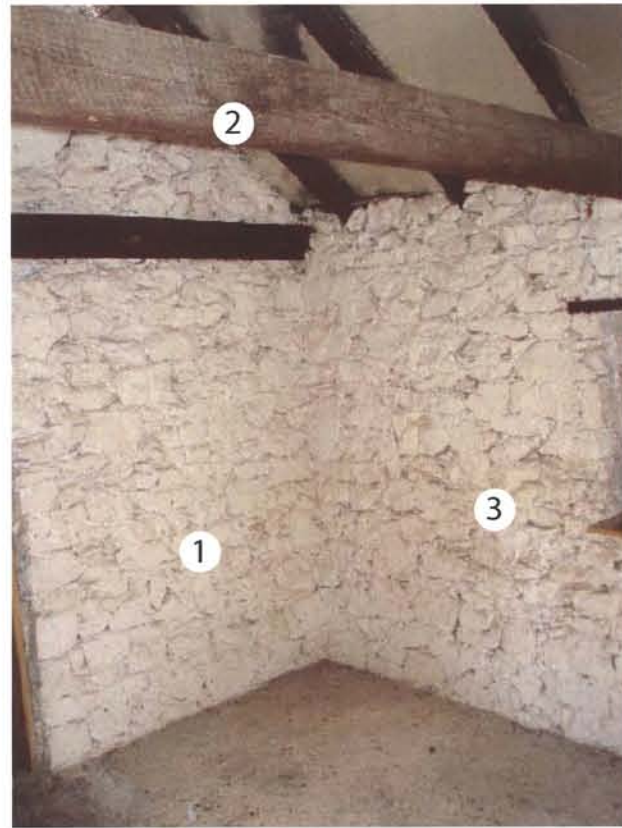
C16- Interior

1. Stone masonry painted, typ.
2. Wood structure requires restoration
3. Stone masonry requires repair/repointing, typ.
4. Exposed electrical switch/fixture, conduit. Remove and replace with period sensitive fixtures and concealed conduit.
5. Remove insulation at ceiling; check for additional water damage at decking and repair as necessary.
6. Water damage to walls, deteriorating stone, typ. Determine future use and repair damage as necessary.
7. Fireplace in disrepair; restore and repair as needed.
8. Concrete floor in disrepair. Repair, re-level, and clean as necessary for future use.
9. Wood door in poor condition; repair as needed.

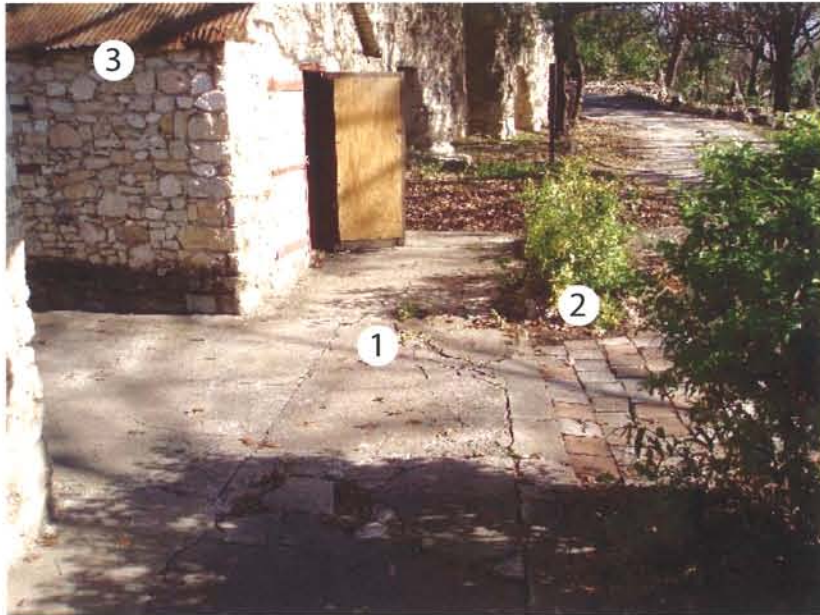
D1- Front entry at Southwest corner

1. Concrete slab cracked/broken, presents unsafe condition; relevel and repair slab for safety and watershed.
2. Plant growth expanding into path; remove source of growth and restore path as needed.
3. Breezeway no longer present; determine feasibility of restoration.
4. Door does not meet ADA clearance requirements
5. Path is inaccessible; incorporate overall accessible path at Historic Mexican Village.
6. Overhead electrical / telephone service; remove all nonfunctional wiring and devices.
7. Area of apparent mortar repair/ patching; remove and replace with period sensitive mortar repair.
8. Grade above building base; regrade for adequate watershed.
9. Exposed wood deteriorated, typ. Determine needs for future use and replace as necessary.
10. Water damage at stone masonry chimney; repair and clean stone; repair and repoint mortar where necessary.

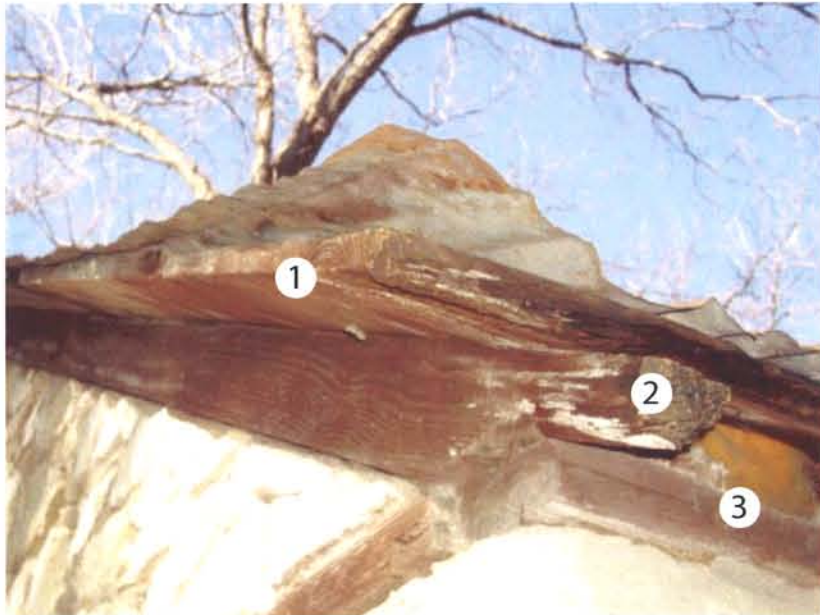
D5- Roof at Southeast corner

1. Corrugated roof deteriorated, buckling typ. Remove, repair structure, and replace with period sensitive roof.
2. Exposed wood deteriorating, typ. Remove and replace as necessary.
3. Insulation penetrating building envelope; remove and seal building envelope.
4. Area of apparant mortar repair/ patching; remove and replace with period sensitive mortar repair.
5. Door does not meet ADA clearance requirements
6. Original porch and roof structure has been removed; determine feasibility of restoration.
7. Chimney cap missing

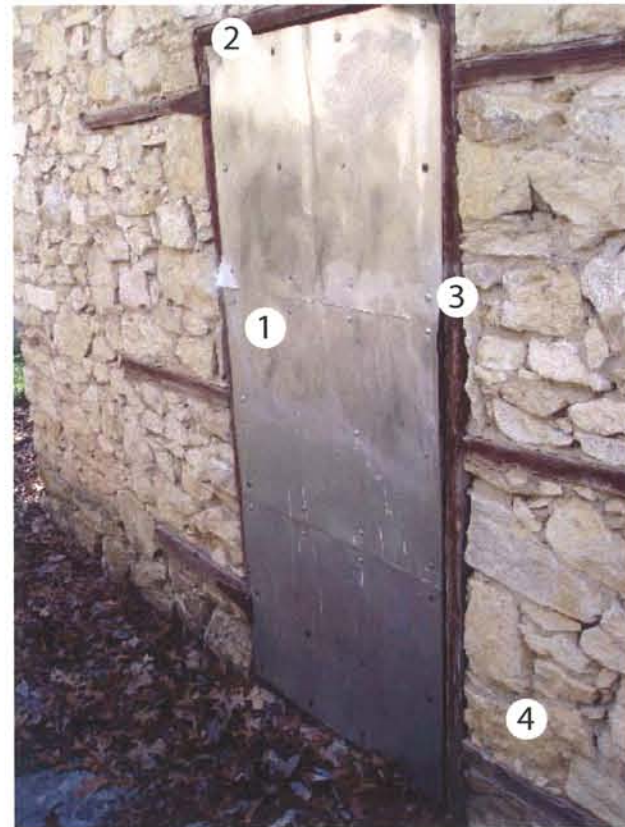
D8- Rear entry at North facade

1. Unsympathetic repair to door; remove and replace with period door.
2. Door does not meet ADA clearance requirements
3. Exposed wood deteriorating; remove and replace as necessary.
4. Stone masonry spalling at building base; remove and replace deteriorating stone.
5. Concrete infill at windows; remove and replace with period sensitive window treatment.
6. Area of apparant masonry repair/patching; remove and replace with period sensitive mortar repair.
7. Corrugated roof deteriorated, buckling. Remove, repair structure, and replace with period sensitive roof.
8. Wood doors deteriorated due to water/insect damage. Remove and replace with period sensitive doors.
9. Continuous crack next to door; assess structural stability and repair/ repoint mortar as necessary.

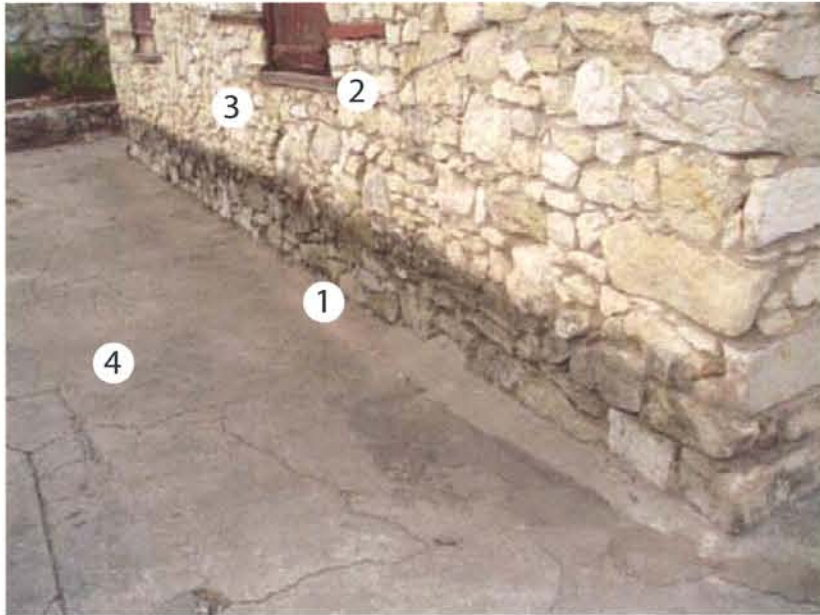
D12- West facade

1. Grade slopes toward building; apparant water damage at splash zone; regrade at building base for adequate watershed.
2. Exposed wood deteriorated; remove and replace as necessary
3. Cracks around openings; repair and repoint mortar as necessary
4. Breezeway no longer present; determine feasibility of restoration.
5. Water damage to stone masonry at chimney; repair and clean stone; repair and repoint mortar where necessary.
6. Vertical crack; assess structural stability and repair/repoint mortar as necessary.
7. Corrugated roof deteriorated. Remove, repair structure, and replace with period sensitive roof.
8. Grade above building base. Regrade for adequate watershed.

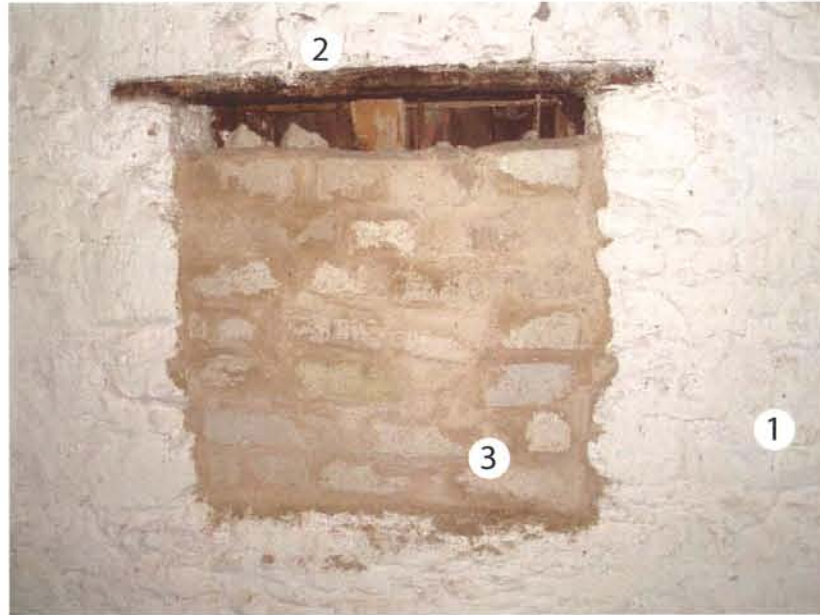
D14- Interior

1. Stone masonry painted, typ.
2. Exposed wood deteriorated, typ. Remove and replace as necessary.
3. Stone / brick infill at window. Remove and replace with period sensitive window treatment.
4. Water damage to stone masonry at wall base, typ. Determine future use and repair damage as necessary.
5. Fireplace in disrepair; restore and repair as needed.
6. Wood structure requires restoration
7. Concrete floor in disrepair; repair, re-level, and clean as necessary for future use.
8. Exposed bulbs; unsympathetic light fixtures. Remove and replace with period sensitive fixtures and concealed conduit.
9. Exposed conduit/ wiring. Remove all nonfunctional wiring and devices.
10. Deck deteriorated; remove and replace.

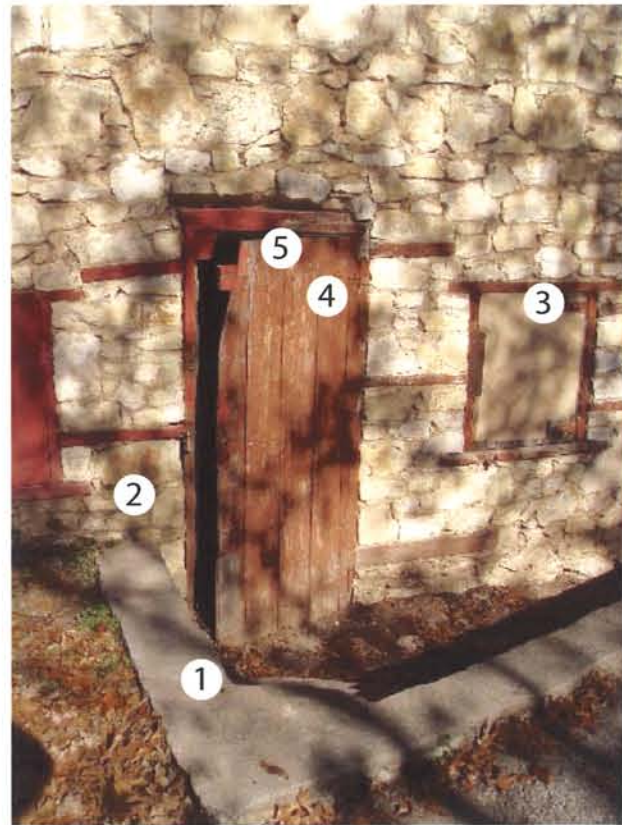
E1- Front entry at South facade

1. Inaccessible entry into building. Incorporate overall accessible path to Historic Mexican Village.
2. Vertical crack near window opening; repair and repoint mortar as necessary.
3. Unsympathetic repair at window; remove and replace with period sensitive window treatment.
4. Exposed wood door/window frame deteriorated; remove and replace.
5. Door does not meet ADA clearance requirements
6. Grade is above building base; regrade for adequate watershed.
7. Area of apparent mortar repair/ patching; remove and replace with period sensitive mortar repair.
8. Exposed roof structure deteriorated; remove and replace.
9. Exposed telephone service; remove all nonfunctional wiring and devices.
10. Transformer & pad should be relocated or concealed
11. Rear porch structure removed; determine feasibility of restoration.
