Japanese Tea Garden Master Plan

Japanese Tea Garden
Master Plan
San Antonio, Texas

June 2007

SWA Group
Project Landscape Architect
Houston, Texas

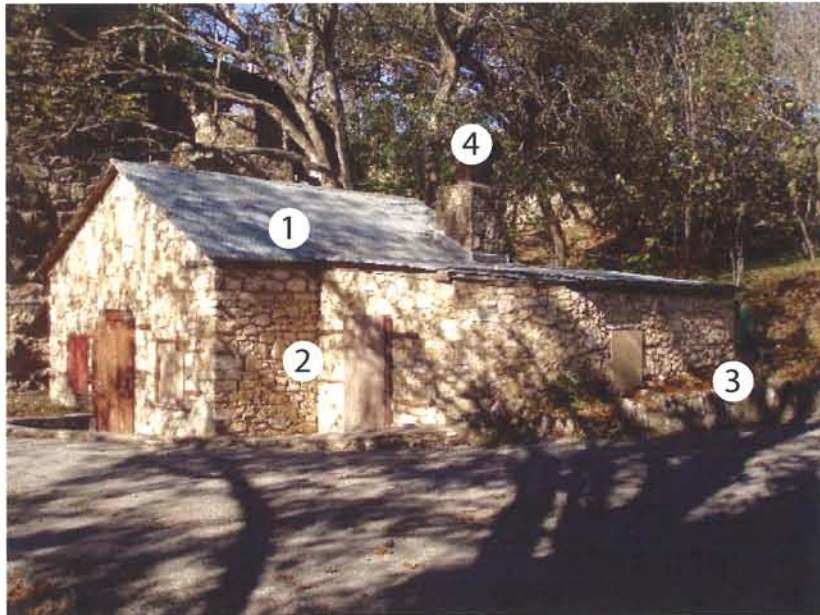
E5- Southeast corner from road

1. Corrugated roof and decking recently installed
2. Continuous vertical crack at inside corner at South side; assess structural stability and repair/repoint mortar as necessary.
3. Grade is above building base; regrade for adequate watershed.
4. Chimney top is deteriorated; determine suitability of fireplace use and restore or repair as needed.
5. New decking in good shape
6. Electrical conduit entry; remove all nonfunctional wiring and devices.
7. Exposed roof structure deteriorated. Remove and replace.
8. Exposed telephone service line; remove nonfunctional wiring and devices.
9. Area of apparent mortar repair/patching; remove and replace with period sensitive mortar repair.

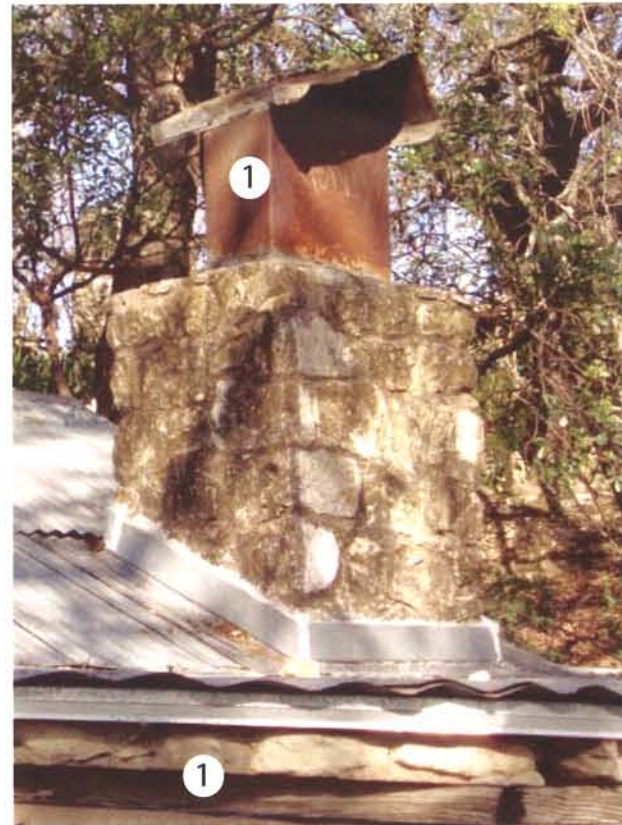
E8- Chimney at North facade

1. Chimney cap deteriorated; restore or repair as needed.
2. Exposed wood deteriorating. Remove and replace with period sensitive window treatment.
3. Continuous vertical crack from window opening to roofline; assess structural stability and repair/repoint mortar as necessary.
4. Area of apparant mortar repair/patching; remove and replace with period sensitive mortar repair.
5. Water damage at stone masonry; clean and repair as necessary.
6. Grade is above building base; regrade for adequate watershed.
7. Door does not meet ADA clearnace requirement
8. Stone masonry spalling near building base; remove and replace deteriorating stone.
9. Unsympathetic window repair; remove and replace with period sensitive window treatment.
10. Drainage at entryway recess

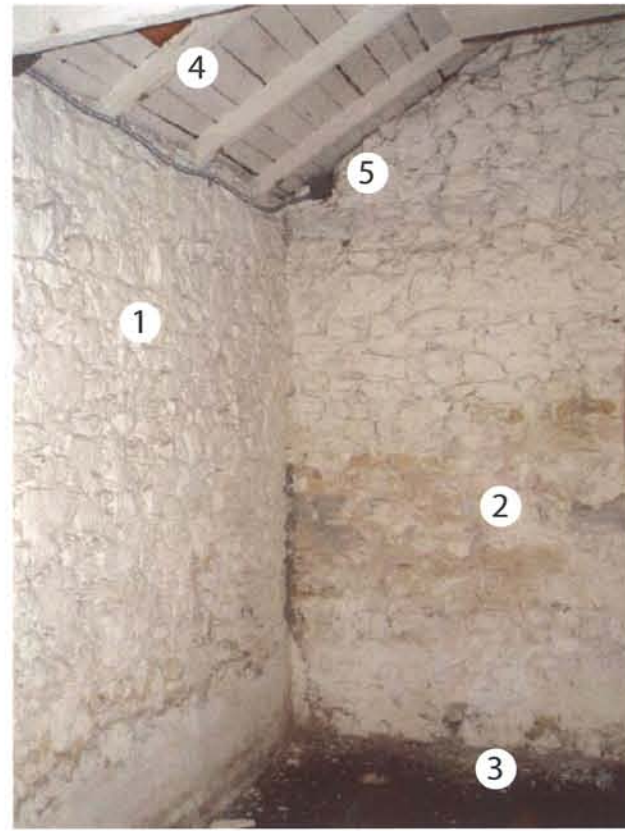
E11- Interior

1. Stone masonry painted, typ.
2. Water damage to stone masonry walls, typ. Determine future use and repair damage as necessary.
3. Concrete floor in disrepair; repair, re-level, and clean as necessary for future use.
4. New roof decking visible
5. Exposed electrical conduit; remove all nonfunctional wiring and devices.
6. Windows and doors in disrepair; remove and replace with period sensitive window treatment.

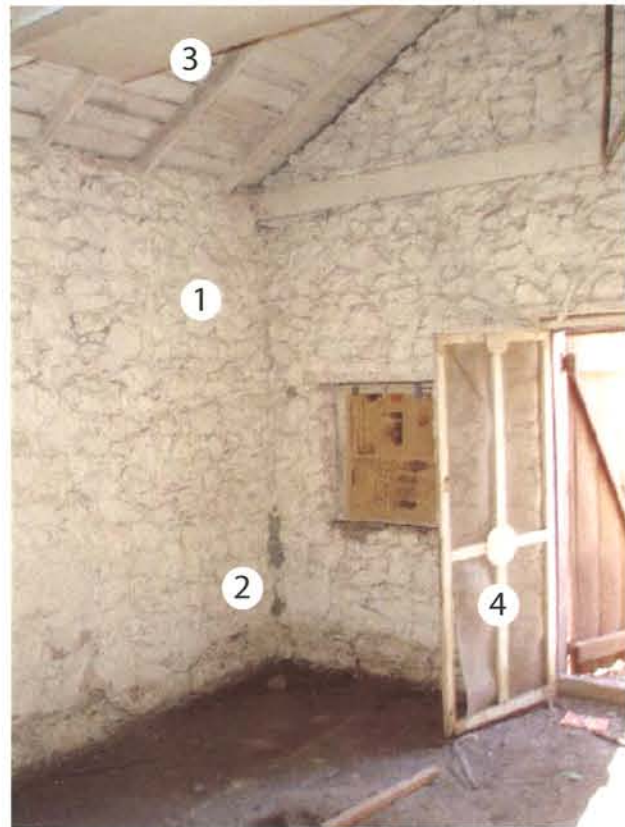
E15- Interior

1. Stone masonry painted, typ.
2. Water damage to stone masonry walls, typ. Determine future use and repair damage as necessary.
3. Unsympathetic light fixture; remove and replace with period sensitive fixtures and concealed conduit.
4. Door in disrepair; repair as necessary.
5. Concrete floor in disrepair; repair, re-level, and clean as necessary for future use.
6. New roof decking visible
7. Door frame rotted; remove and replace.
8. Area of apparant mortar repair/ patching
9. Fireplace in disrepair; restore and repair as needed.

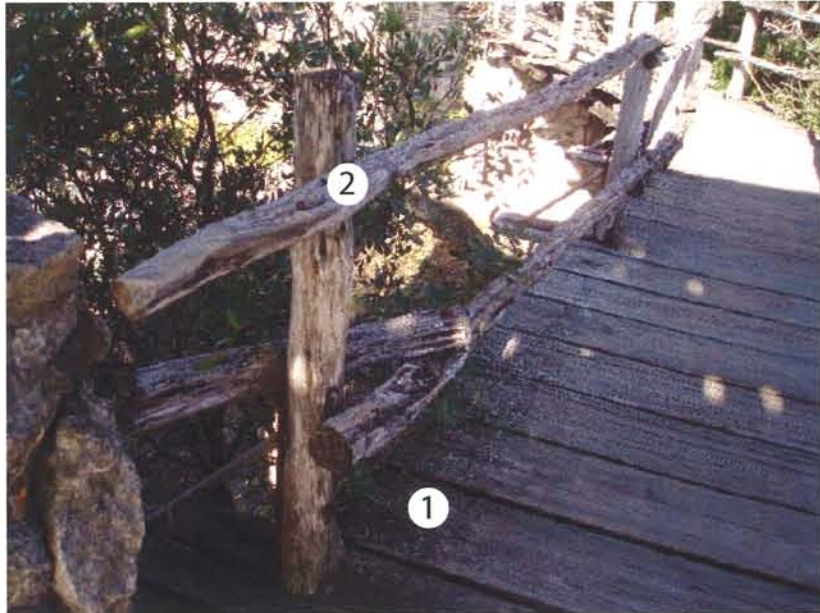
F1- Bridge

1. Wood bridge decking deteriorated; water damage apparant. Restore and repair as necessary to prevent further deterioration.
2. Hand rail deteriorated, nails exposed, guardrail not code compliant. Remove and install or repair period sensitive railing where needed.
3. Handrail bracing replaced with steel supports; remove and replace with period sensitive cedar post bracing as necessary.
4. Roof at overlook deteriorated, typ. Remove and replace with palapa-style roof.
5. Exposed wiring; remove all nonfunctional wiring and devices.
6. Unable to determine functionality of lighting; restore fixture and install electrical service as necessary.

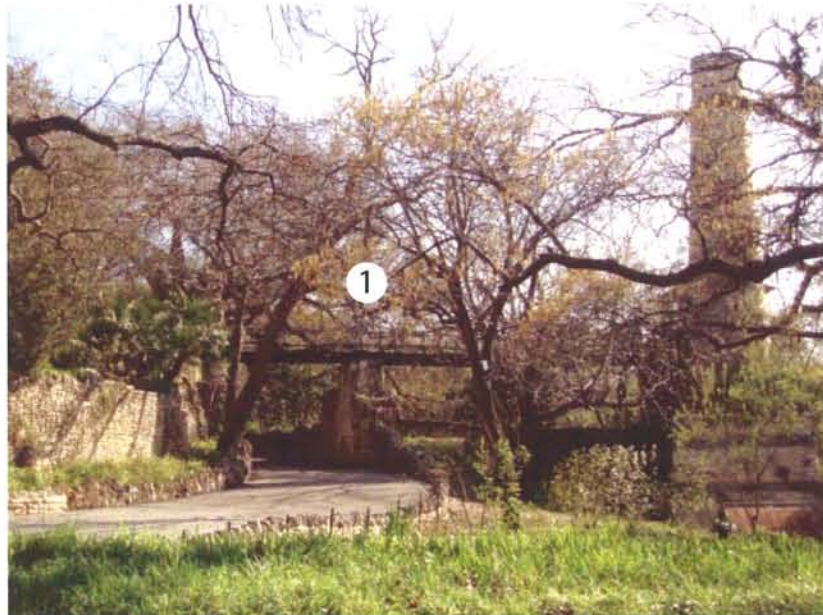
F4- Bridge from road

1. Thatched Palapa roof from pavillion no longer present
2. Insufficient guardrail at overlook, presents unsafe condition; determine need and install period sensitive railing where necessary.
3. Roof and structure deteriorated; remove and restore
4. Overgrowth of plants damaging stone masonry; remove source of growth and restore masonry where necessary.
5. Vertical crack at stone column; repair and repoint mortar as necessary.

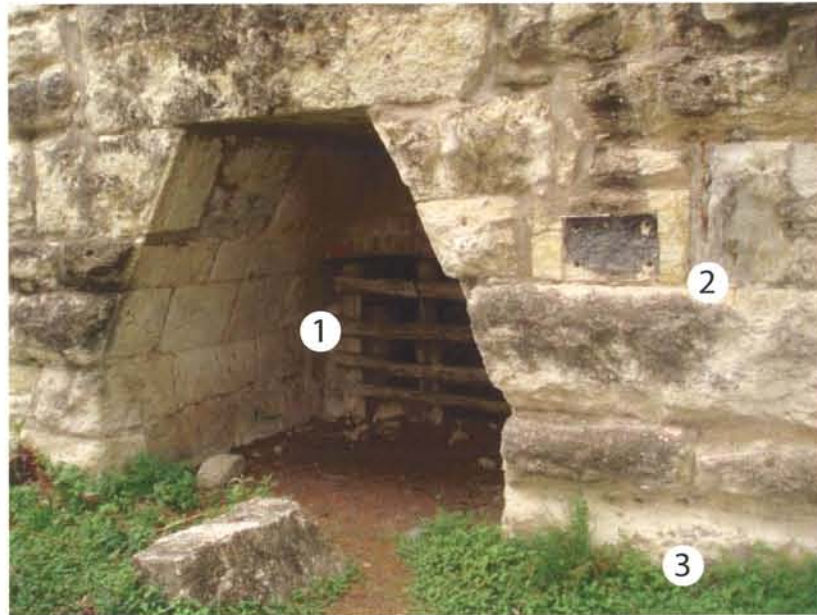
G1- Kiln opening

1. Kiln openings require cleaning, restoration
2. Plaque missing/removed from wall; stone masonry damaged; clean and restore.
3. Undefined landscape/ boundary at base. Determine needs for accessible path and delineate if needed.
4. Plant growth damaging historic features; remove source of growth or prohibit future growth and restore masonry where needed.
5. Existing electrical service; recommend removing or relocating
6. Smokestack vandalized near overlook; install preventative guardrail or other means of security.
