EVALUATION OF COOL PAVEMENT SURFACE TREATMENTS USING FRICTION, TEXTURE AND ADHESION PROPERTIES

PREPARED FOR:
City of San Antonio

REPORT DATE
February 12, 2024

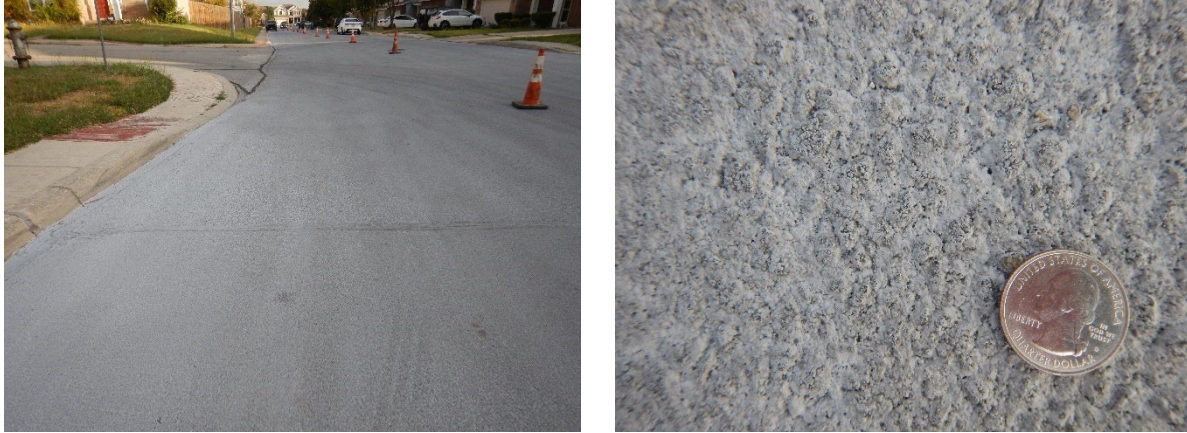
Figure 14. Photos of Mountain Star treatment with Seal Master.

The Mountain Star treatment site was tested in June and September due to a breakdown of the DF Tester during the June measurements, which required retesting in September to validate the June measurements.

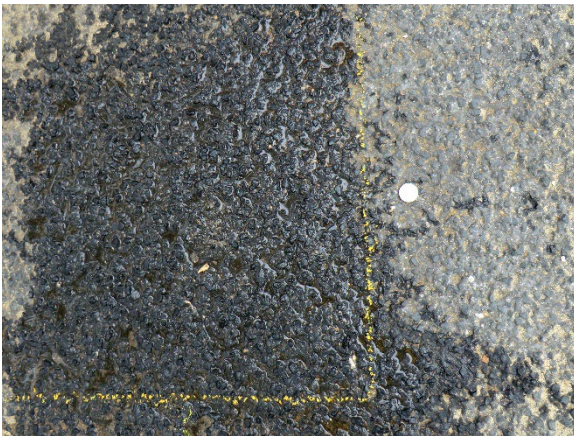
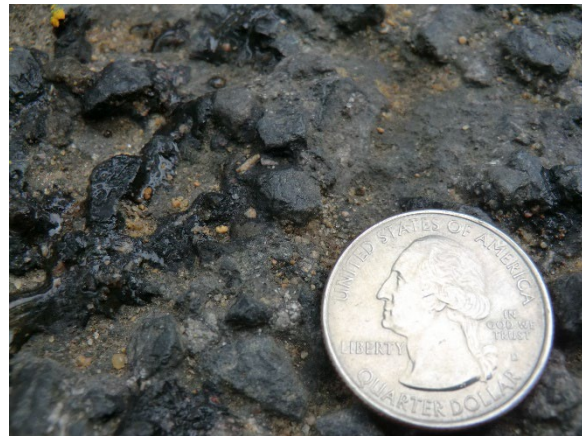
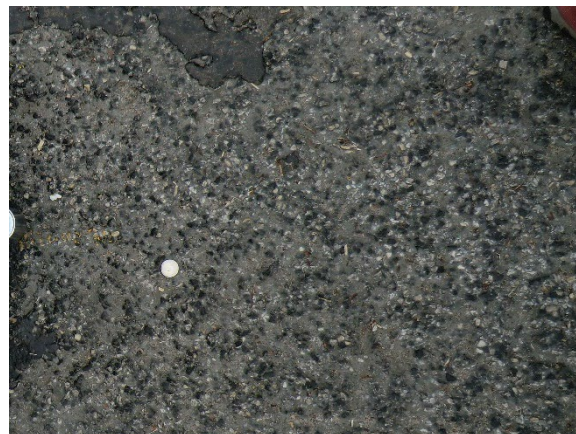
Figure 25. Photos of Encino Ridge St. treated section with Pavement Tech (top) and Encino Grove control section (bottom).

DF Tester friction values from the wheelpath test locations for the treated and control sites are shown in Table 44, and values for the test locations outside of wheelpath are shown in Table 45. It was noted by the test team that the treated surface was extremely rough and course-textured, which can sometimes affect DF Tester measurements.

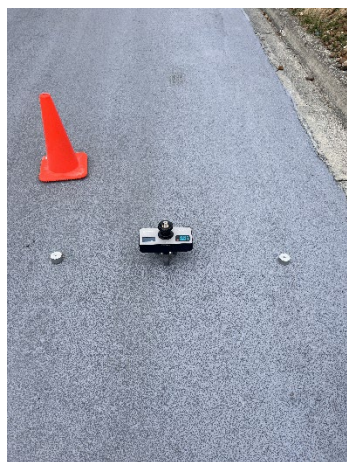
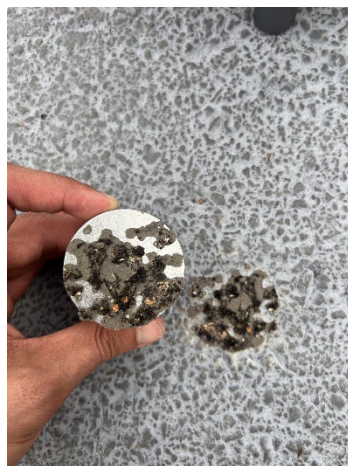
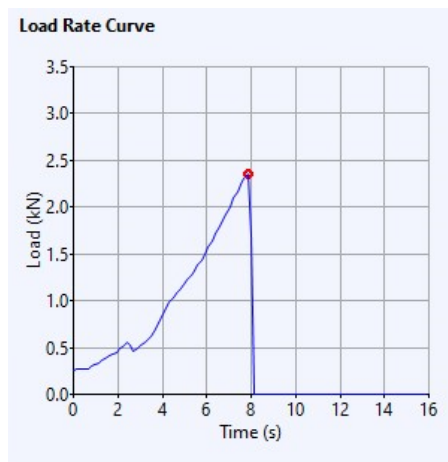
Figure 35. Demonstration of the Pull-off tester at the site with a sample diagram of the peak load over time.

The pull-off tester is applied in the wheel path and outside the wheel path in the treated section only (see Figure 34). The maximum pull-off force is determined when the aluminum cylindrical disk is separated from the surface. The peak load time is also determined from the load -time curve provided by the instrument. Using the peak load and the duration time until the separation, the total adhesion energy is determined representing the area under the triangle in Figure 34. The summary of the pull-off forces and peak time are compiled in Table 59.
